# final report

Project code: P.PIP.0734

Prepared by: William Trieu, Merv Shirazi, Kavin Miranda  
Scott Automation and Robotics

## **Automated Forequarter Cell Installation for Lamb – Wagstaff Cranbourne Pty Ltd.**

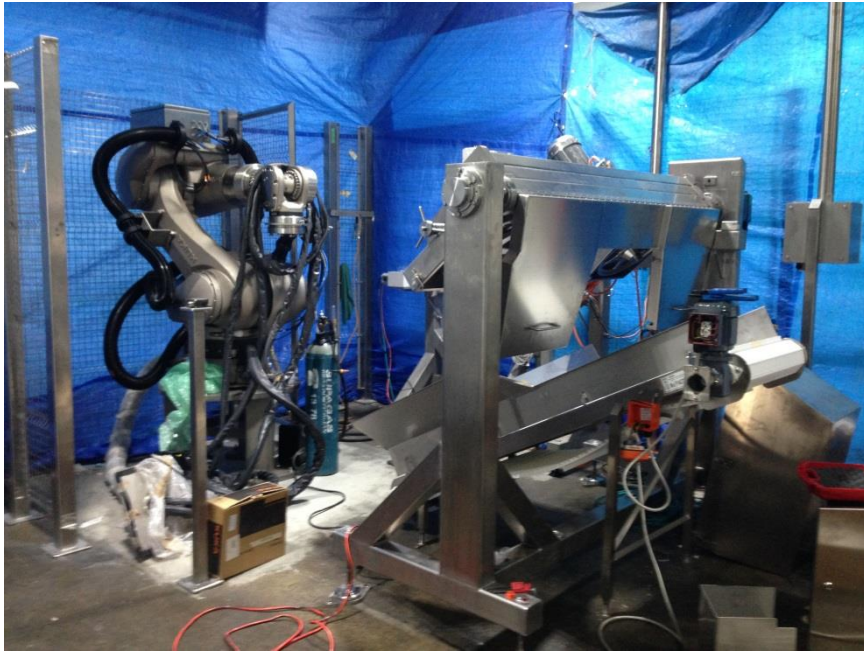
**Fig. 4: Robot System Installation at Wagstaff Pty. Ltd.**

Initially, the Forequarter system and fencing was drilled into the concrete in the room setup for the installation at Wagstaff Cranbourne Pty. Ltd.

The robot controller and panel was installed out of the room, in a separate area, this was due to the fact that the controller cabinet wasn't suitable for application in a clean room/wash down environment.

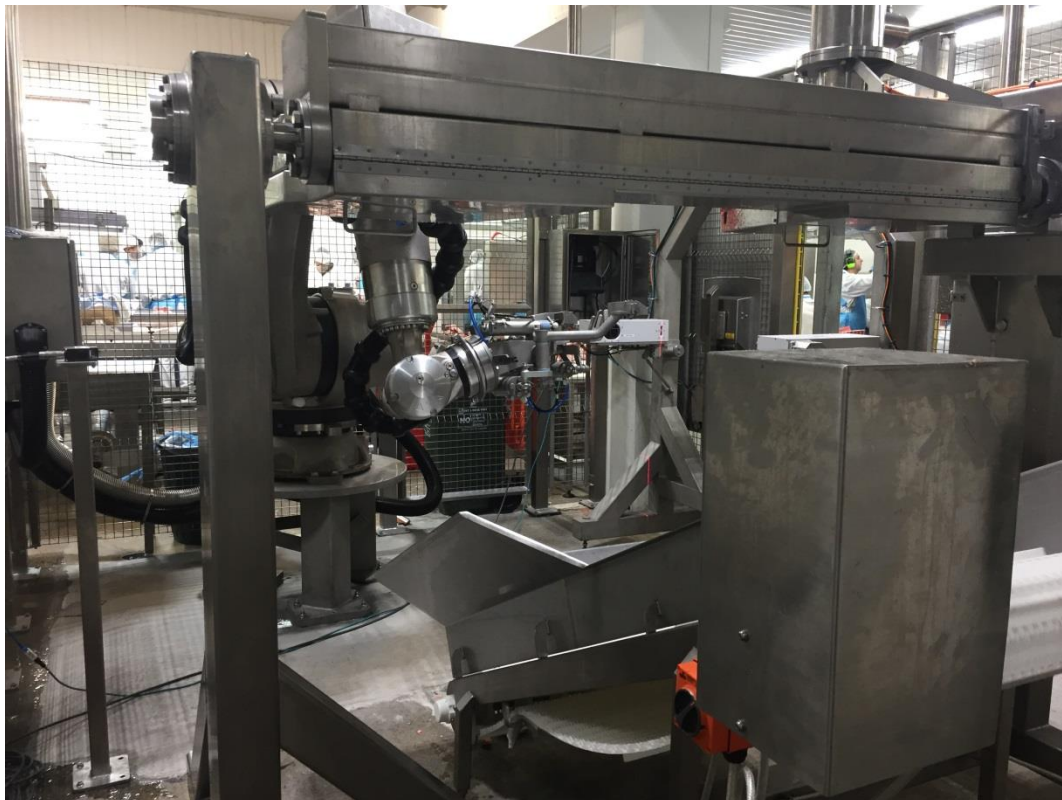
**Fig. 10: Robot with Gripper, Bandsaw, and Product Conveyor**

**Fig. 11: Robot with Gripper, Bandsaw, and Product Conveyor 2**

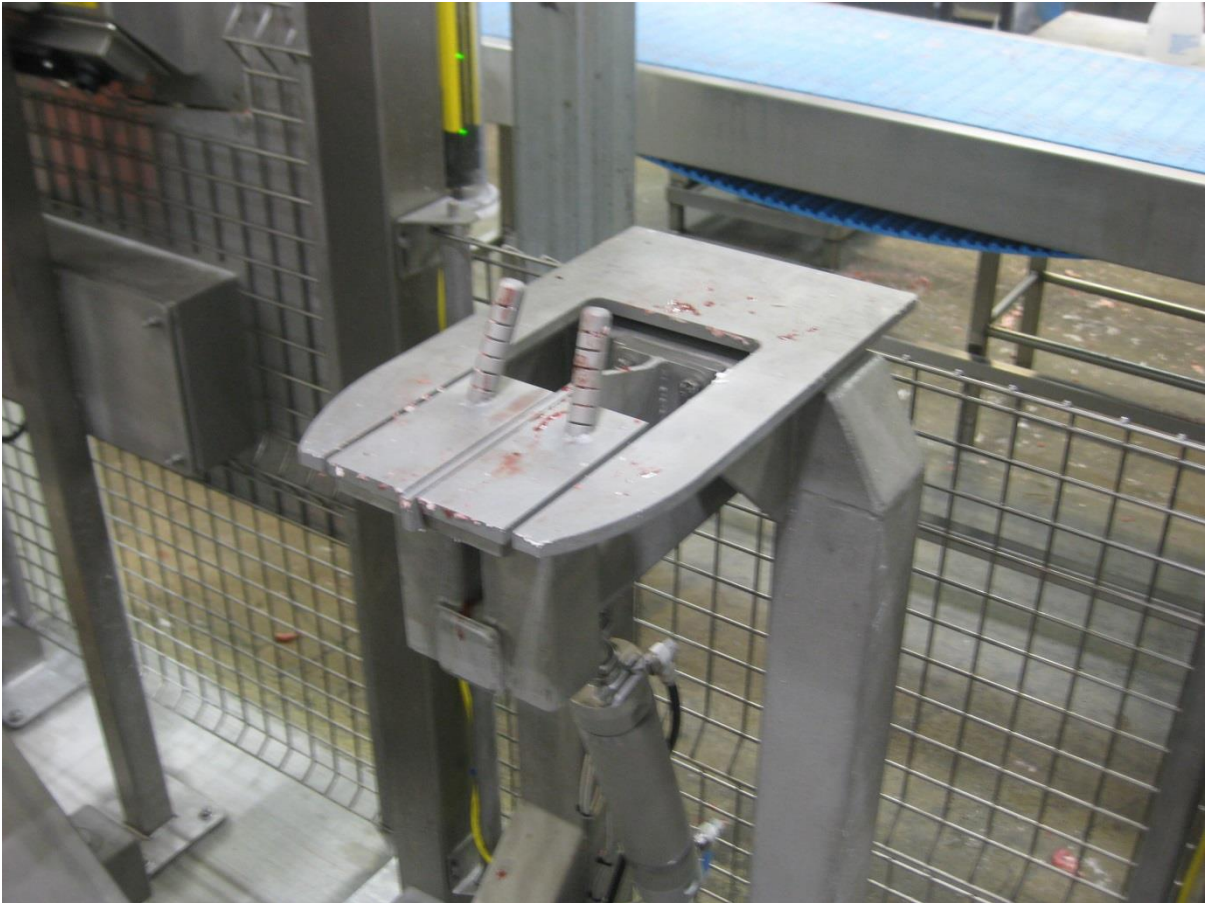
**Fig. 12: Original Load Table**

It was found that the locating pins on the load table were too long, resulting in minimal contact between the forequarter rib arches and the locating pins during loading. This typically resulted in product being loaded askew, and ultimately producing bad cuts. The locating pins were replaced with interchangeable pins, allowing pins of different lengths to be tested.

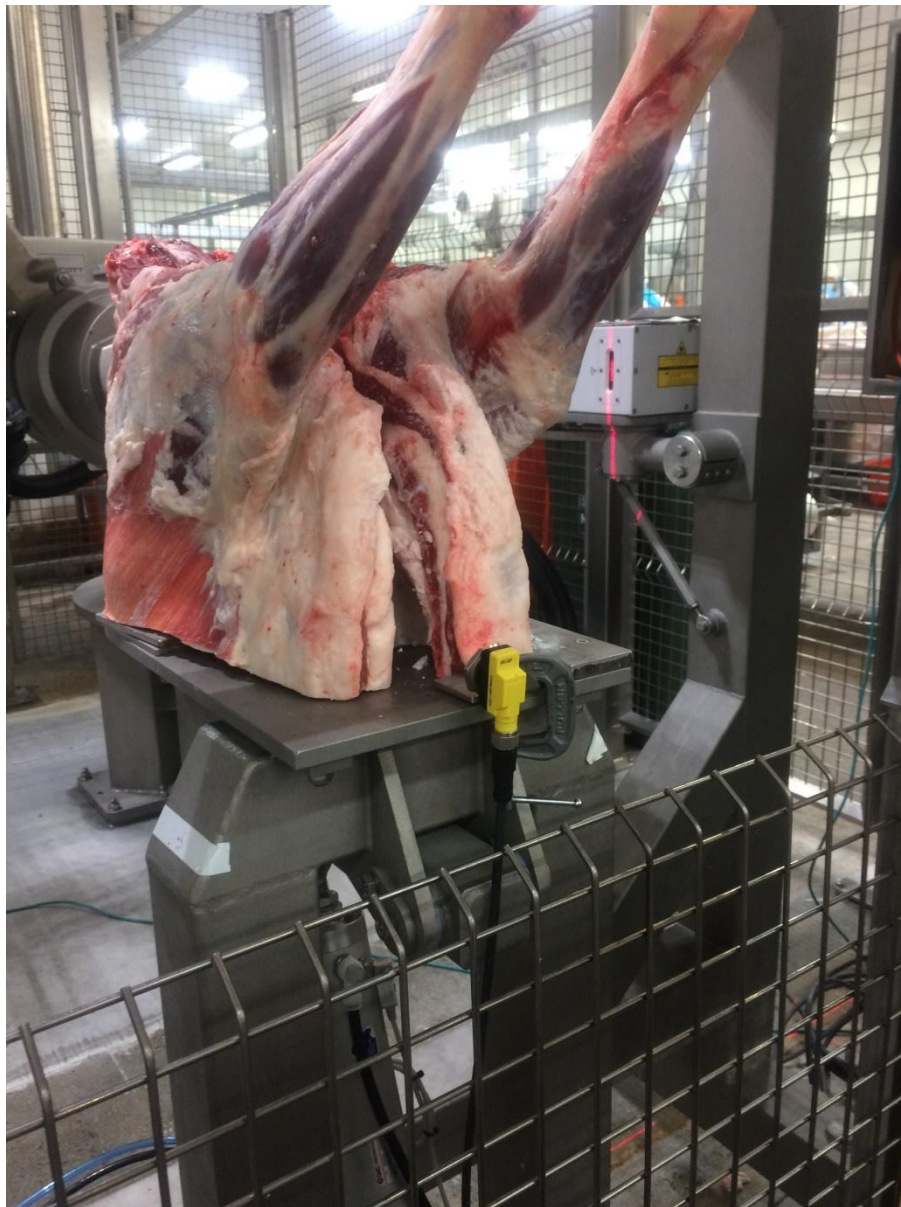
**Fig. 17: Initial Laser Trial Setup**

An alignment laser was trialed to assist the operator in positioning the forequarter central to the load table. The premise was to project a crosshair along the fat seam that runs along the centre of the forequarter. The initial trial was deemed promising, however the laser used was too narrow and weak and therefore not fit for the application.

**Fig. 18: Initial Laser Trial Projection**

**Fig. 19: Initial Laser Trial Projection Close Up**

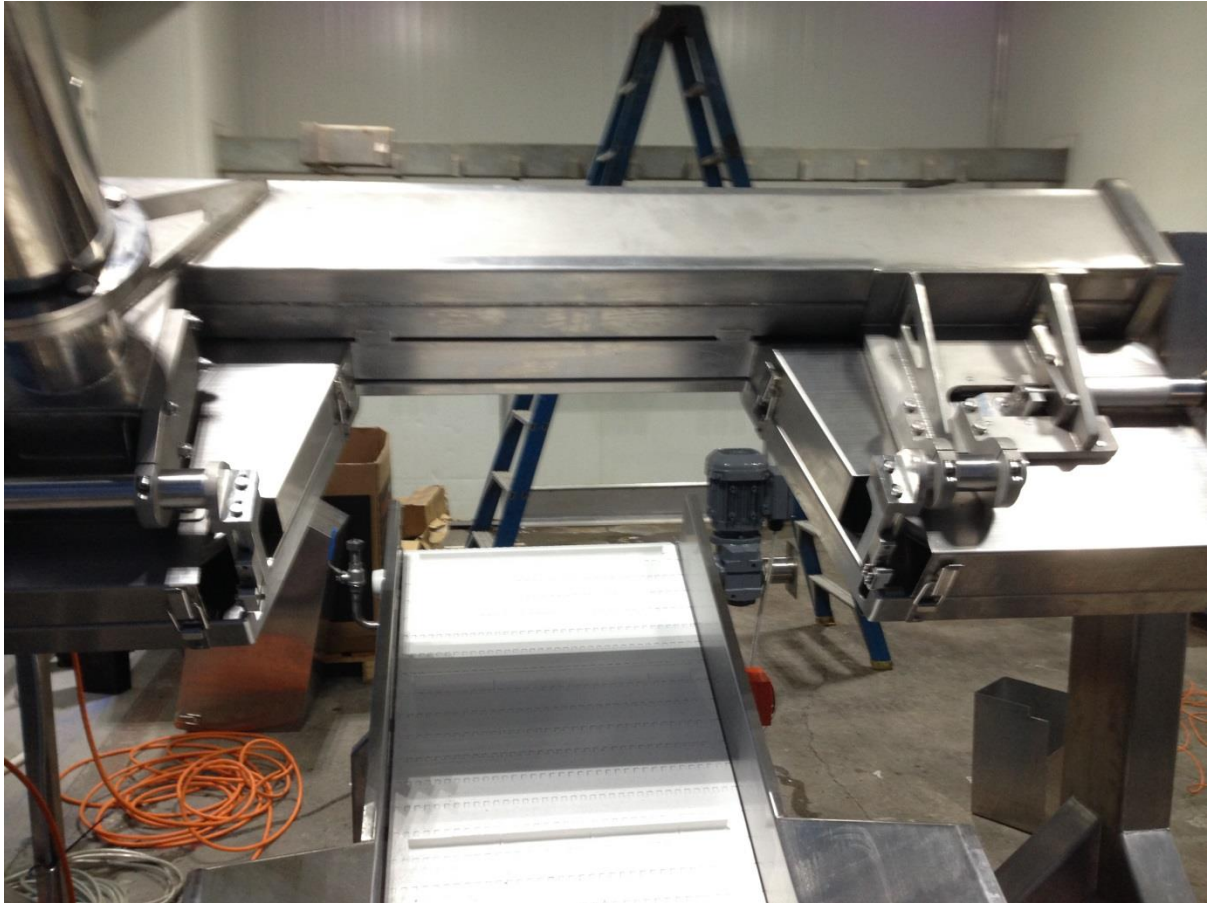
**Fig. 20: Original Bandsaw Blade Guides**

New bandsaw blade guide support arms were fabricated to accommodate the new blade guide locations. This was done to ensure the blade guide supporting arms were wholly supported within the blade guide support arm clamps.

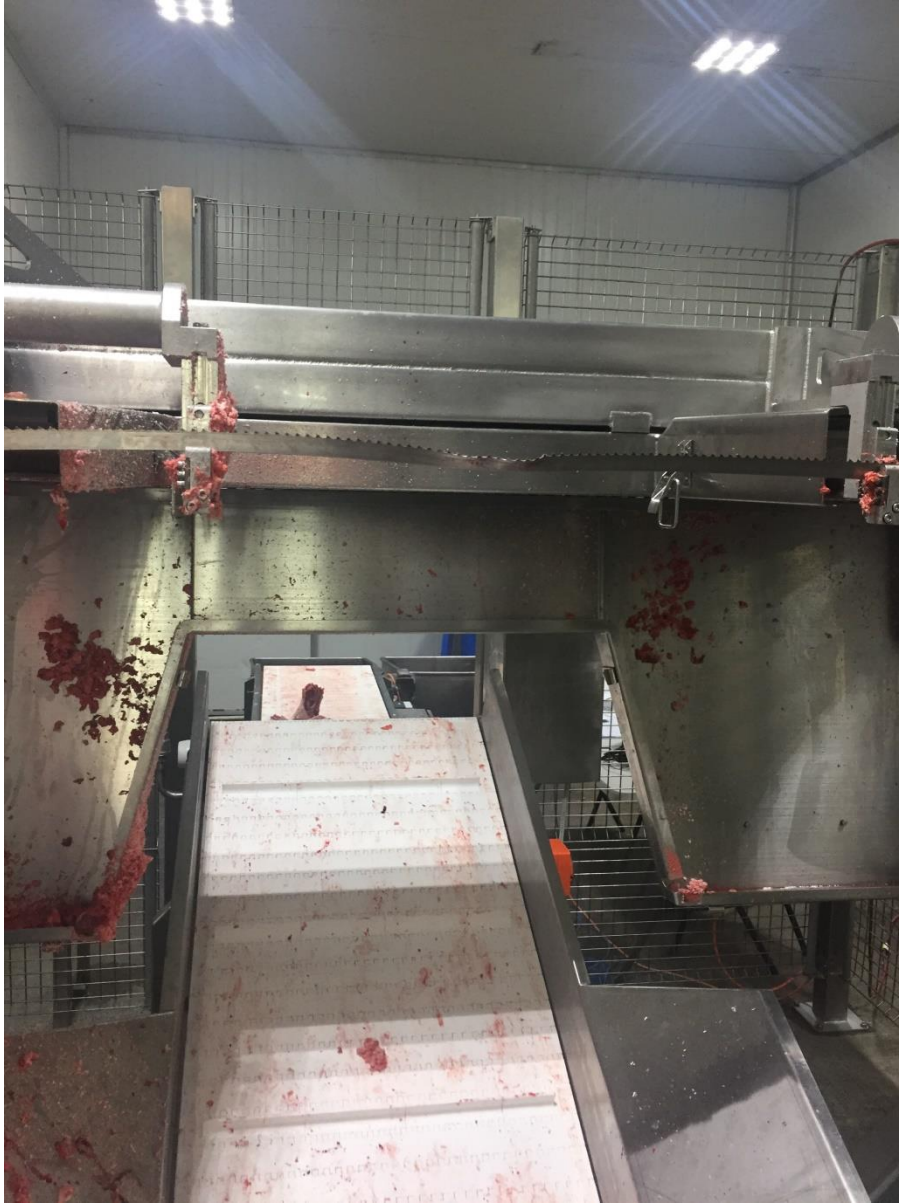
**Fig. 21: Adjusted Left Bandsaw Blade Guide to Fix the Issue of Excessive Blade Deflection and Damage as in the Image Above. The issue has been fixed by modification of guide, bearing, and shaft.**

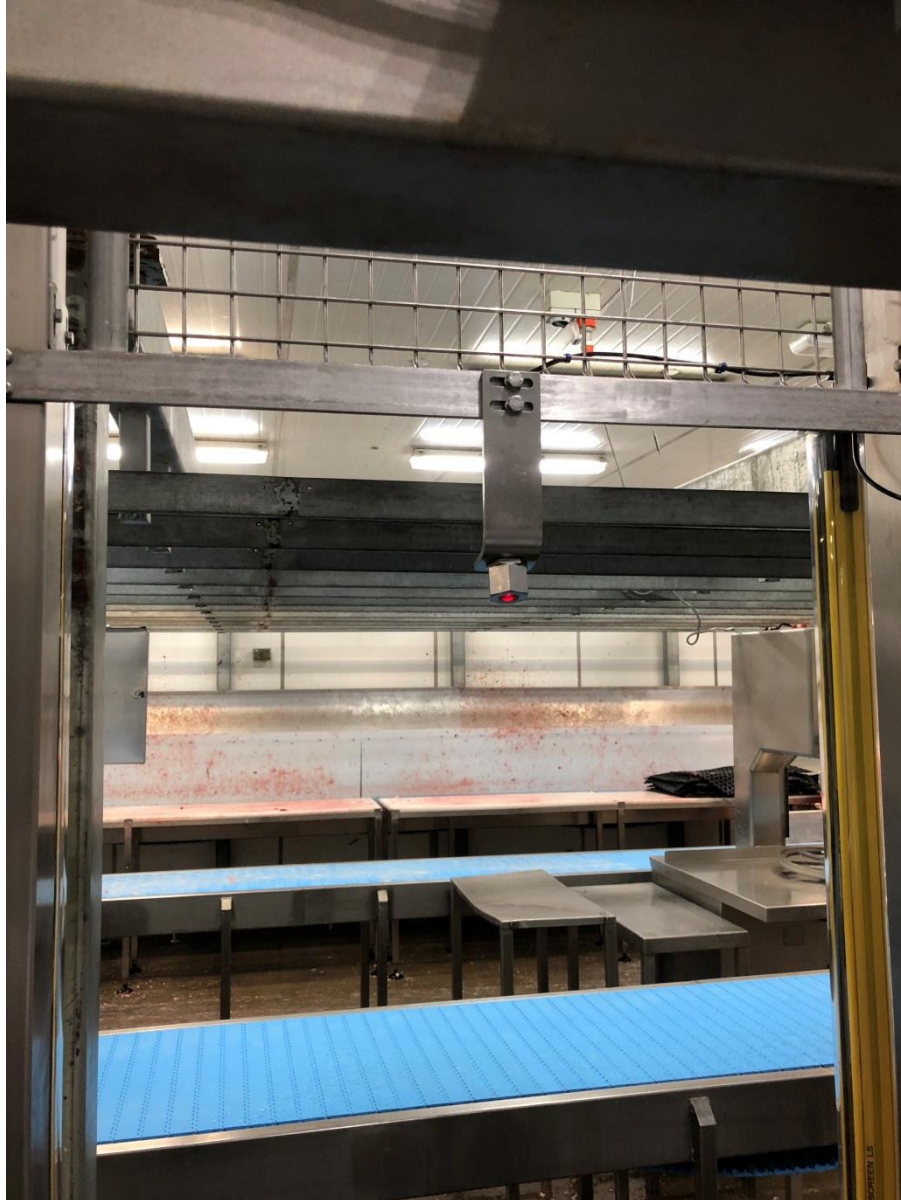
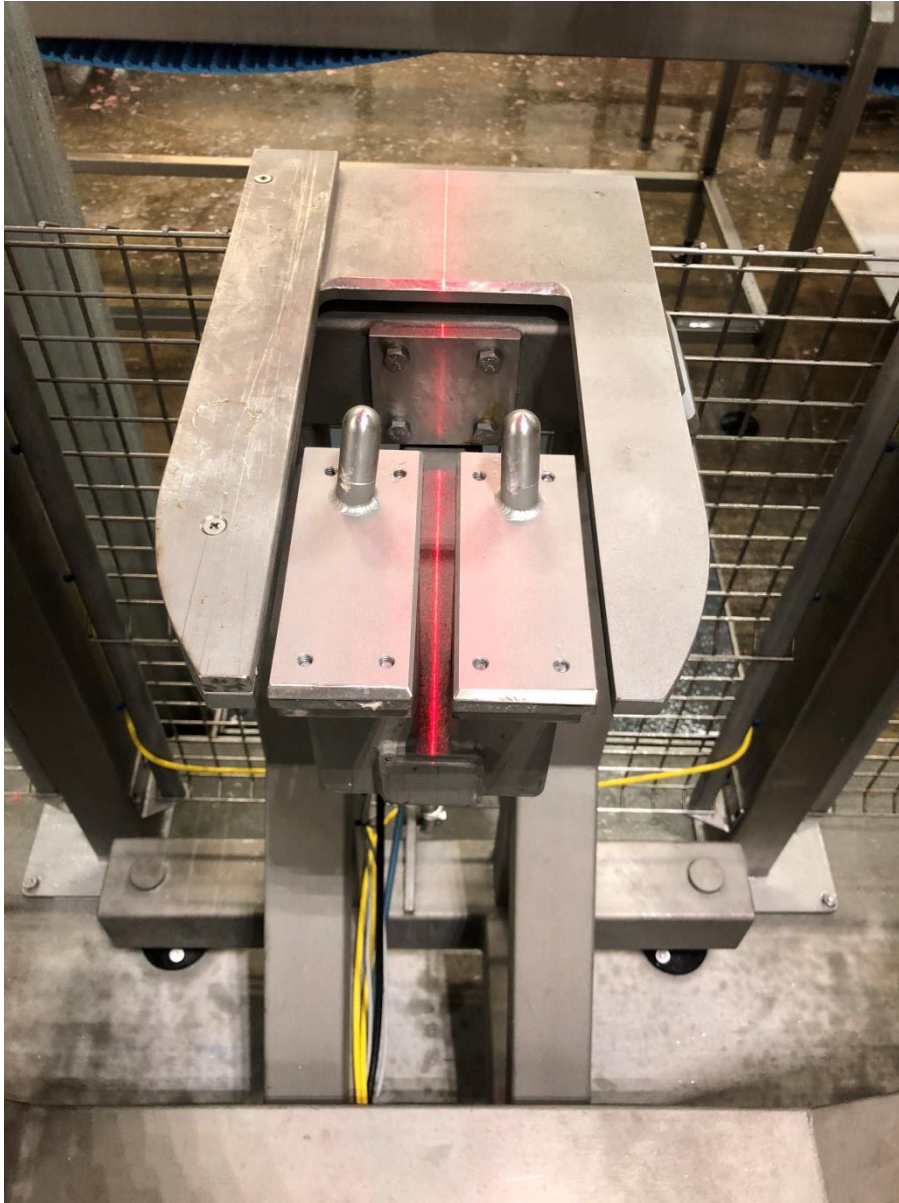
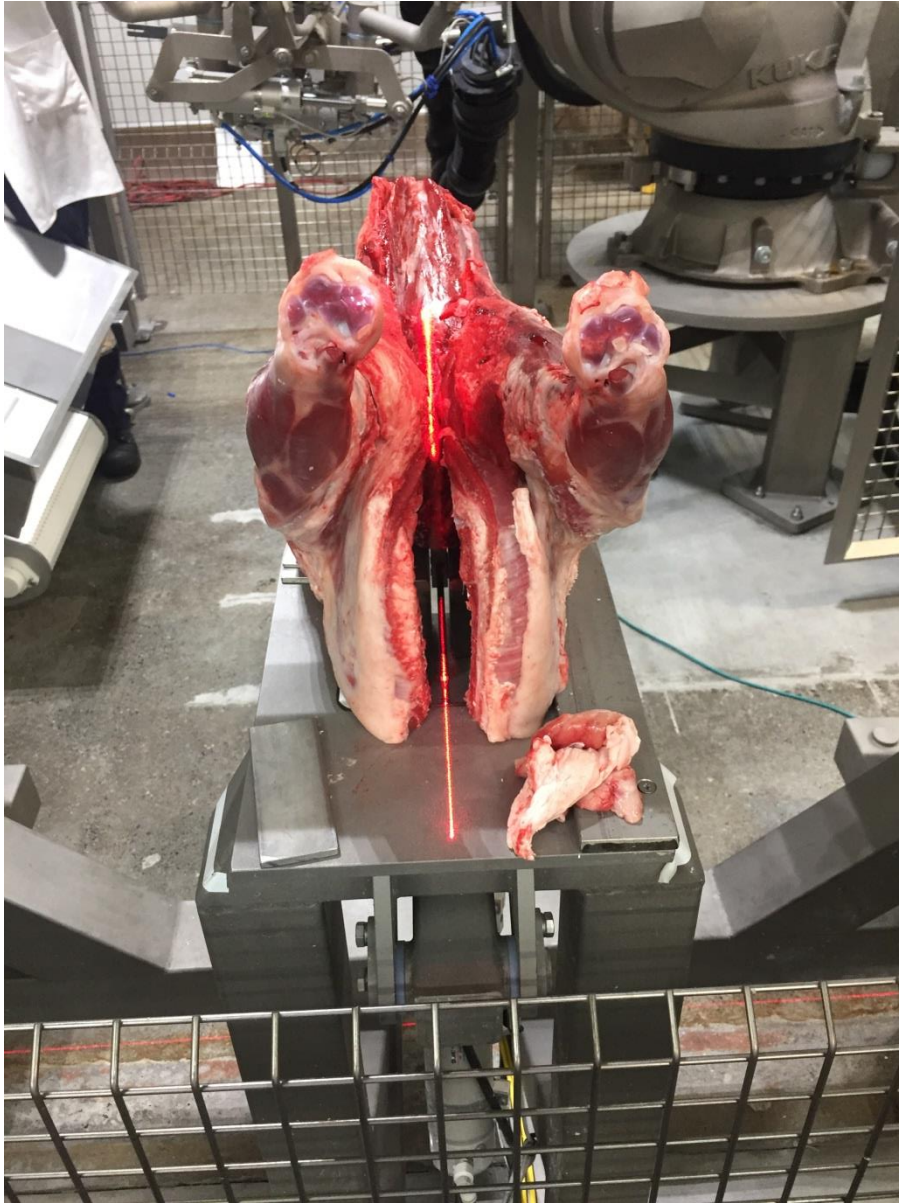
**Fig. 22: Alignment Laser**

A high power laser was fitted above the load table to project a line down the centre of the forequarter. This is used to assist the operator in positioning the forequarter central to the load table.

**Fig. 23: Load Table with Alignment Laser**

**Fig. 24: Alignment Laser Projected on Product**

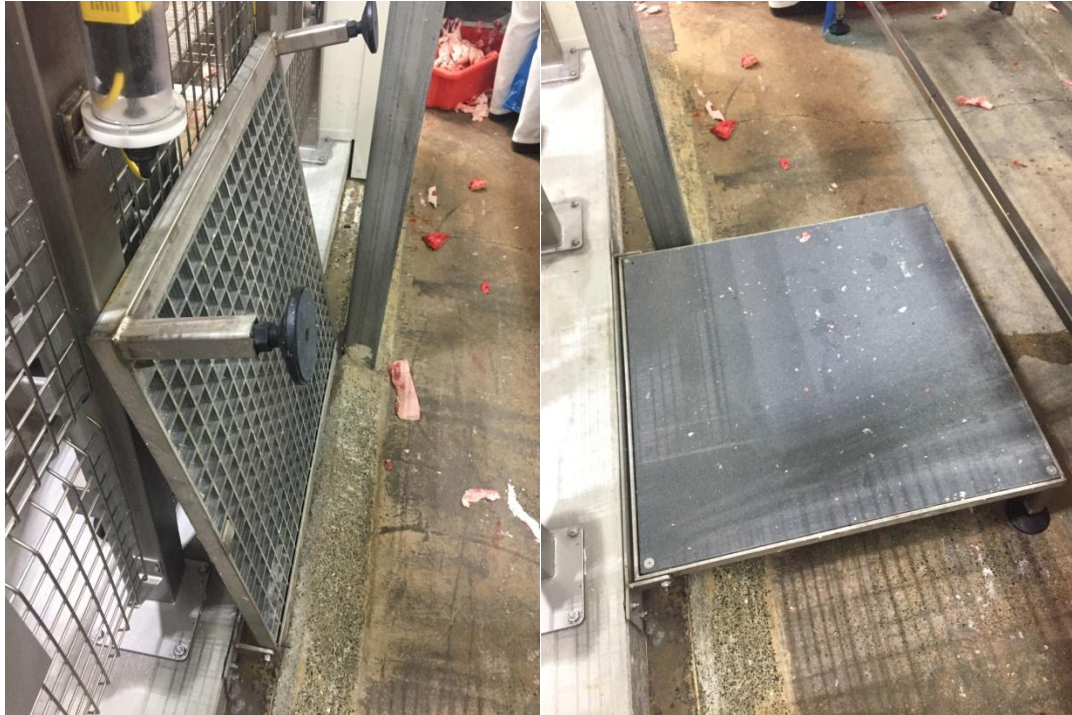
**Fig. 25: Operator Platform – Raised / Lowered**

An operator platform was fabricated and commissioned by Wagstaff Cranbourne Pty. Ltd. to raise the operator in line with the load table. This reduced the height that the operator is required to lift the product during loading, and decreased the potential for an RSI related injury.

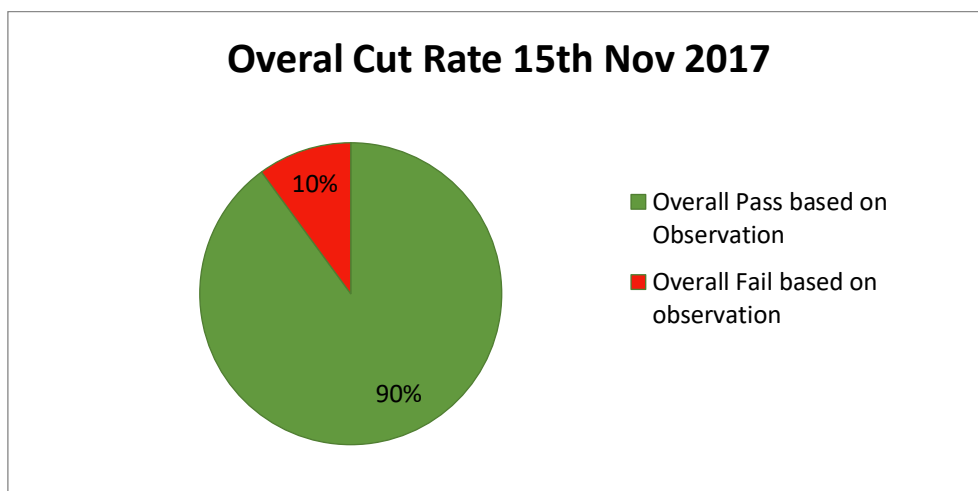
Fig. 26: Production Breakdown 15<sup>th</sup> Nov 2017

- Production run:
  - o 189 product through the cell
  - o 40 product rejected and not processed
  - o 134/149 cut product were acceptable
- Failure breakdown:
  - o 5 bad cuts was due to bad shanks
  - o 2 bad cuts was due to bad knuckles
  - o 1 bad cut was due to bad necks
  - o 7 bad cuts was due to bad splits

Fig. 27: Overall Cut Rate 15<sup>th</sup> Nov 2017

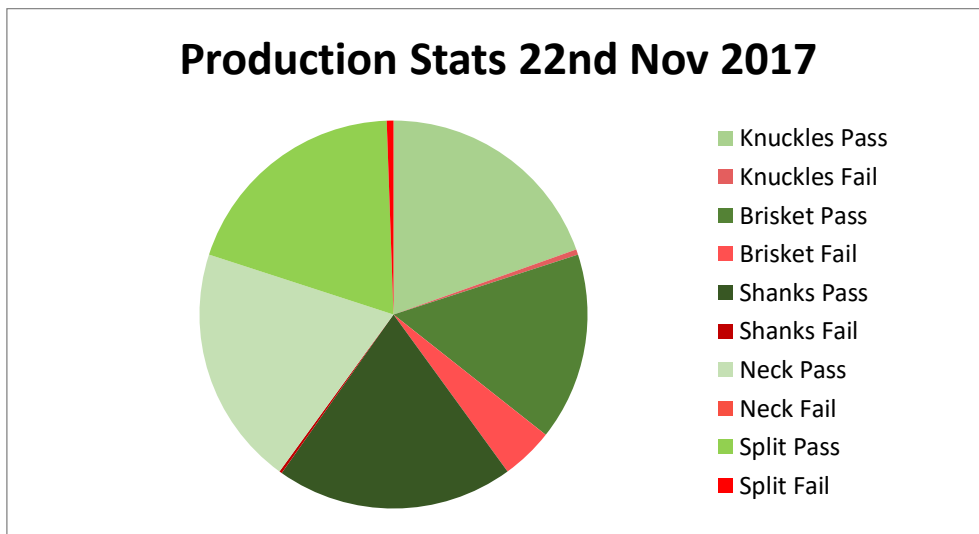
Fig. 32: Production Breakdown 22<sup>nd</sup> Nov 2017

- Robot feedrate reduced. Bandsaw speed increased.
- Production run:
  - o 187 product through the cell
  - o 8 product rejected and not processed
  - o 168/179 cut product were acceptable
- Failure breakdown:
  - o 2 bad cuts was due to bad shanks
  - o 4 bad cuts was due to bad knuckles
  - o 5 bad cuts was due to bad splits

Fig. 33: Overall Cut Rate 22<sup>nd</sup> Nov 2017

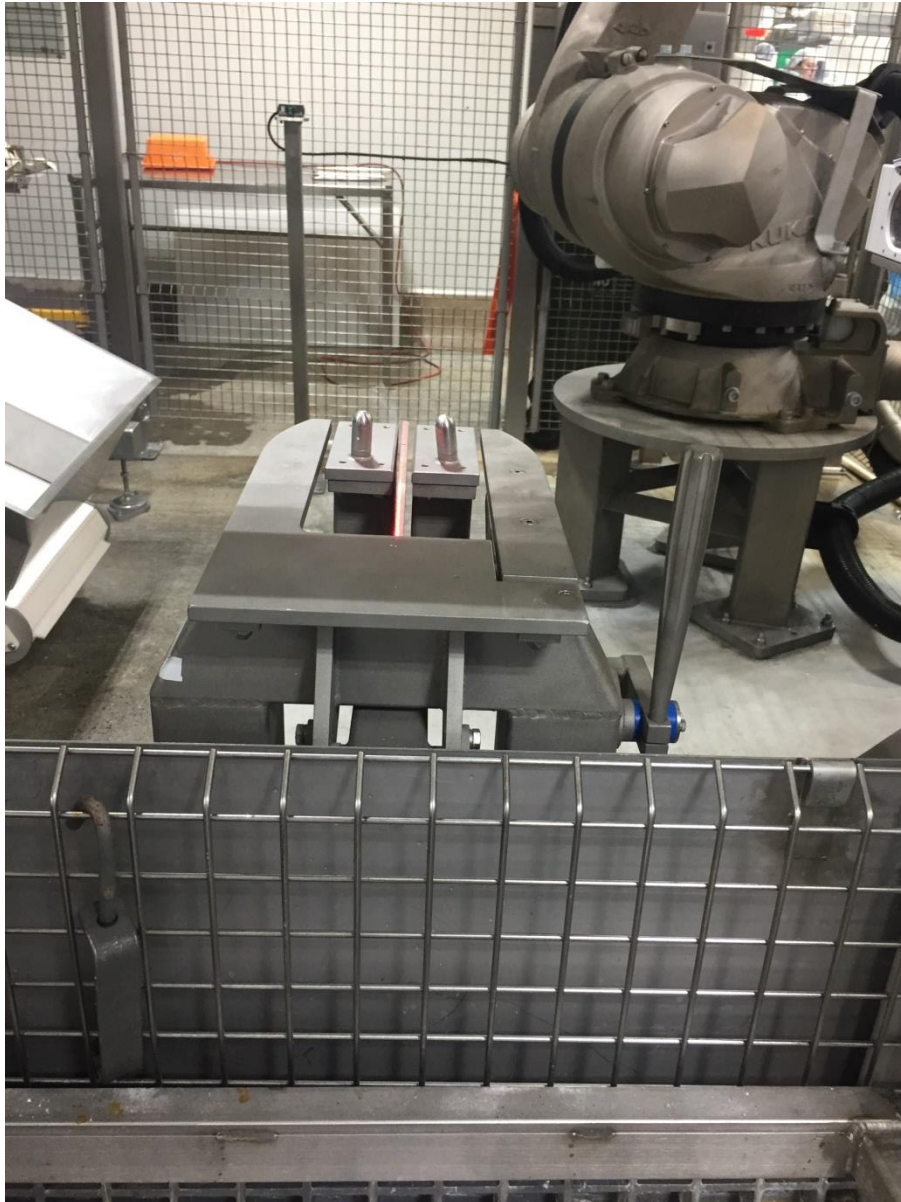
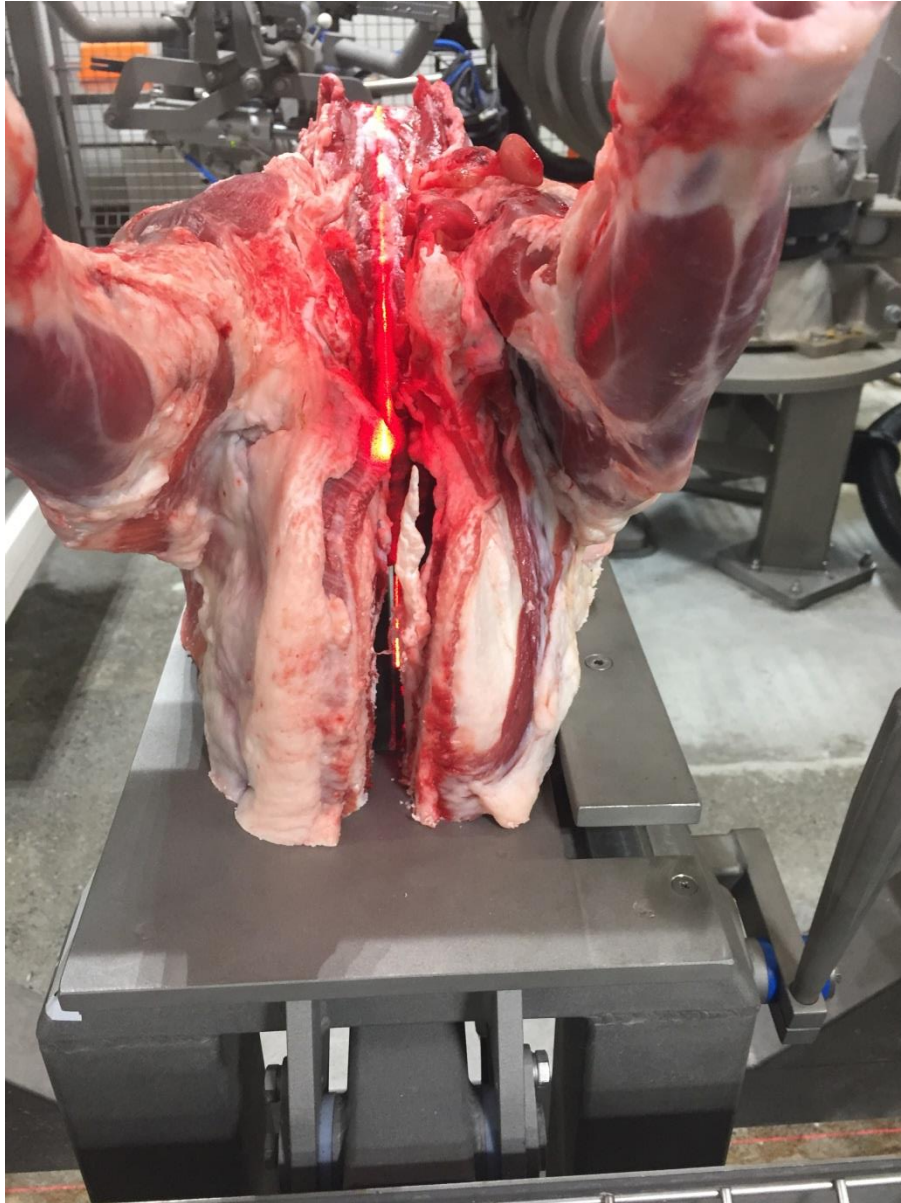
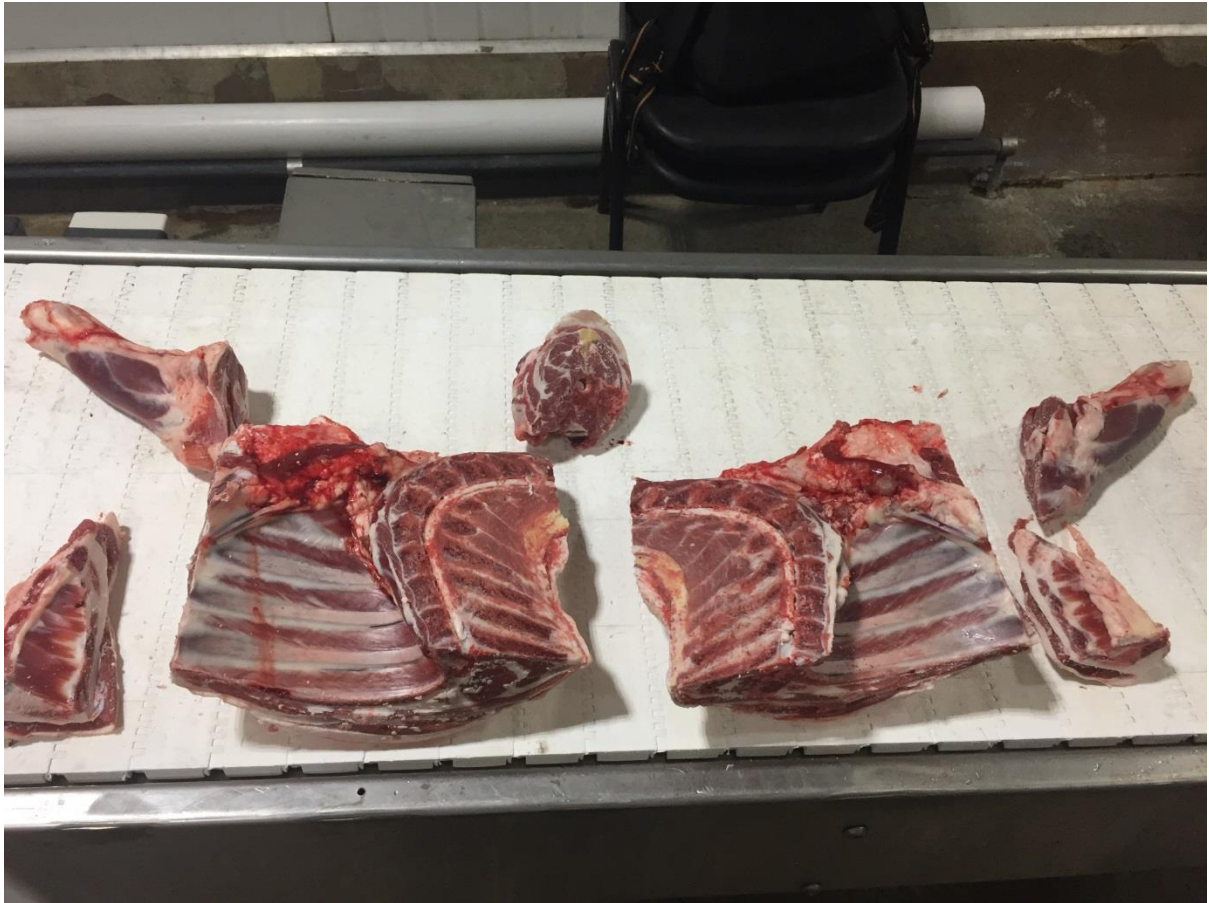
**Fig. 38: Adjustable Load Table – Front View**

A new load table with adjustable lifter was designed and fabricated in New Zealand, and commissioned at Wagstaff Cranbourne Pty. Ltd. on 18<sup>th</sup> January 2018. This modification allowed the table to accommodate product that has been cut askew, and eliminated the need for operators to prop the product up using shims.

**Fig. 39: Product on Load Table Prior to Alignment**

**Fig. 40: Product on Load Table following Alignment**

**Fig. 41: Product Processed with New Load Table**

All operators and supervisory staff have been trained in the correct operation of the new load table. A small product run was processed with the new table with favourable results.

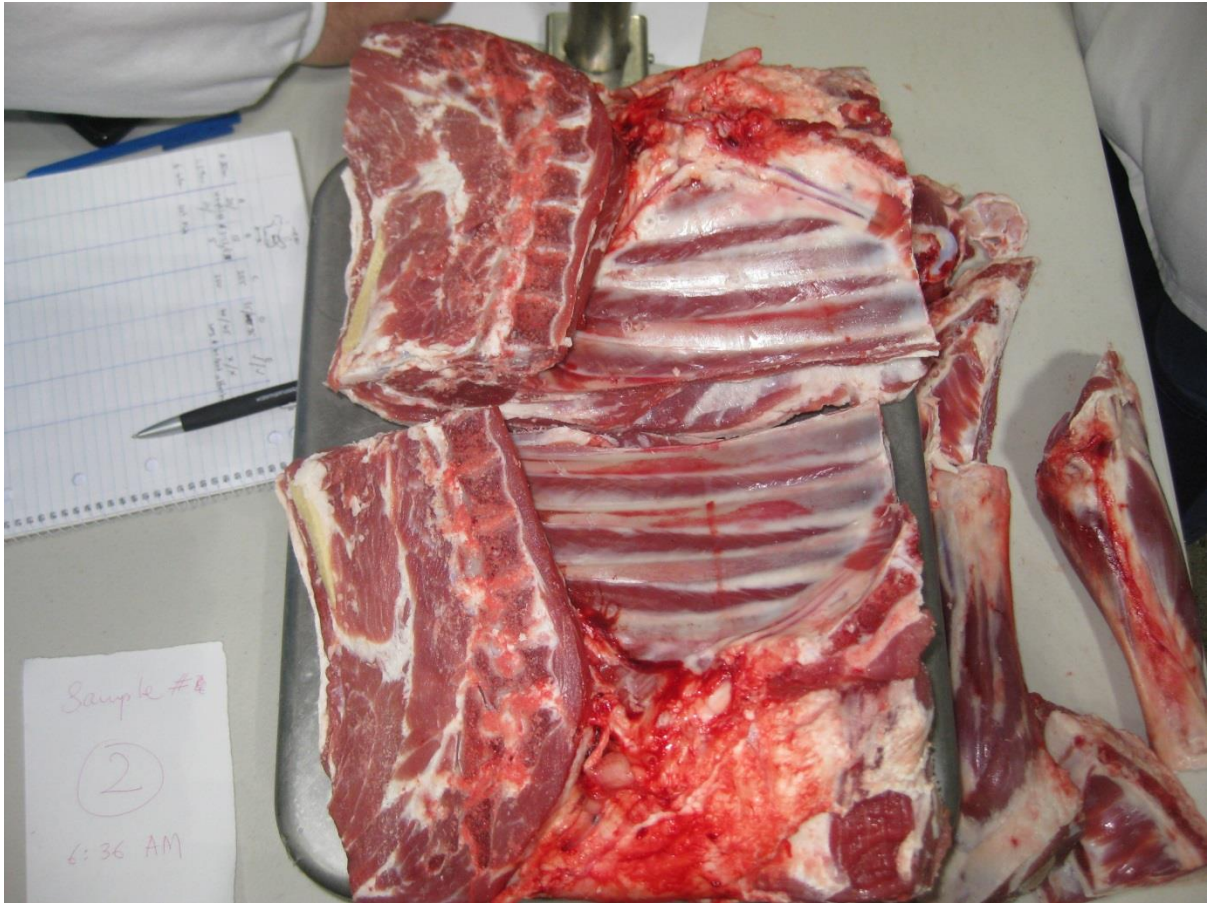
**Fig. 42: Ideal Primal Cut (Symmetrical Features) Vs Angled Primal Cut (Asymmetric Features)**

Often forequarters are cut with an angled primal plan. This issue occurs when the carcass is sitting unevenly on the bandsaw while being cut and results in the askew product (i.e. three ribs on one side and four ribs on the other). As the robot and vision system is unable to correct for this offset, it often results in poor split cuts.

**Fig. 43: Cut Results on an Angled Forequarter**

The installation and commissioning of the adjustable load table currently caters for the skewed cuts, however it is ideal from the control system standpoint that the primal cut plane be straight. The adjustable load table allows the operator can readily lower / raise one side of the forequarter to compensate for bad primal cuts.

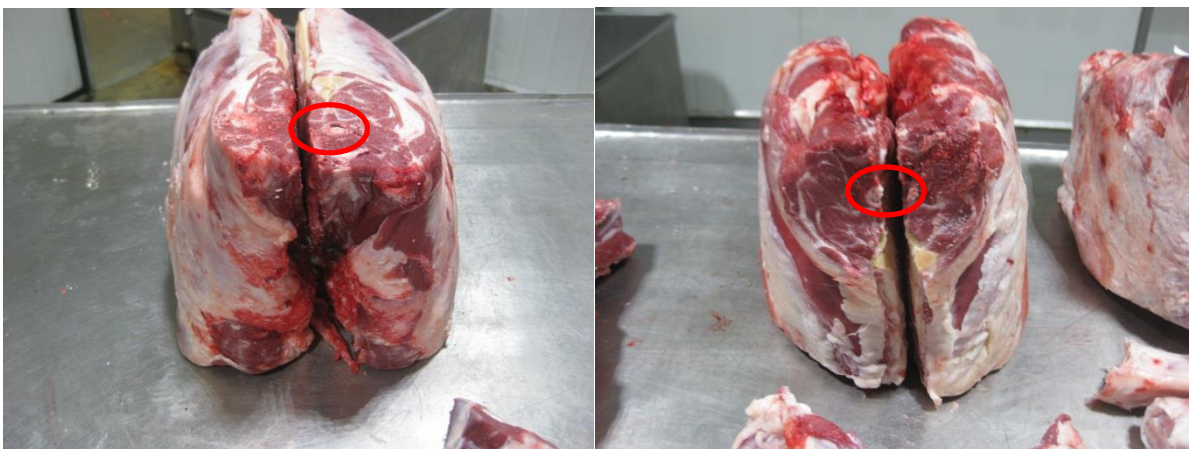
**Fig. 44: Split Cut on Angled Product Vs Good Product**

Fig. 44 below depicts the cut on asymmetric (left) vs symmetric (right) forequarters. The left image clearly shows the split cut path diverges to the side of the product, leaving significantly more meat on the right side of the product and is clearly offset from the spine.

The right image shows a symmetrical forequarter. The cut path follows the spinal cavity perfectly with the blade entering and exiting the forequarter in the centre of the spine. The spinal fluid can be removed as required.

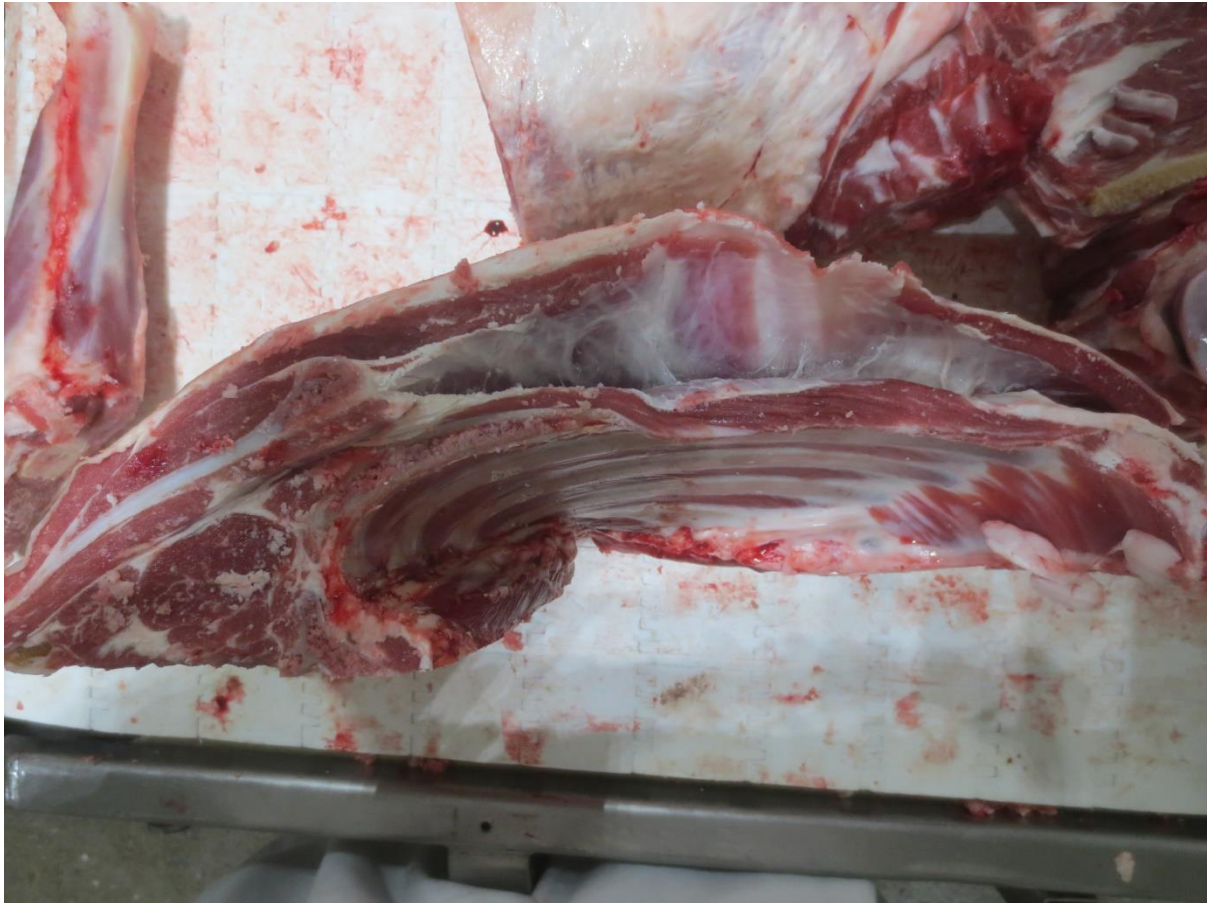
**Fig. 48: Muscle Separation Example**

The forequarters processed at Wagstaff Cranbourne Pty. Ltd. experiences varying levels of muscle separation. This issue is often seen in older animals where the muscles are no longer firm. It is also observed in smaller animals that are excessively stretched during the de-hiding process.

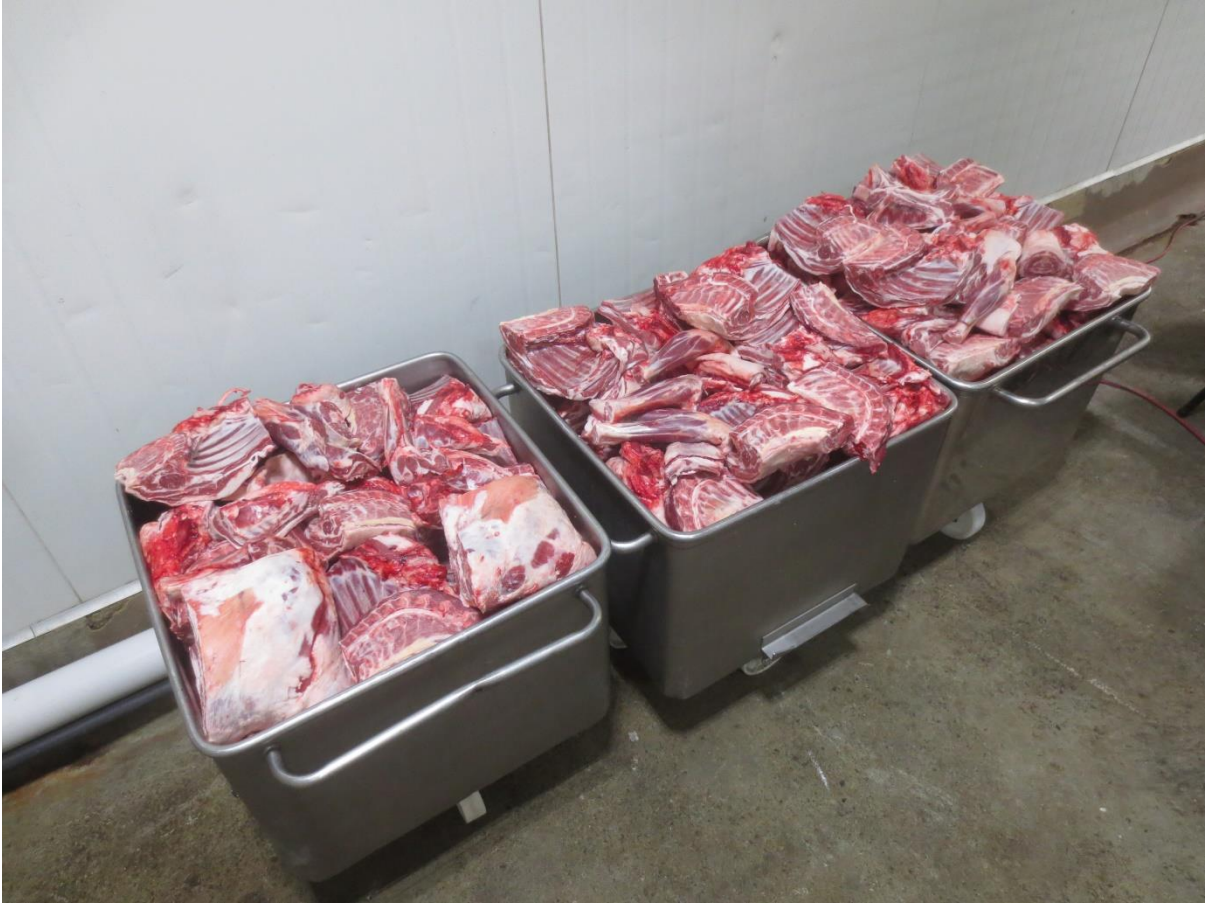
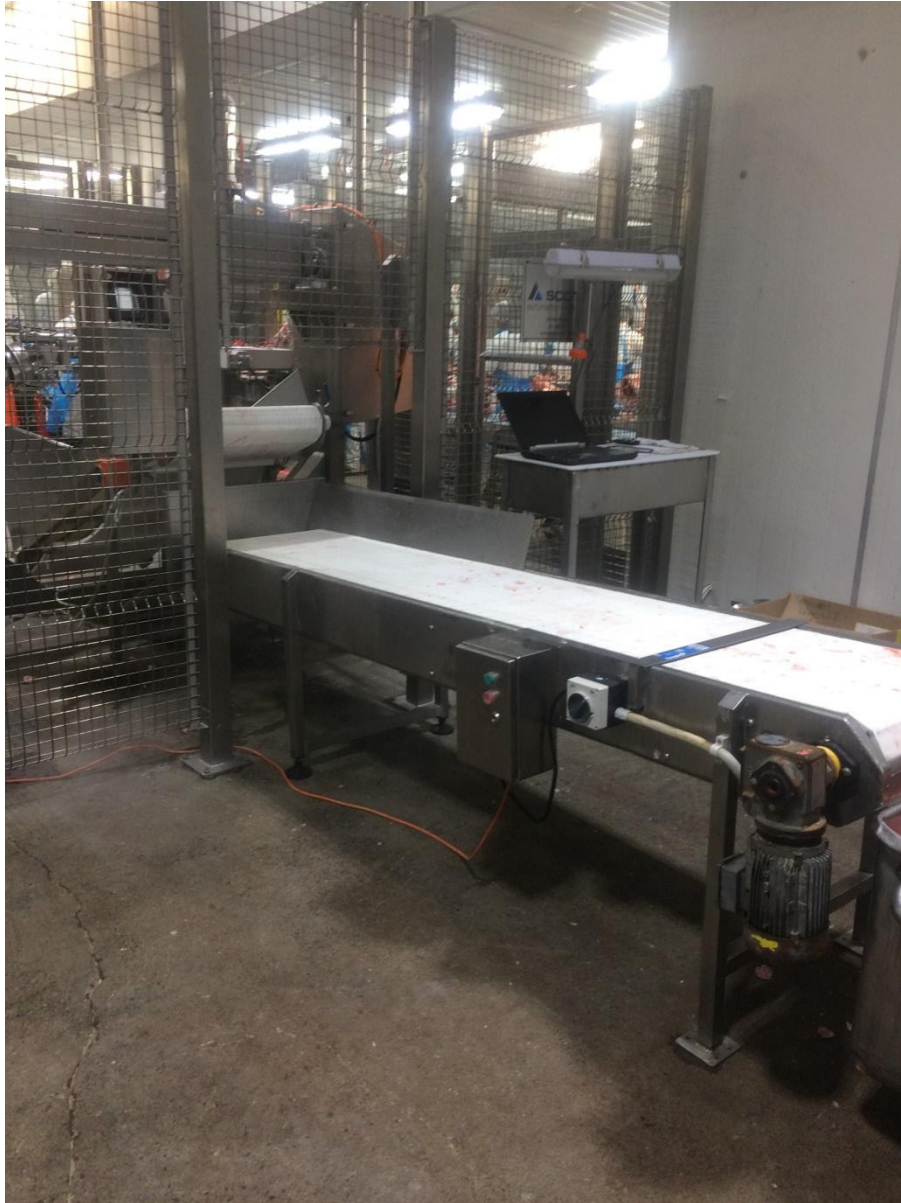
**Fig. 49: Product to be Fed back into Boning Room**

At present the product return conveyors are still in development. All product processed by the system had to be indexed out of the cell via the placeholder outfeed conveyor, visually assessed, and then loaded into tubs and manually fed back into the boning room. This was a laborious and time consuming task that severely limited the amount of product that could be processed by the system.

Wagstaff Cranbourne Pty. Ltd. is currently undertaking the design, manufacture, and installation of the conveyor network to feed processed forequarters back into the boning room. It is anticipated that these tasks will be complete by mid-January 2018.

**Fig. 50: Placeholder Outfeed Conveyor**

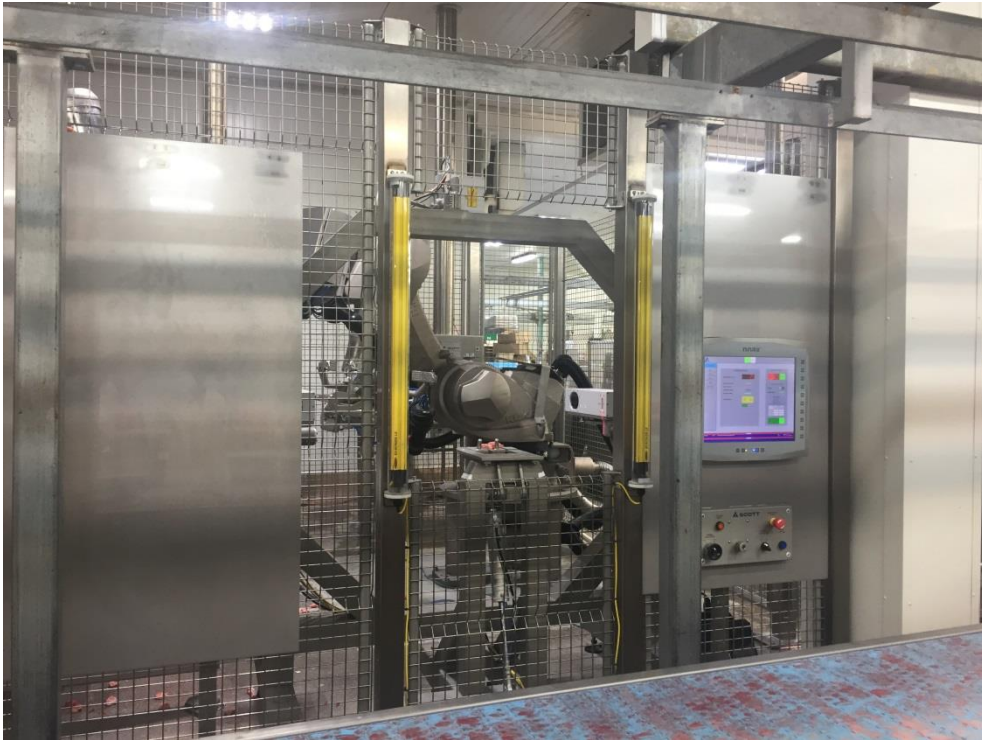
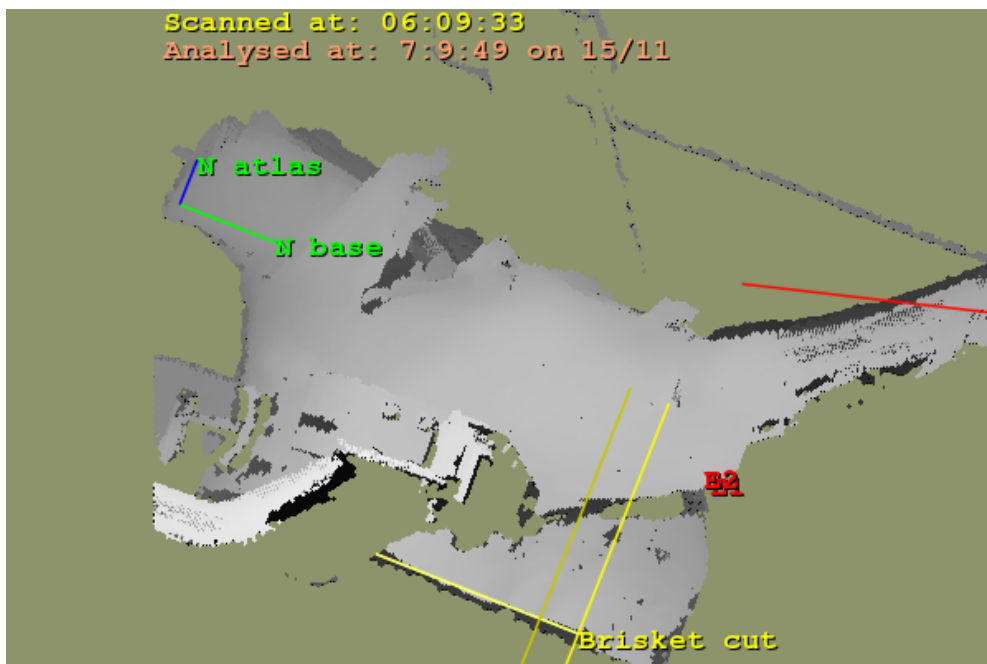
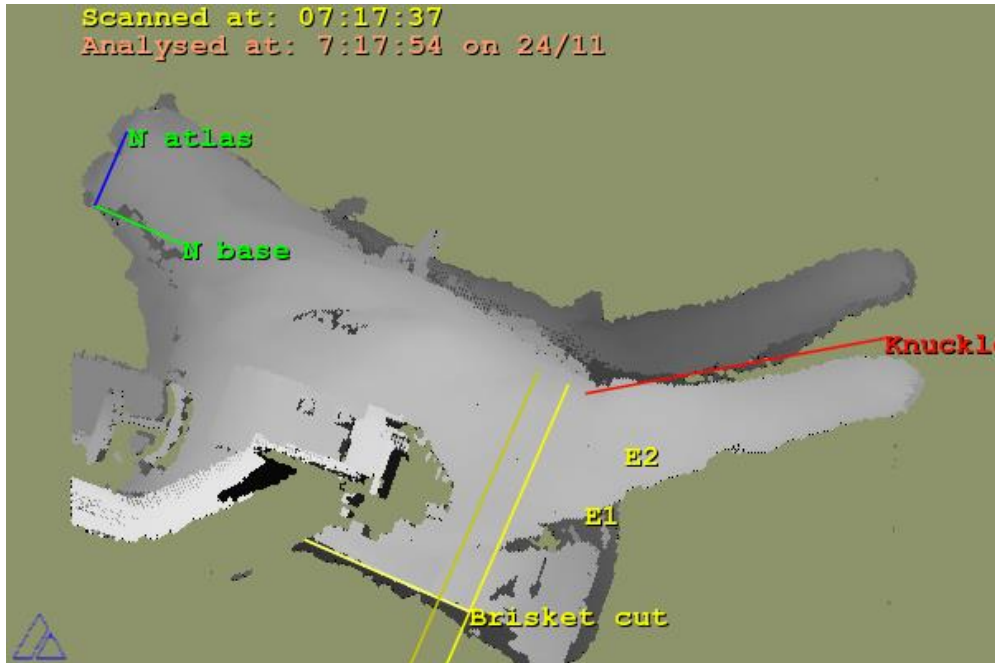
Fig. 51: Stainless Steel Light Guards

The vision system is susceptible to interference from external light sources – particularly natural and fluorescent lighting. These external light sources produce noisy images where features cannot be correctly identified.

In order to minimize noise, stainless steel light guards were hung on the cell guarding. These guards blocked out the bulk of the fluorescent lights from the boning room and drastically improved the quality of the vision analysis results.

Fig. 52: Vision Scan with Light Interference

**Fig. 53: Vision Scan without Light Interference**
