# final report

Project code: P.PSH.0688

## **Standalone Lamb Chine Bone Saw Australian Sales and Marketing Demonstration and Commercialisation Unit.**

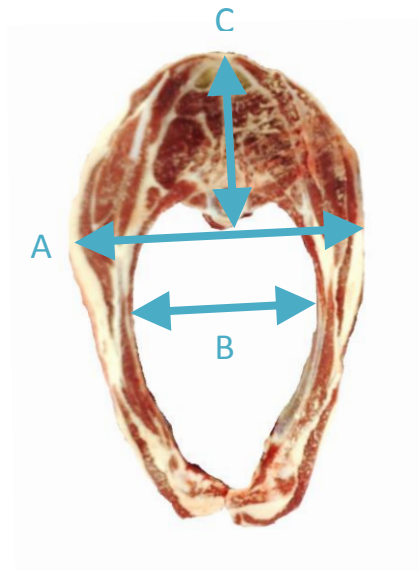
Four key measurements were identified as being critical for high yield processing of racks. The first three measurements (A, B & C) are shown in the image below. The fourth measurement (D), was the overall length of the rack along the spine.

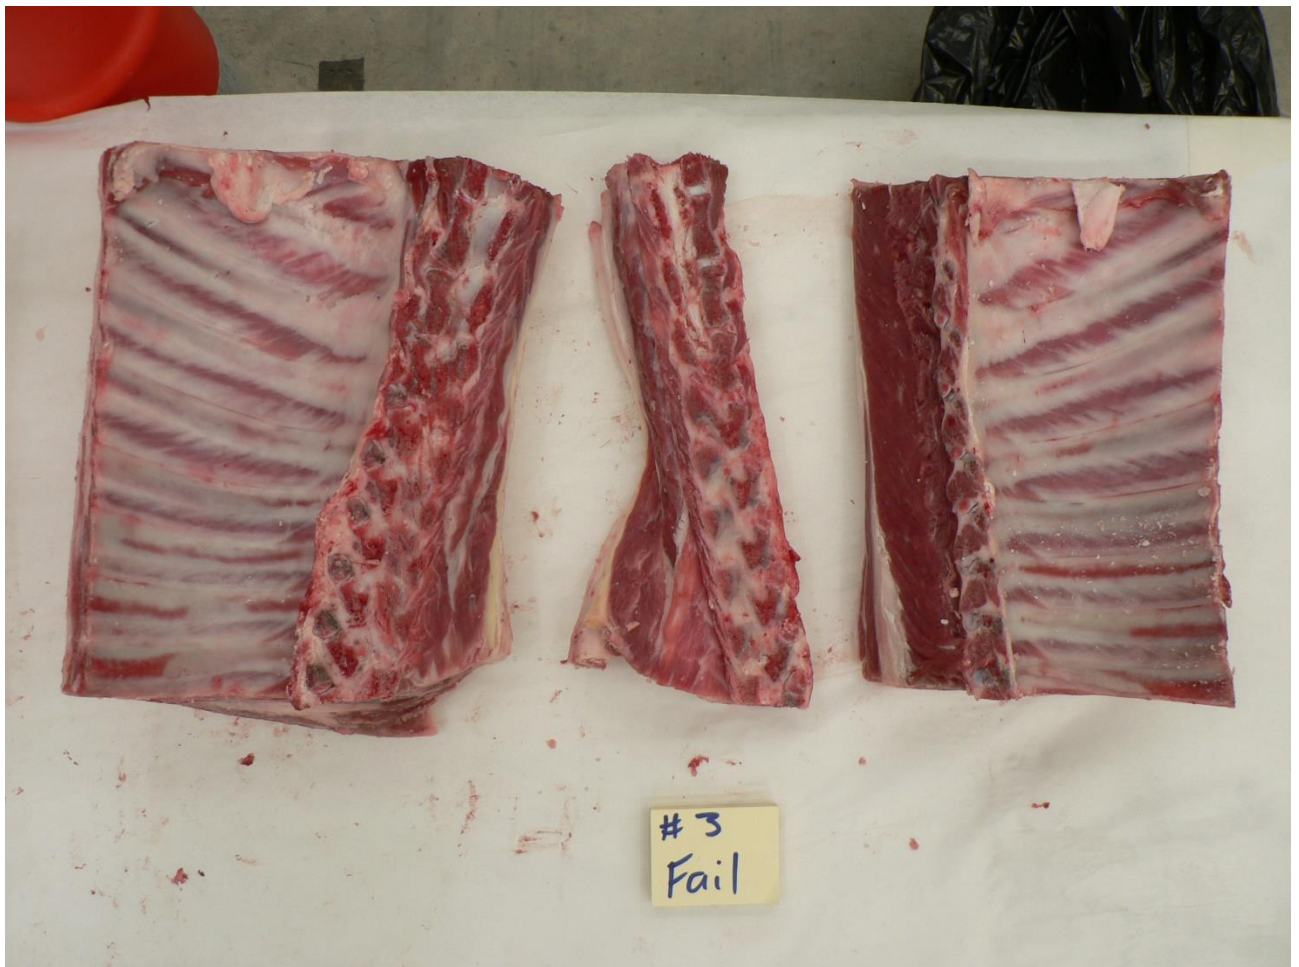
**Figure 1: LCBS Product Trial 3 Result (Fail)**

1. During normal operation, the operator loads the saddle onto the product infeed conveyor and as the product enters the machine enclosure a set of product guide rails secures it in the correct orientation. Early tests found that some products would slip out of position before they reached the product guide rails. This would result in a non-symmetric cut if the featherbones didn't find their way between the upper cutting blades. This is what occurred during product trial 3, shown in the Figure 1 below. A video of product trial 3 has been provided.

To resolve this, a second set of product guide rails was installed at an earlier point on the product infeed conveyor, outside of the machine enclosure. This modification had the secondary benefit of providing the operator with another reference surface to ensure correct product loading. The CAD model of this modification is identified as item 1 in Figure 2 overleaf.

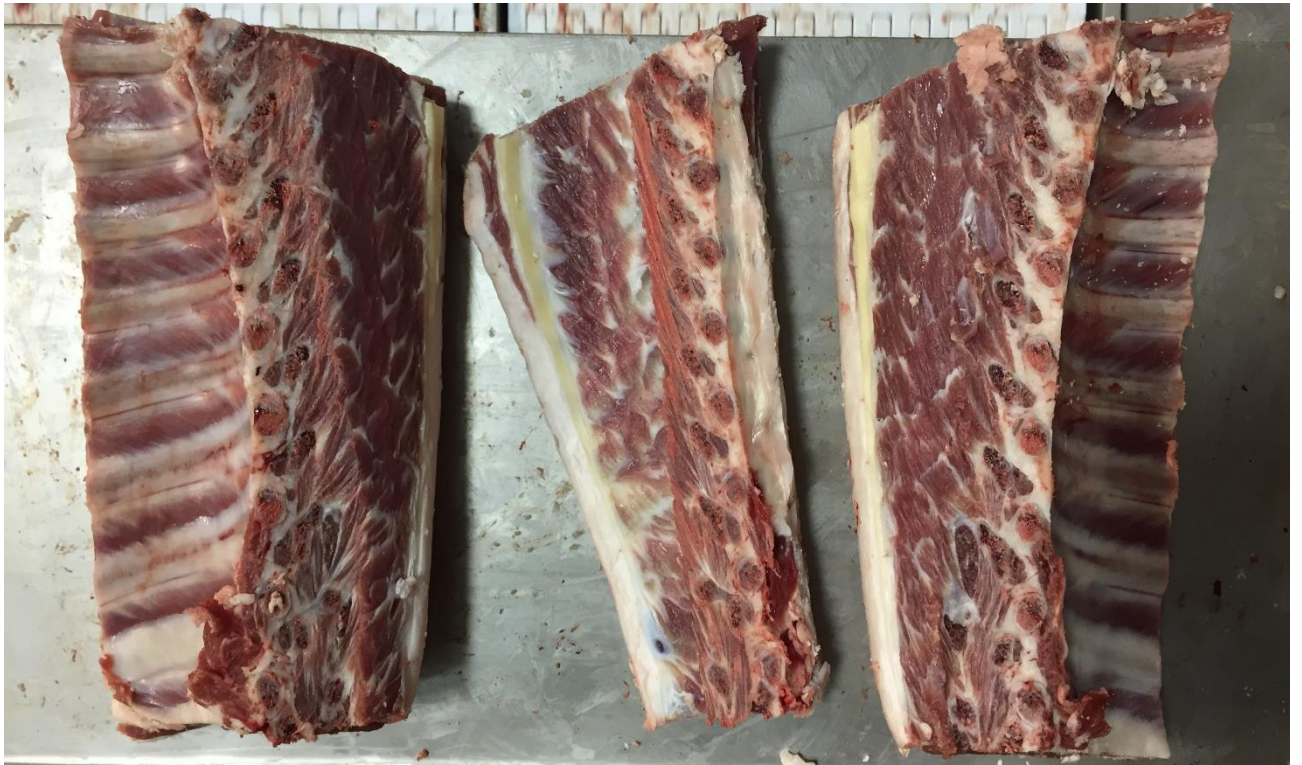
Figure 14: Example CFO Racks processed by the LCBS

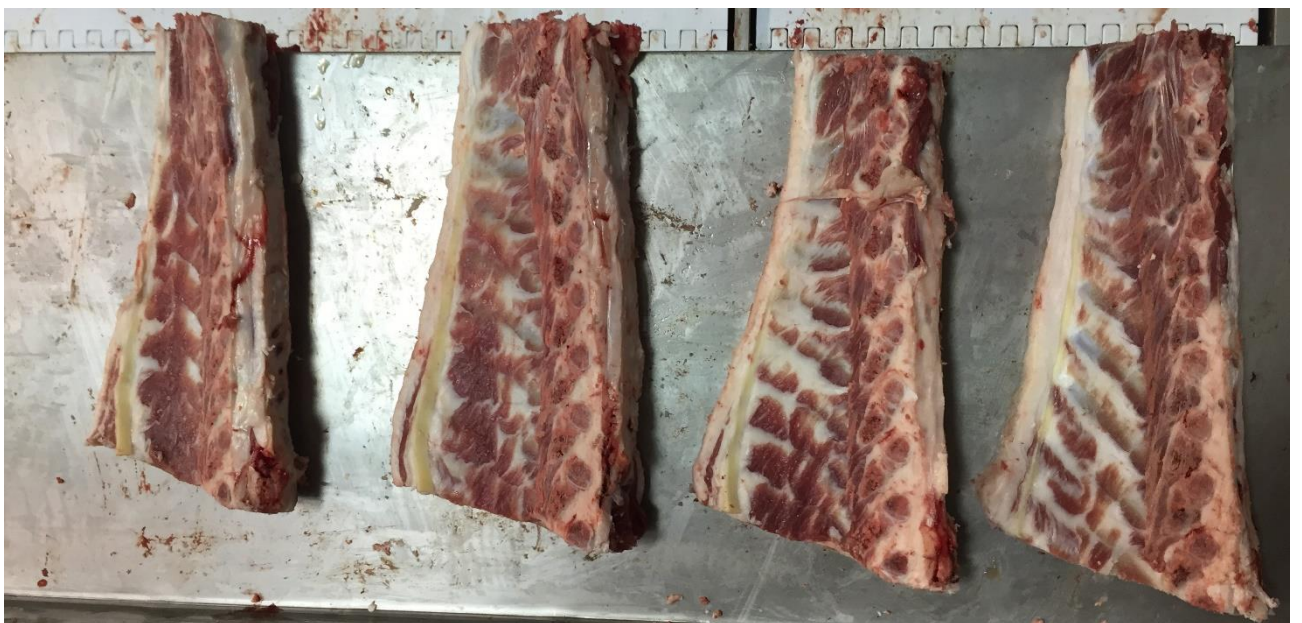
Figure 15: Example Chine/feather Bones extracted by the LCBS

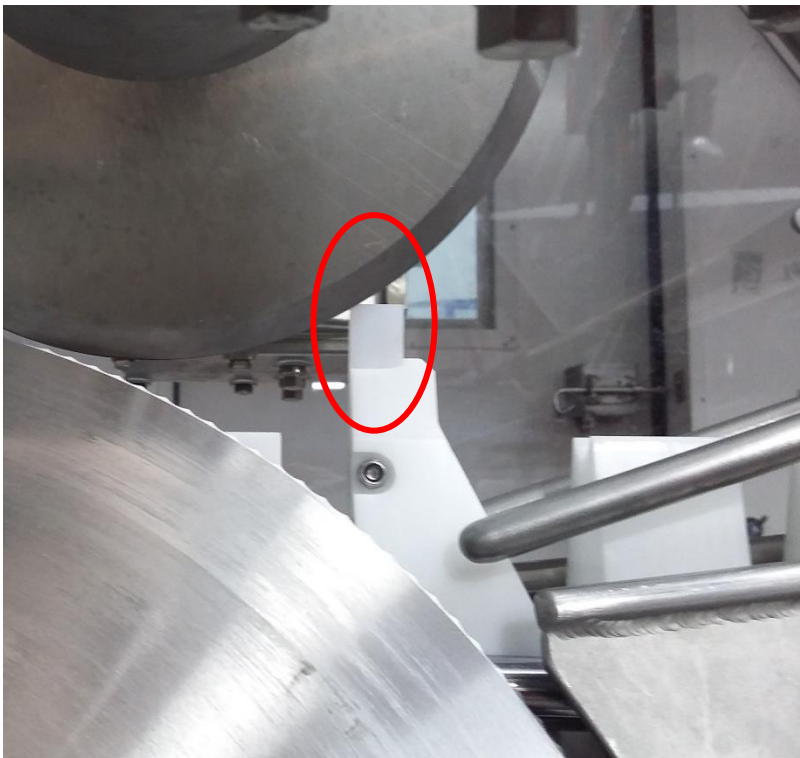
**Figure 17: Replaceable product pusher inserts come into close proximity of cutting blades**

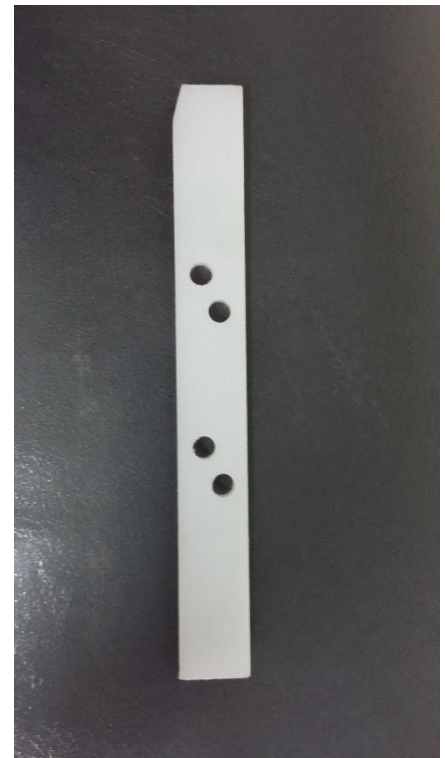
**Figure 18: Modified reversible pusher**

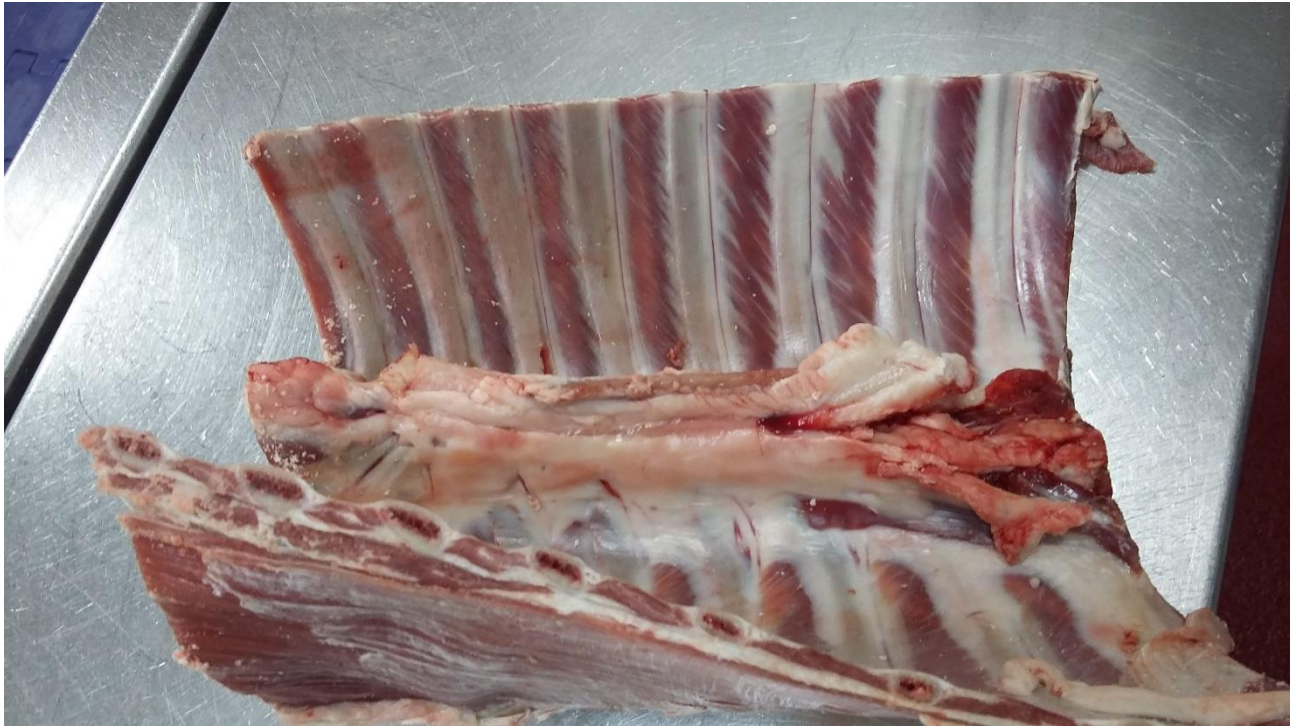
**Figure 19: Excessive fat and other remnants on the rack spine**

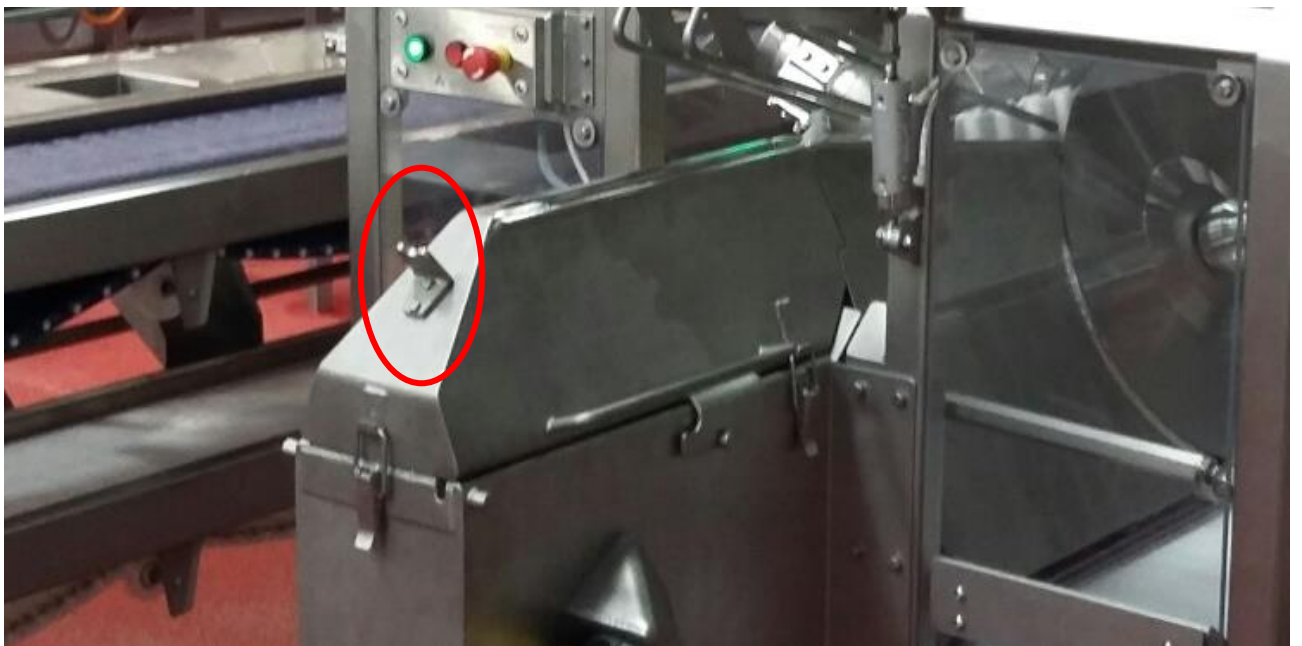
**Figure 20: Spine scraper installed onto loading station**

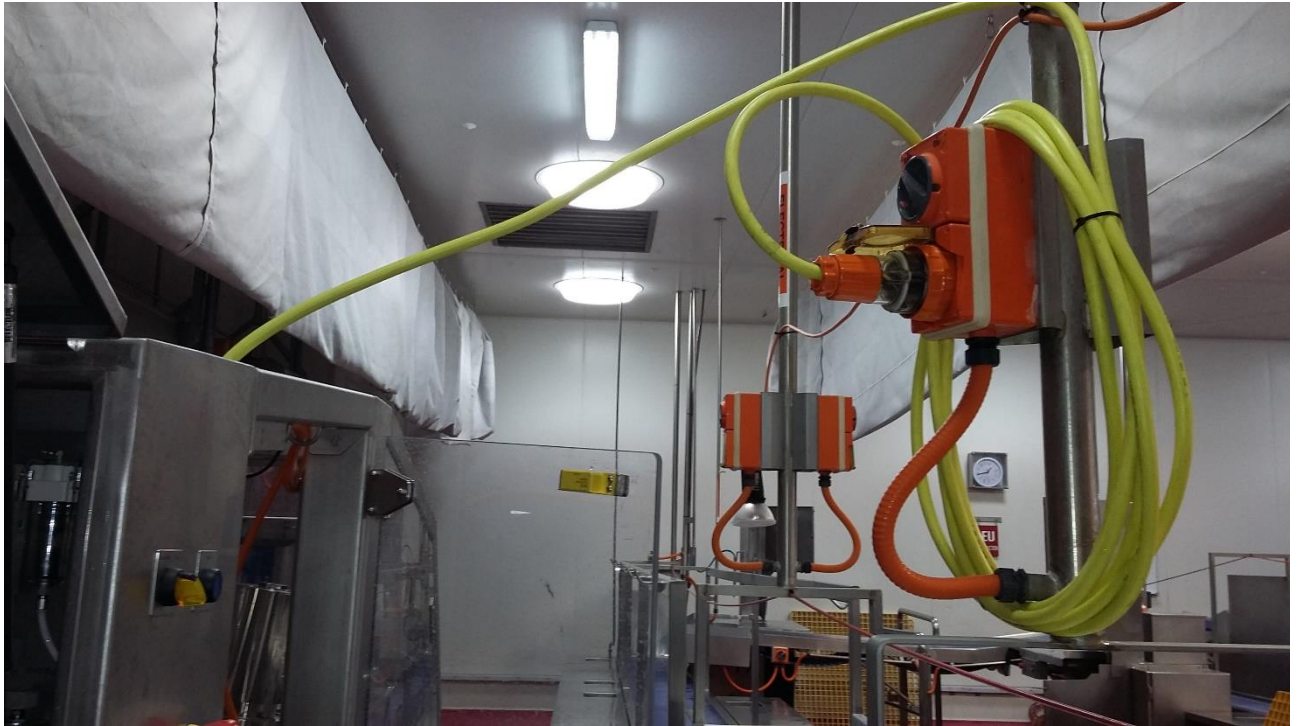
**Figure 23: Power supply now enters machine near the top**

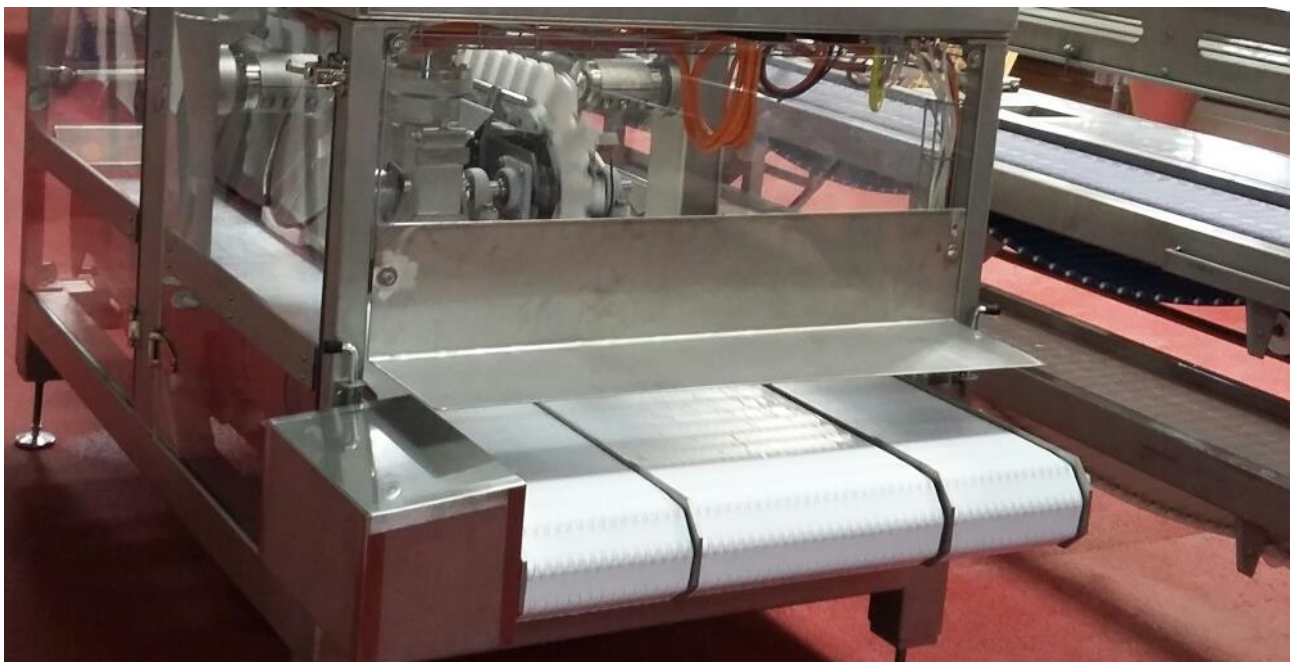
**Figure 24: Additional guarding at end of product discharge conveyor**

The rod lock, which locks the position of the product relative to the cutting blades, was activating later than anticipated.	The rod lock sensor was moved to force an earlier rod lock activation. (Figure 21)
The loading station cover was slightly off centre to the product chain conveyor. This increased the opportunity for products to be pushed through the cutting blades off centre, resulting in a failed cut and/or damaged pushers.	A large shim was added to realign the loading station, and a locating pin and slot was integrated into the loading station cover. (Figure 22)
The air and electrical services exited onto the floor, despite most supplies typically being located overhead.	The electrical and air services were redirected to exit near the top of the machine. (Figure 23)
There was the opportunity for an individual to reach inside the machine via the product discharge conveyor. This presented a hazard.	An additional guard that covered the product discharge conveyor was added. (Figure 24)

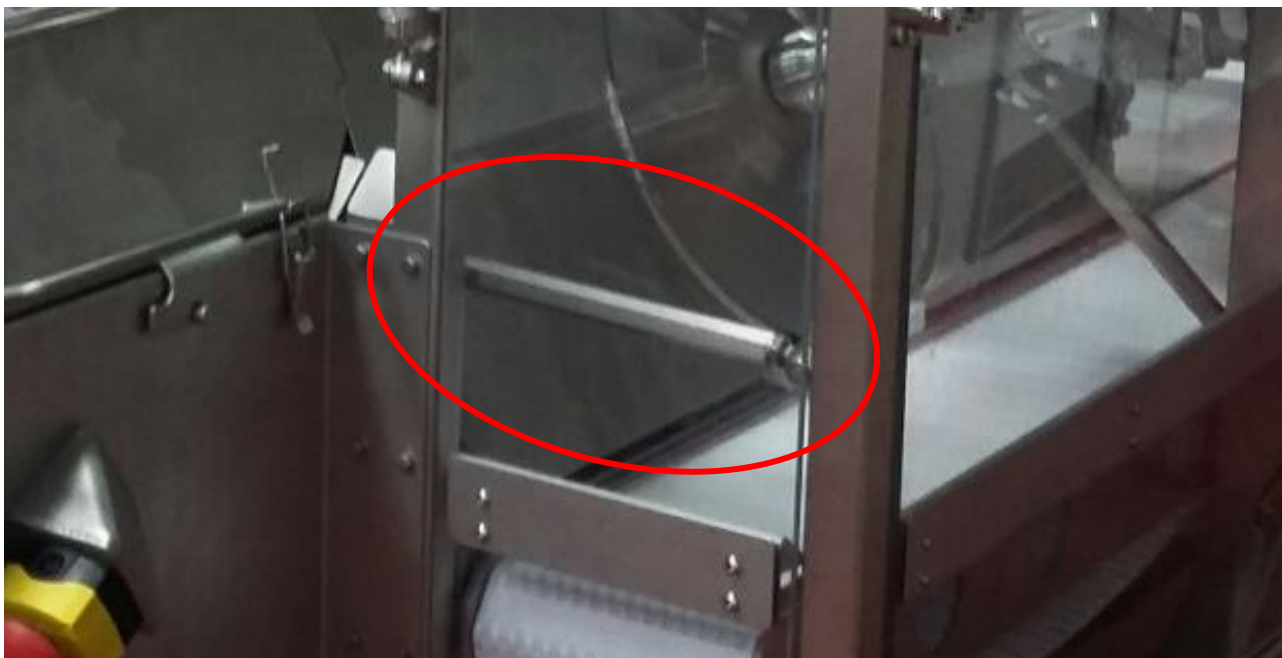
The mounting points on the rail that guides the product chain are few and far between. This results in a lack of support and rigidity in the product chain.	A future revision of the machine should include more of these mounting points at critical areas like the product loading station, and as close to the circular saws as possible.
The configuration of the rod eye (Figure 25) near the product loading station that helps locate the product chain horizontally, forces the chain to rotate and move out of axis slightly whenever it is deflected by product. This affects the location of the cuts on the product and can contribute to failed products and yield loss.	A redesign of this feature to balance out the forces and resulting deflection in the product chain as it is deflected downwards is required.
After the rack is processed, the extracted chine/feather bone has to balance on the product chain until it is ejected onto the outfeed conveyor. Sometimes the chine/feather bone falls off of this chain too early and lands/mixes with the product. This can cause an inconvenience for processors down the line.	Guards should be installed to prevent this mixing at both the chain and outfeed conveyor locations. However, there is a risk of inadvertently creating a snag problem within the machine, especially for any product that is not correctly processed/separated by the blades.

**Figure 25: Rod eye that controls the horizontal position of the product chain - Needs revision**

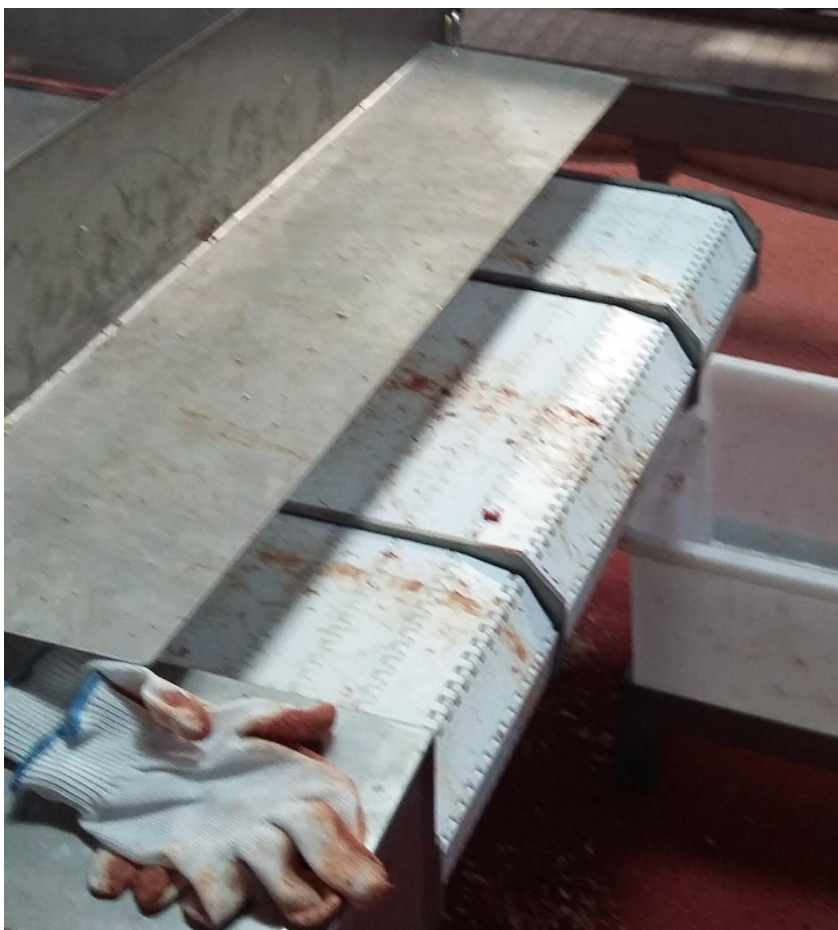
The product and bone outfeed conveyors all exit along the same line (Figure 26). This makes it difficult to keeping the parts separate for transport (via a secondary conveyor) to the product and waste belts.	Future machines may have to have their product outfeed conveyor design customised to meet site requirements. A staggered outfeed conveyor would make sorting and transport of parts easier in some situations. There is no reason why a secondary conveyor couldn't be part of the same offering.
Cleaning the machine is difficult and time consuming. In particular, the product chain sprockets requires that the machine be stopped, opened, sprayed, closed and started multiple times to be able to properly clean.	A targeted "self-cleaning" capability could be introduced to facilitate easier cleaning of more difficult components. These could be as simple as correctly placed access holes (possible hazard) or external plugs that feed appropriately located internal spray fittings.

**Figure 26: Product (Left and Right) and Bone (Middle) conveyors, all exit along the same line**

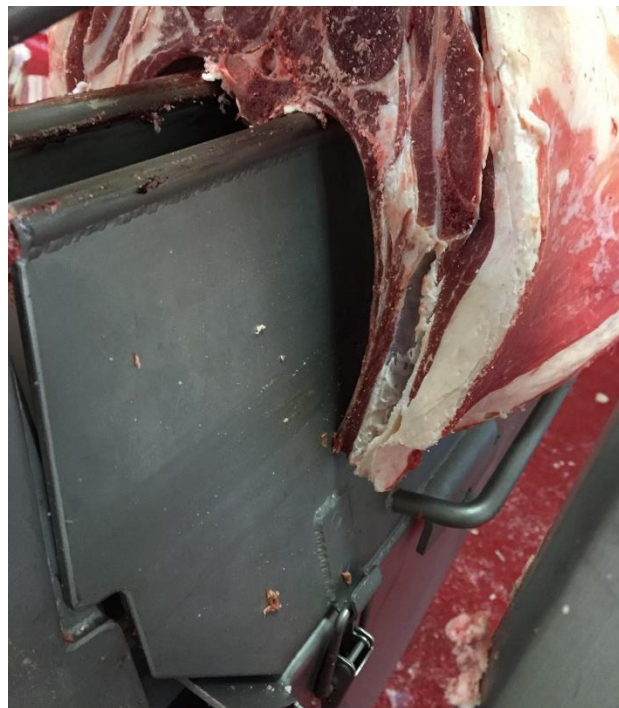
Identified Issue	Resolution
<p>There is a small gap at the interface between the loading station cover and the product pusher chain covers. This gap can be a snag point on certain product with very narrow ribs, as can be seen in Figure 30 below. This snag point can push the product out of alignment while on the product pusher chain and result in a failed cut.</p>	<p>Operators are now trained to push the product beyond this snag point when loading. This does not have a significantly negative impact on throughput.</p> <p>When at a suitable workshop, this gap should be modified/softened to prevent any opportunity for the product to snag.</p>

**Figure 27: Gap at interface of loading station cover and product pusher chain cover is a snag point**

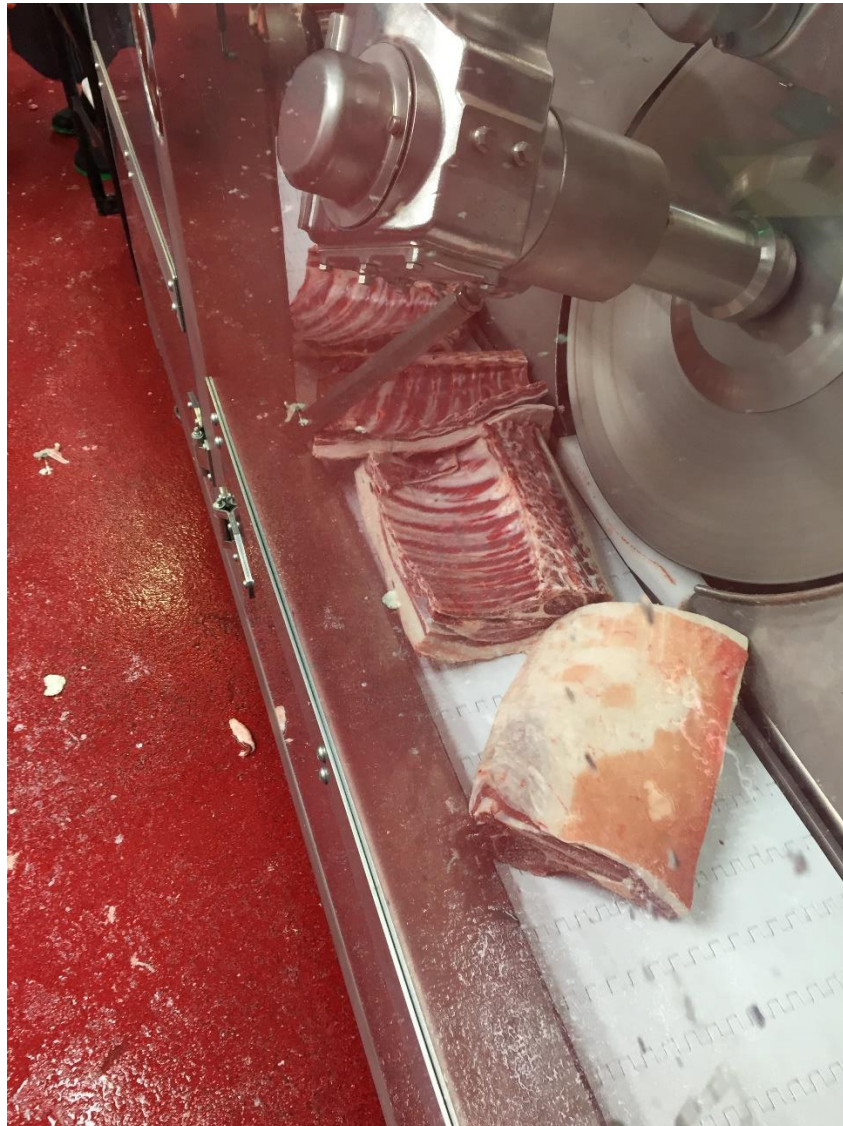
<p>The conveyor belt that ejects the product after processing is too small for some of the largest product. This problem is exacerbated by some of the door guarding and other structures in the path of the conveyor as can be seen in Figure 28 below. At present the operator has to stop the machine and clear the obstruction manually.</p>	<p>Modifications to the path can be made to help guide large product down the conveyor. However, ultimately the conveyor itself will have to be improved in some way, either by making it wider or perhaps experimenting with added ribs or paddles.</p>
--	--

**Figure 28: Large products are becoming stuck on the small conveyor**

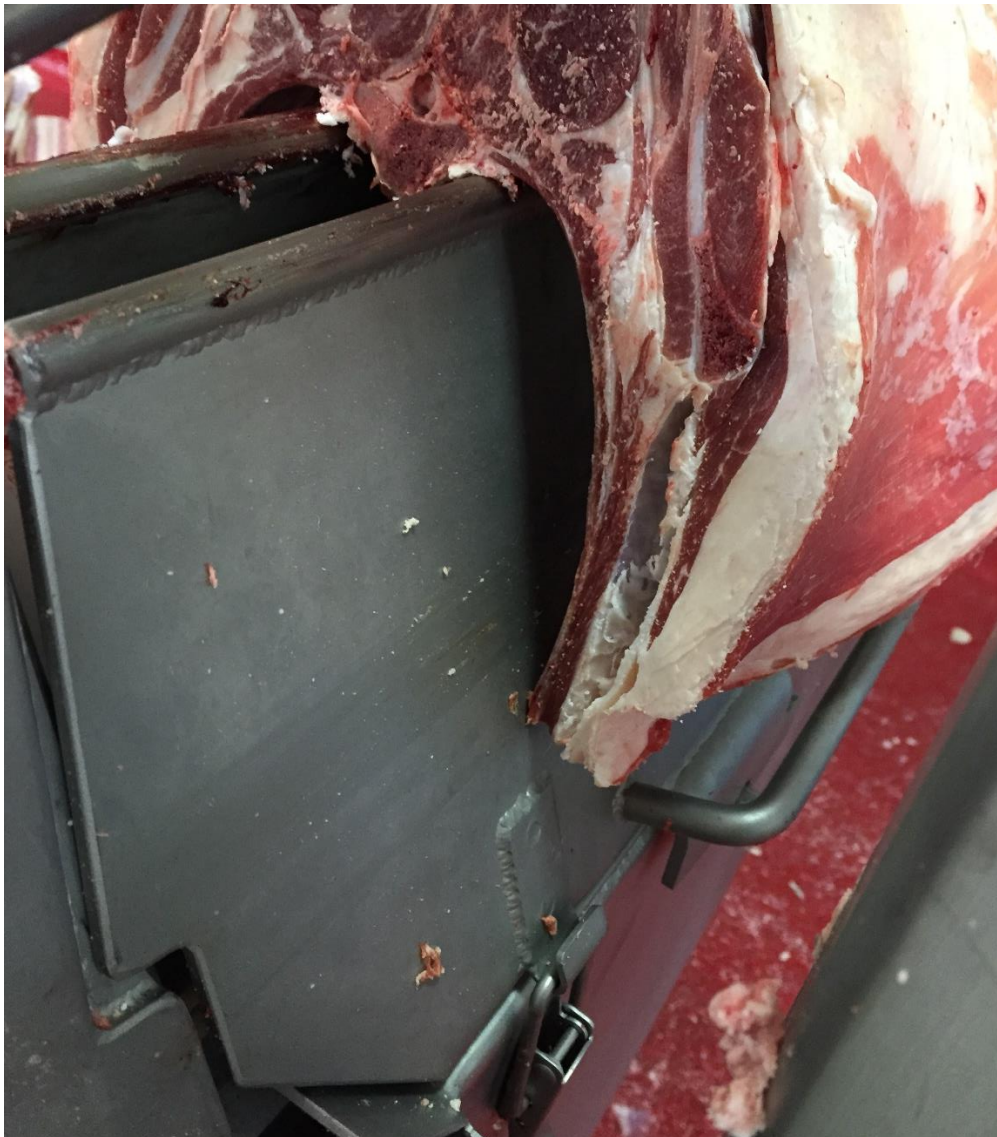
**The small gap shown in Figure 30 below can be a snag point on certain product with very narrow ribs. This snag point can push the product out of alignment and result in a failed cut.**

**Figure 30: Gap at interface of loading station cover and product pusher chain cover is a snag point**

**PARTIAL RESOLUTION.** Operators are now trained to load the product beyond this snag point. This does not have a significant impact on throughput.

**PENDING UPGRADE.** When at a suitable workshop, this gap will be modified to prevent any opportunity for the product to snag.

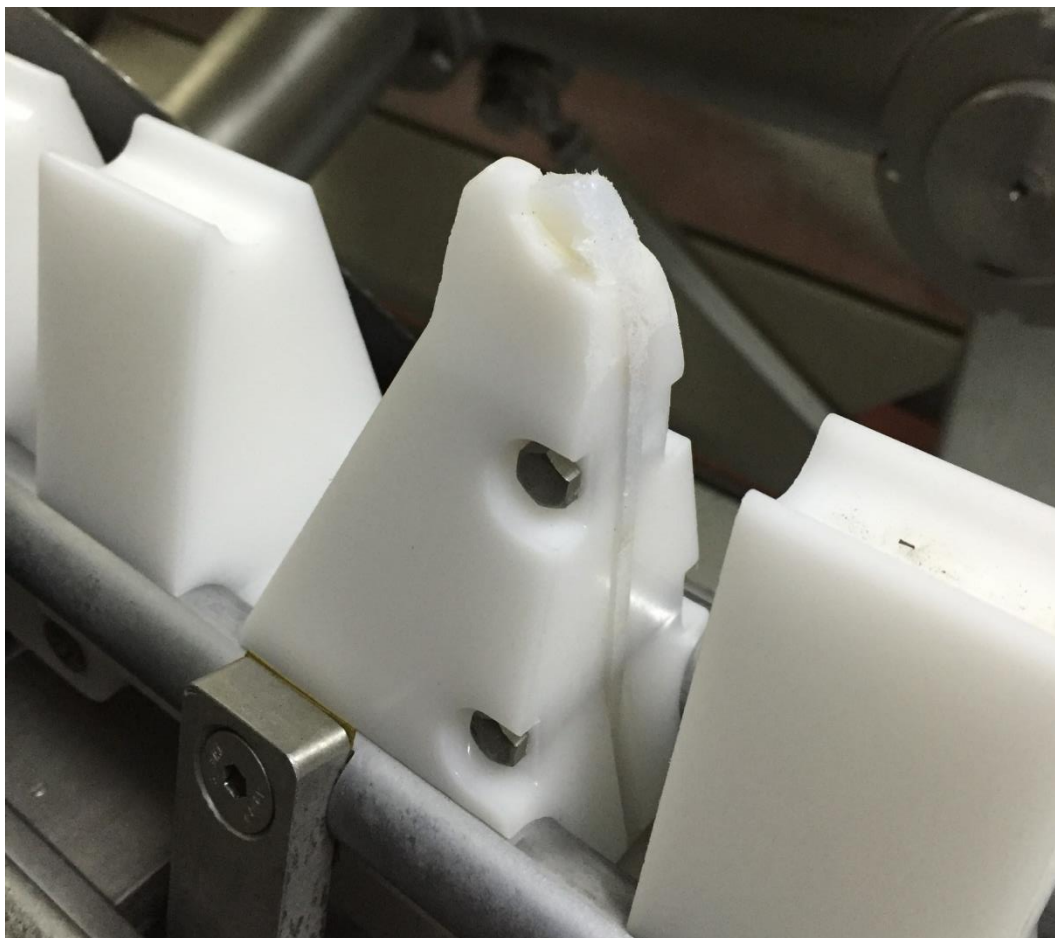
Identified Issue	Resolution Progress
<p>During this demonstration the LCBS was trialled with worn down pusher inserts to assess the impacts this has on production (Figure 31). It was determined that worn down pushers do increase the risk of failed cuts.</p>	<p>IN PROGRESS. An entirely new pusher chain and pusher insert configuration has been designed (Figure 32). When completed, this new product pusher system can be installed while the machine is on-site.</p>
<p>The cutting edge of one of the top (feather) circular knives has been chipped (Figure 33). After investigation it was found that this sort of damage has not been seen on other similar knives on similar systems and so is likely due to incorrect or incorrectly loaded product.</p>	<p>IN PROGRESS. The damaged blade will be replaced. If the damage reoccurs, further investigation will be required.</p>

Figure 31: Worn down product pusher and wear insert
