Project Code: P.PIP.0317
Prepared by: Gavin Inglis
MAR
Date published: September 2013

PVE Robotic Hock Tip and Neck Sanitising System Recommission

MLA project code: **P.PIP.0317**
MLA project title: **PVE Robotic Hock Tip and Neck Sanitising System Recommission**
Project leader: **Gavin Inglis**
MLA project manager/coordinator: **Darryl Heidke**
Milestone number: **4**

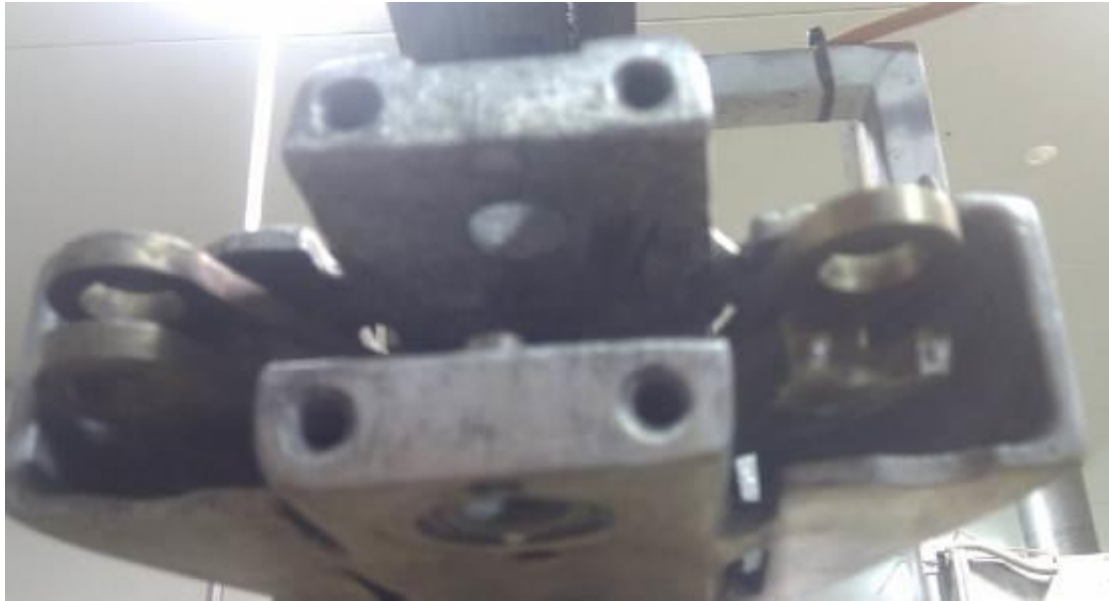
Following completion of MS3, Rewiring of the Hock Tipper to suit the new Layout and Safety system, recommissioning of the Hock Tipper was commenced. It was found however that some parts of the Hock tipper had been damaged while the system had been sitting idle and this needed repair. Spare parts were sourced from the tool supplier in Germany and the tool overhauled at MAR's Sydney office. The image below shows the damage to the tool:

Fig.1 Damage to Hock Tipping tool.

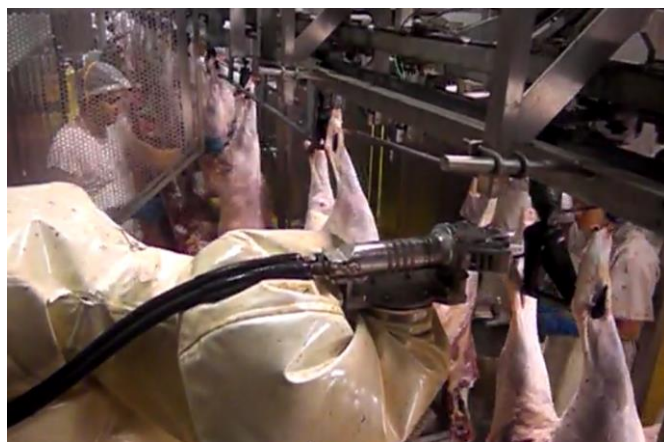
Following the repair MAR returned to site to recommission the robot. The issue previously had been that the robot struggled to keep up with the speed of the line when it went above 8.5/ min. Modifications were made to the cycle and sterilization process to enable this to occur. The attached video shows the Hock tipping robot in operation following these modifications. The image below is a still from the video:
