# final report

Project Code: PRTEC.042

Date published: January 2006

## **Development of Vision & Laser Sensing Systems Suitable for Beef and Sheep Slaughter Tasks**

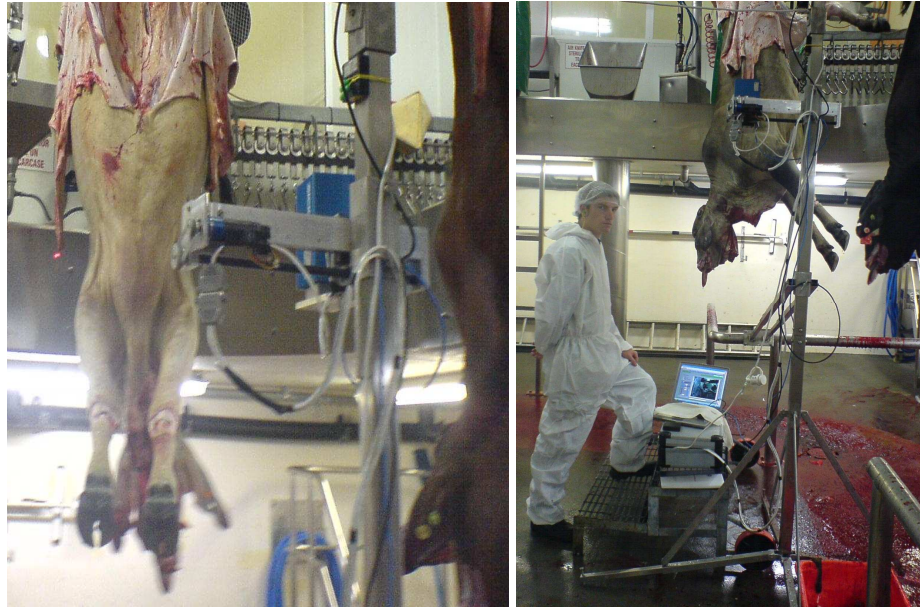
**Abdominal-thoracic sensing on-site**

A scanning rig has been developed that allows researchers to set up in an abattoir and gather data on the carcasses without interfering with normal production. The scanning rig included suitable mounts for a digital camera and a scanning laser. The height of the camera and laser could be independently set to heights between 700mm and 2400mm from the floor, with the laser being able to be traversed over a distance of 300mm horizontally. The complete rig was designed to be installed on an operating slaughter floor very quickly and with little or no interruption to normal production.

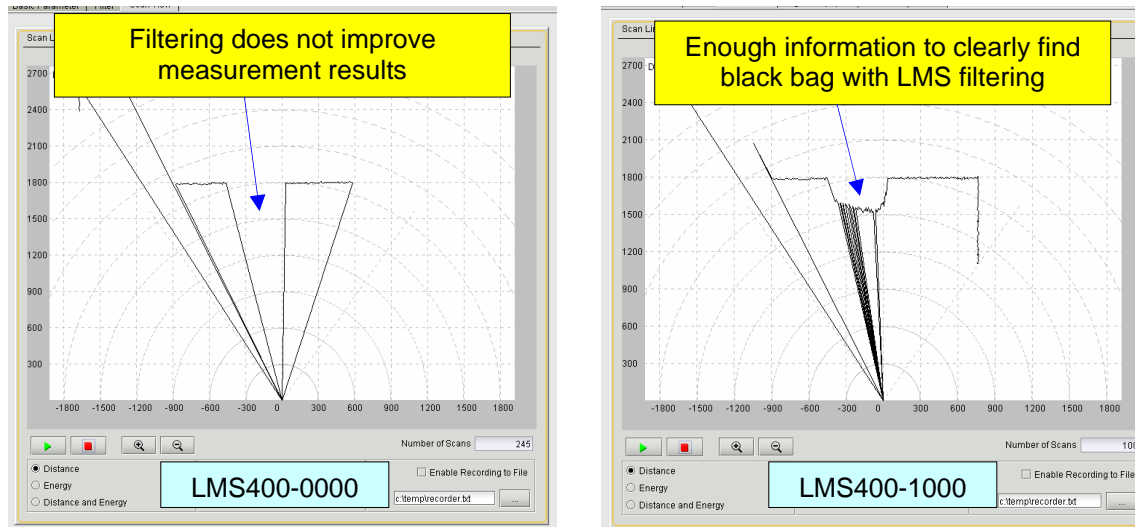
**Comparative results of the early and late model lasers on a dark surface**

In milestone 1 it was found that the SICK LMS400-0000 laser measuring sensor was not reliable on dark coloured carcasses, and large amounts of data regarding the carcass profile were not gathered. Initial investigations from milestone 1 indicated that the SICK LMS400-1000 using a 7.5mW laser could better suit the application. Testing of the sensing system using the new LMS400-1000 laser unit produced results with less than 5% faulty readings per scan, which gathered enough data on the carcass profile to produce a cutting path reliably.

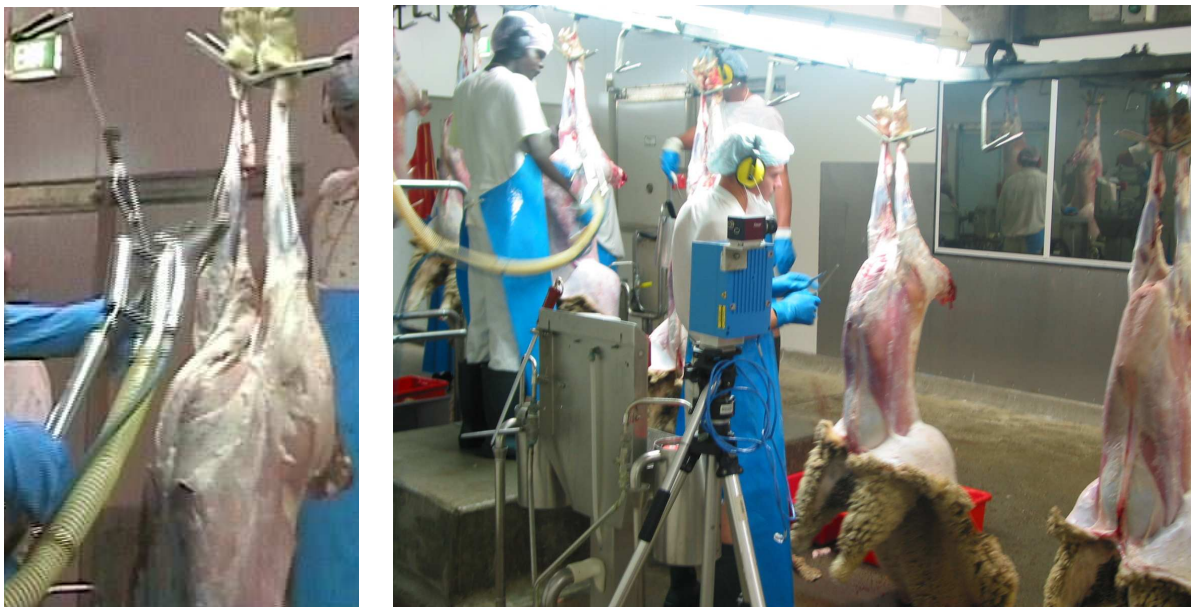
**Manual Y-cut VacSan process and sensing system being demonstrated in a typical sheep plant**

The sensing system integrating both vision and laser data analysis was demonstrated to an MLA representative on the eighth of March, 2006 in a typical sheep production plant. Approximately 170 carcasses were successfully analysed at production speeds during the demonstration.

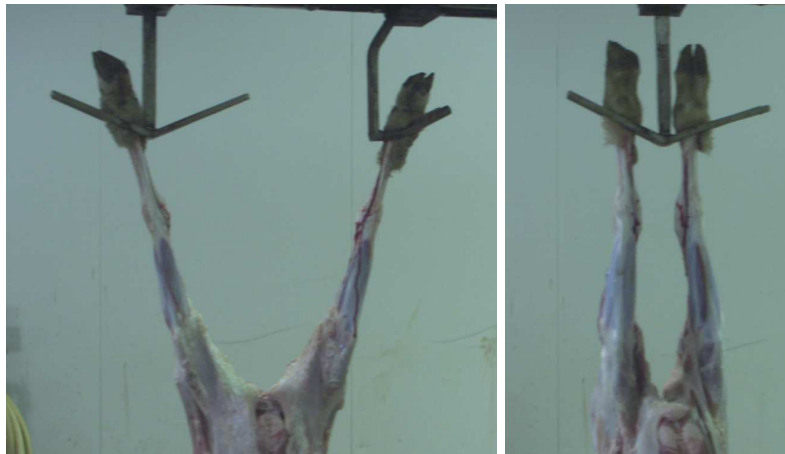
***Sheep leg reposition***

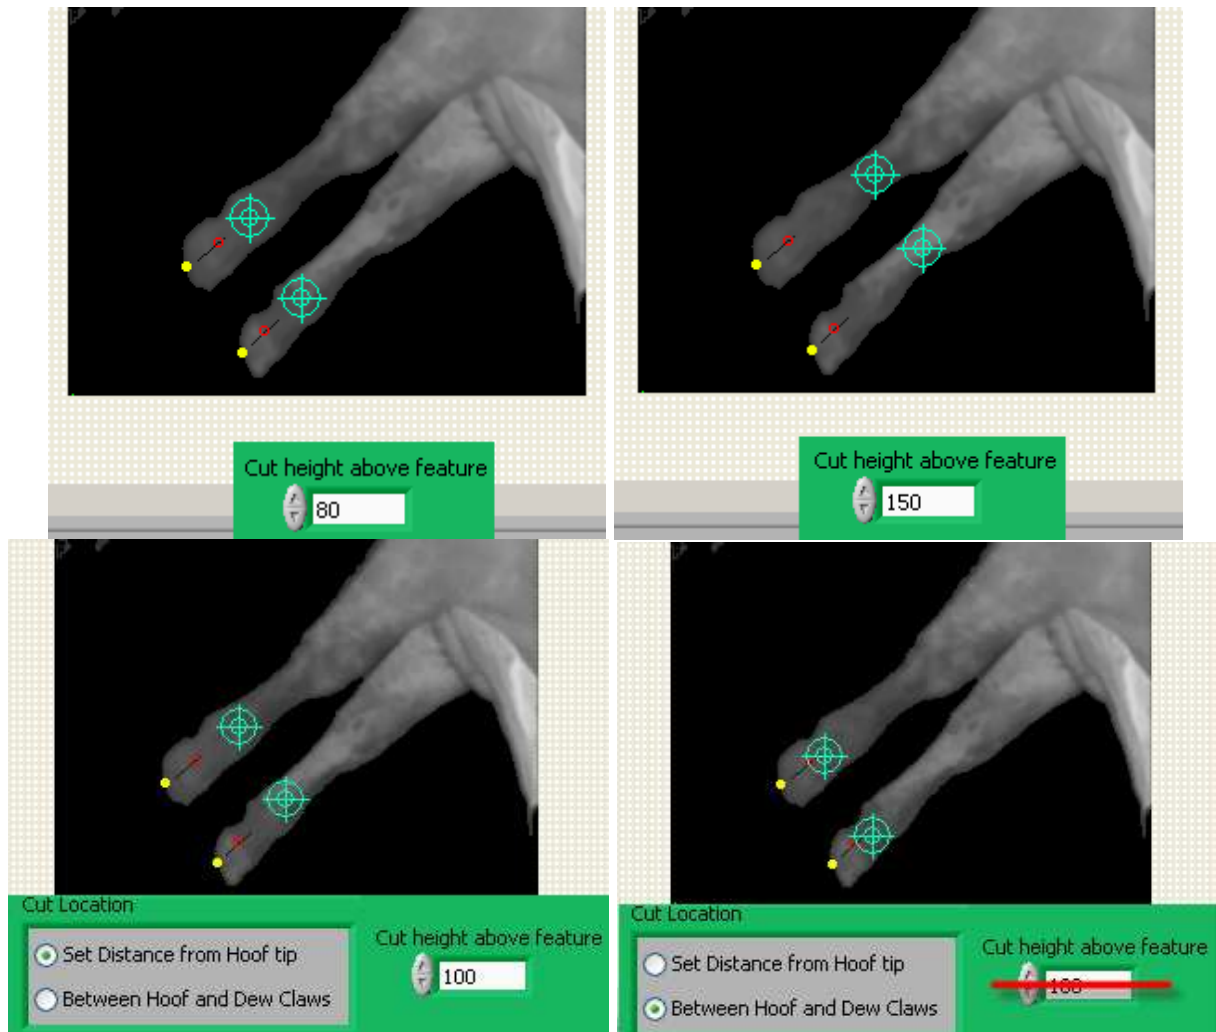
***Available operator settings allow for the final hock cut location to be varied***

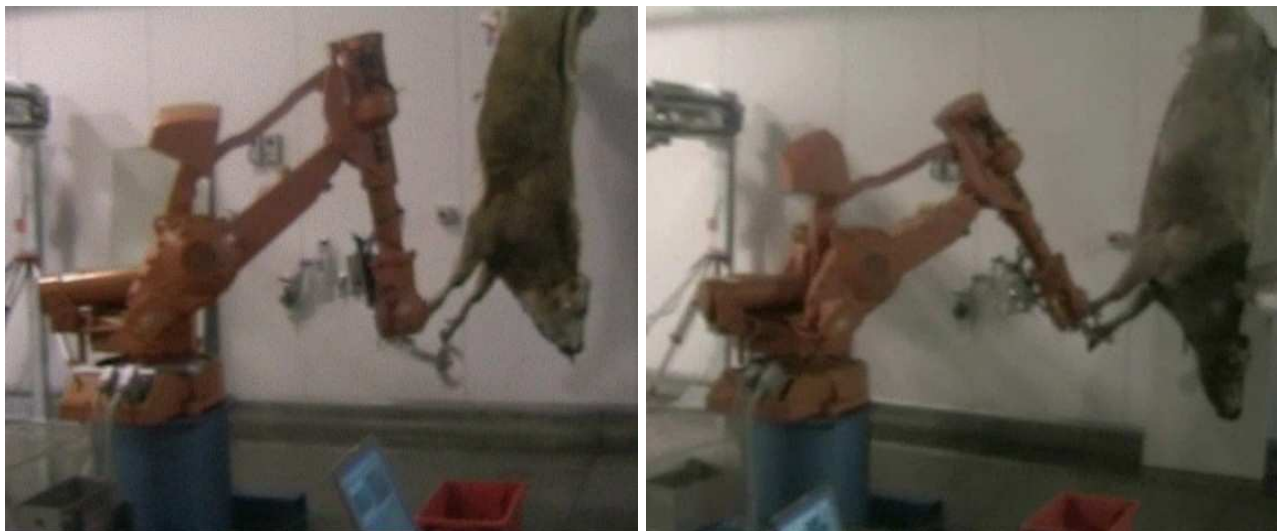
***The sensing system is integrated to a robot to demonstrate a fully automated beef hock cutting system***

The combined robotic system was demonstrated to an MLA representative on June 8, 2006 using one carcass that was moved to simulate the delivery of different carcasses. The calibration of the sensing system to the robot tool system was also successfully demonstrated to be robust and easy to implement.

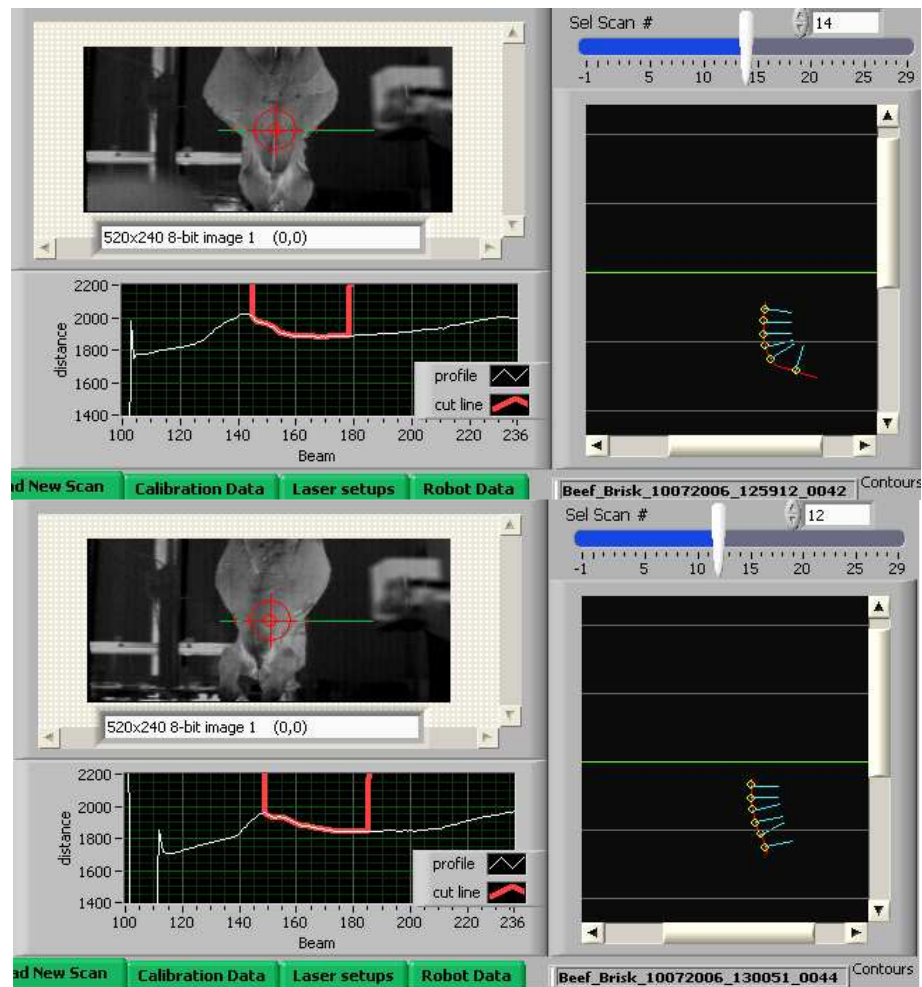
**Typical results of the cutting path after the combination of the thermal image analysis and the laser profiling analysis**

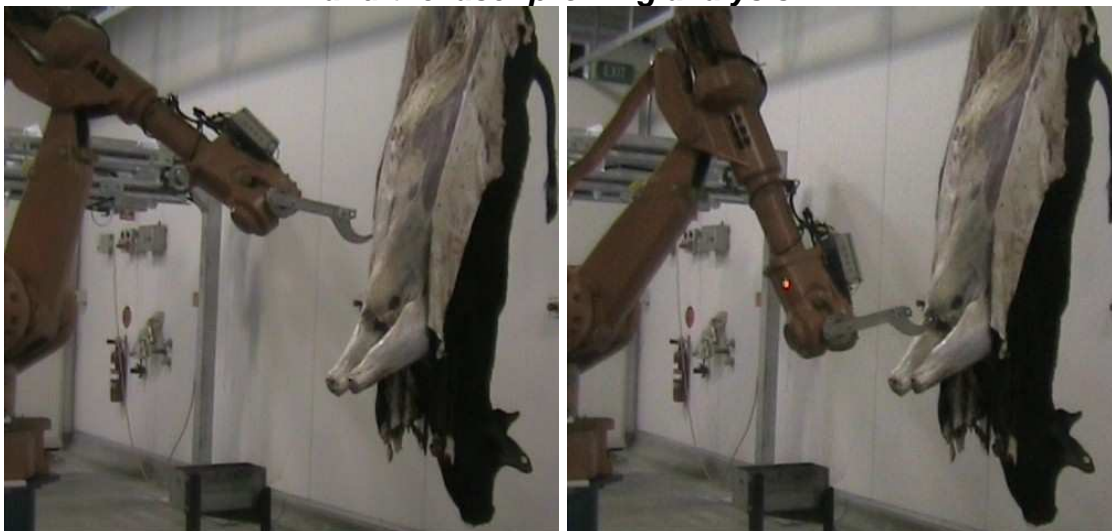
**The sensing system is combined with the robot to demonstrate a fully automated brisket cutting system**

The sensing system was integrated to the test facility at FSA in Cannon Hill including the use of an ABB4400 robot fitted with a mock cutting tool. This automated system was successfully demonstrated to an MLA representative in a single carcass moved into several different positions, and a video showing this demonstration was released.

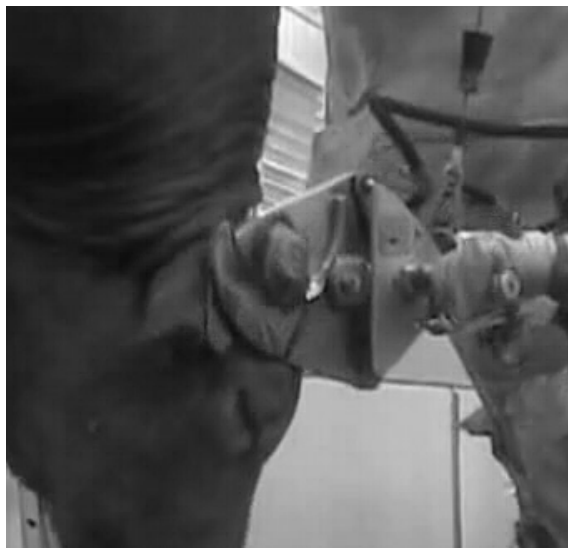
***Typical beef horn removal process***

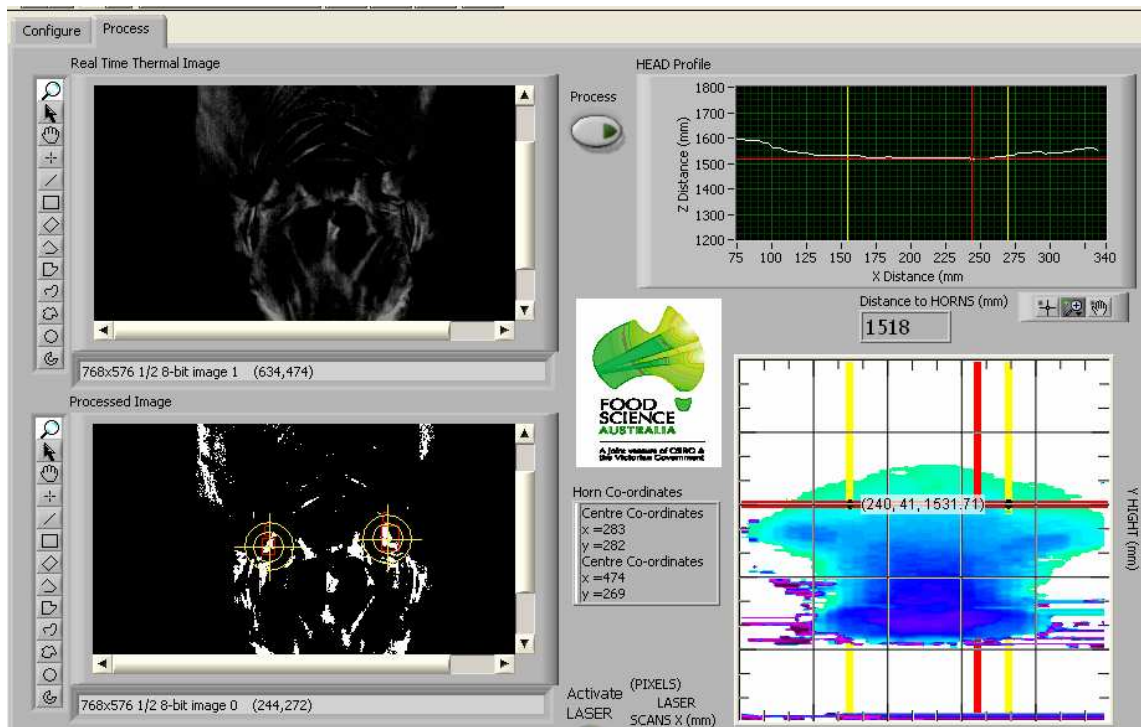
**Thermal and laser analysis combined to locate the horn location in 3 dimensions perpendicular to the head**

The method used to calculate the distance and height of the tip of the head (adjacent to the bases of the horns) and the side of the head (between the ears and horns) using laser profile data from the LMS 400 was found to be accurate and repeatable on all carcasses observed during both demonstrations. This was concluded through the observation of the data and results displayed in real time and through the subsequent analysis of the data collected during the demonstrations.

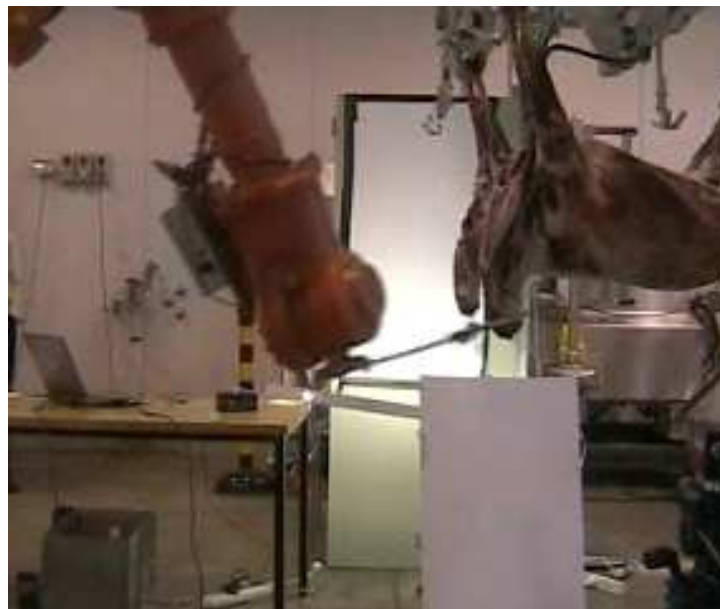
***The sensing for the sheep neck tipping was integrated to a robot and a fully automated neck tipping system was demonstrated at the Food Science Australia facility***

It has been concluded that the automated neck tipping operation can be completed in the time allowed in a typical sheep processing plant and the operation guarantees that tool is sterilised between carcasses. The time remaining after the automated neck tipping operation allows for the possibility of including another simple operation within the same cycle time using the same robot and tool.
