# final report

Project code: P.PIP.0141  
Prepared by: Mike Spence  
Churchill Abattoirs  
Date submitted: April 2006

## **Churchill Abattoir (CA) large scale demonstration wastewater recycling plant**

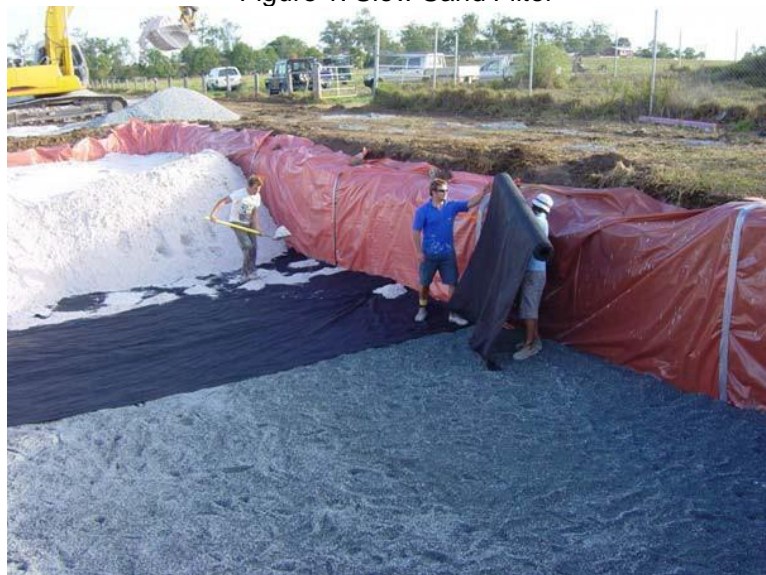
Figure 1: Slow Sand Filter

The purpose of the project is to trial a low-cost recycling system at Churchill Abattoir. Churchill Abattoir undertook pre-requisite preliminary work that included the sand filter; primary waste/recycled water delivery, and storage. Figures 1 show the installation process of a SSF approximately 20 x 10 x 2m. The SSF is a plastic sheet sealed unit with a gravel base containing perforated pipe connected to a sump at either end (raw inlet –treated outlet), geofabric forms a top and bottom layer to contain the sand with gravel and pipes in the top layer as shown. The whole unit is designed to contain and treat all raw water and exclude seepage into and out of the filter.

The 2-way valve allows the water to be directed to the storage tanks or returned to the Pond 3 lagoon. The filter was supplied using 2 x 50mm suction lines: 1 x siphon, and 1 x pumped. The pump was used to maintain a flow of approximately 4 L/s.

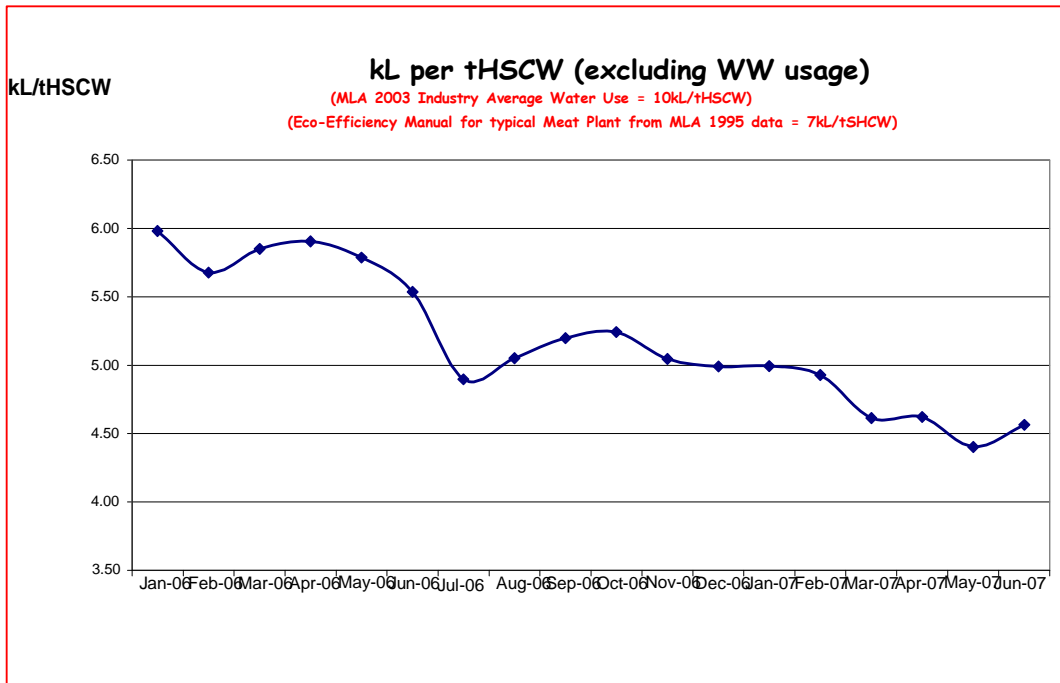
Figure 10 – Water Reduction Charts (kL/t HSCW)

Figures 10 and 11 show the reductive trend in water use commencing Jan 2006 when the SSF effectively came on line. Apr and May 2007 delineate the introduction of a concerted effort to meet WEMP targets. Larger water savings are envisaged when the boiler and condensing towers come on line. However, 11 ML is still a substantial saving due to the SSF.

Comparing the periods 1 Jul 2005 – 30 Jun 2006 and 1 Jul 2006 – 30 Jun 2007, water usage dropped about 11 ML during the 06/07 financial year. The pressure to implement water savings arising from the Government WEMP initiative did not impact until about May 2007. While the full range of water savings originally envisaged was less than expected, 11 ML remains substantial.

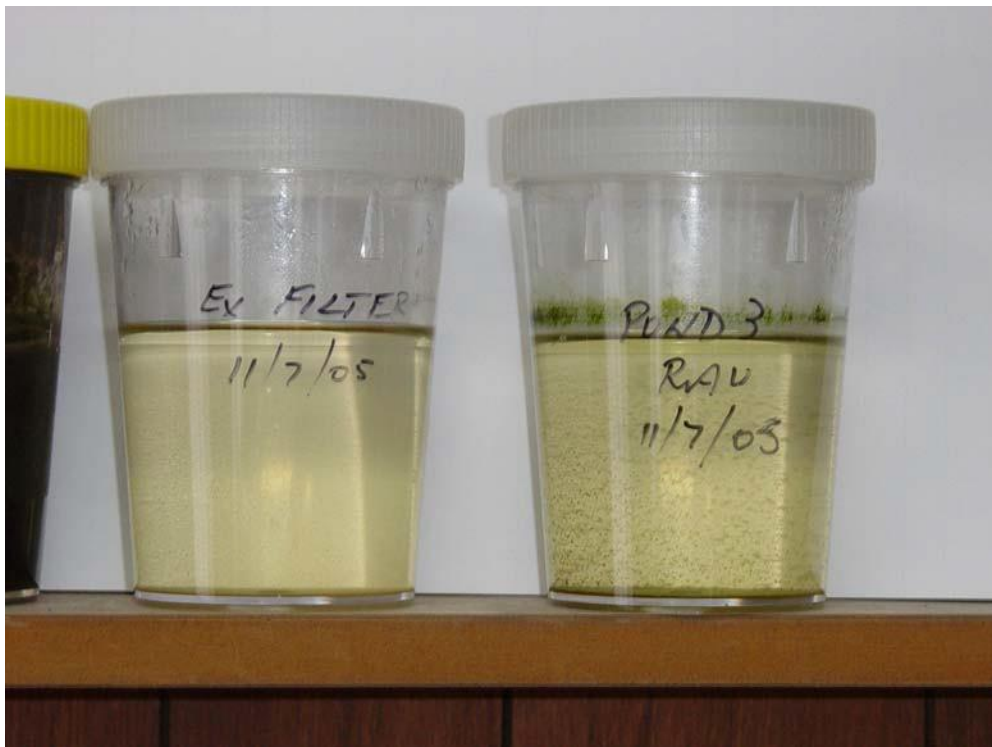
**Figure 12 – Initial Visual Quality Comparison**

Figure 12 is a visual comparison of water quality in July 2005 of pre- and post-SSF. Both samples have been shaken to enable the visual characteristics to be identified. The discolouration in both samples is due to Green Algae (Chlorophytes) and Blue-Green Algae (Cyanophytes). It is evident that the post-SSF sample is much clearer than the 'Raw' sample although the post-SSF sample still shows discolouration.

Table 1 shows analytical results undertaken by Buckman Laboratories in late July 2005 when the SSF had been in operation for a about one month. Churchill Abattoir was advised that the filter would only become effective after 3 – 6 months continuous operation. However, it was apparent that the SSF removed Oil and Grease and a percentage of Suspended Solids (200 – 157 mg/L). While Turbidity was reduced, pH, and EC remained relatively constant as expected. It was believed that Total N should have been significantly reduced but this did not occur.

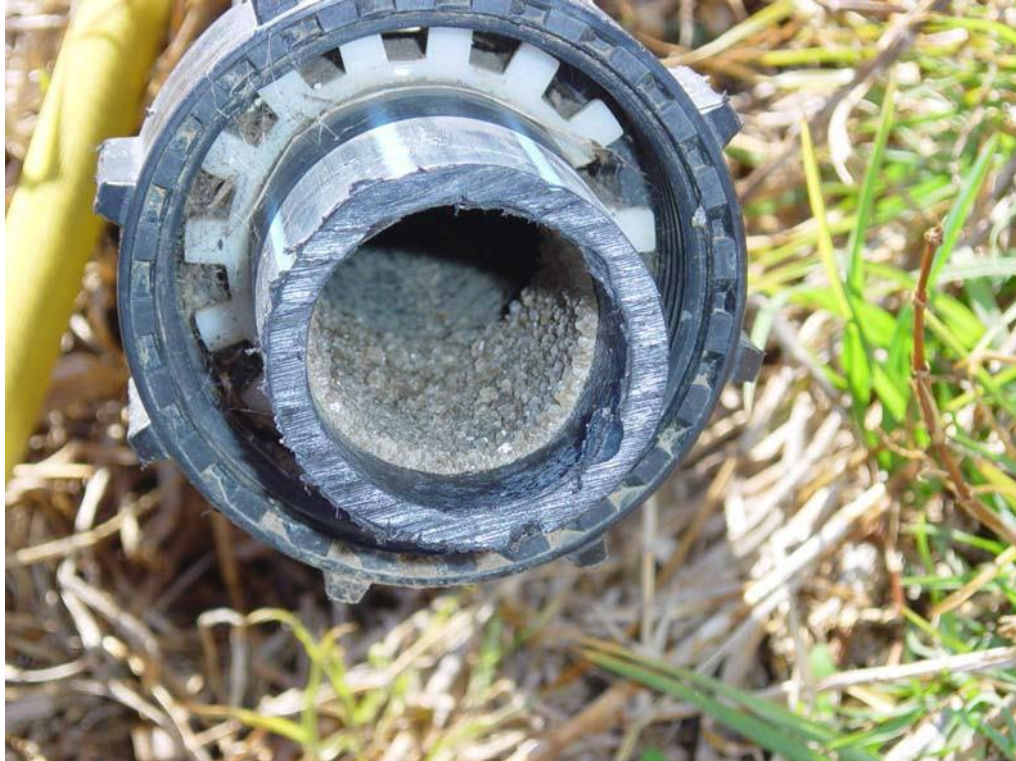
**Crystalline 'Struvite' Build-up**

Struvite is a crystal of magnesium, ammonia, and phosphorus. Figure 16 shows the crystalline formation in a siphon line to the SSF. It has not been substantively established that the crystals are Struvite but observation from other industries suggests that it is more than likely Struvite. Regardless of its naming, the crystals have formed in pipes, pumps, and all other surfaces. This has meant that the SSF has been suspended until a solution to remedy the situation has been found. The Struvite crystals have seized the irrigation and other pumps. It is believed it is not prudent to continue at this time.

Experience from other sites where Struvite is an issue suggests that it is found where wastewater is recycled from treatment ponds; e.g., flushing of pig sheds. Whether this is the case in this instance is yet to be proven. A plan to resolve the issue is discussed later.

Struvite has disrupted the use of wastewater from Pond 3. It is likely that the SSF may be compromised by Struvite. Churchill Abattoir is embarking on a pre-treatment system to extract Struvite from Pond 3 prior to SSF treatment. Construction of this system has recently commenced.

Pump cleaning with six types of acid was trialled. Formic Acid from Buckman Laboratories proved to be successful in softening the Struvite. The difficulty is that long supply pipes are difficult to treat in this way. Some success was had by high pressure pumping of the lines. Where small nozzles are used in various applications the Struvite particles clog the apertures that require constant cleaning.
