# final report

Project code: P.PSH.0274  
Prepared by: Kevin Wilkie, Ian Willmot  
Cumberland Systems Ltd /  
Proand Ltd  
Date submitted: April 2007

Direct skid mark identification

## Stage 2 final report

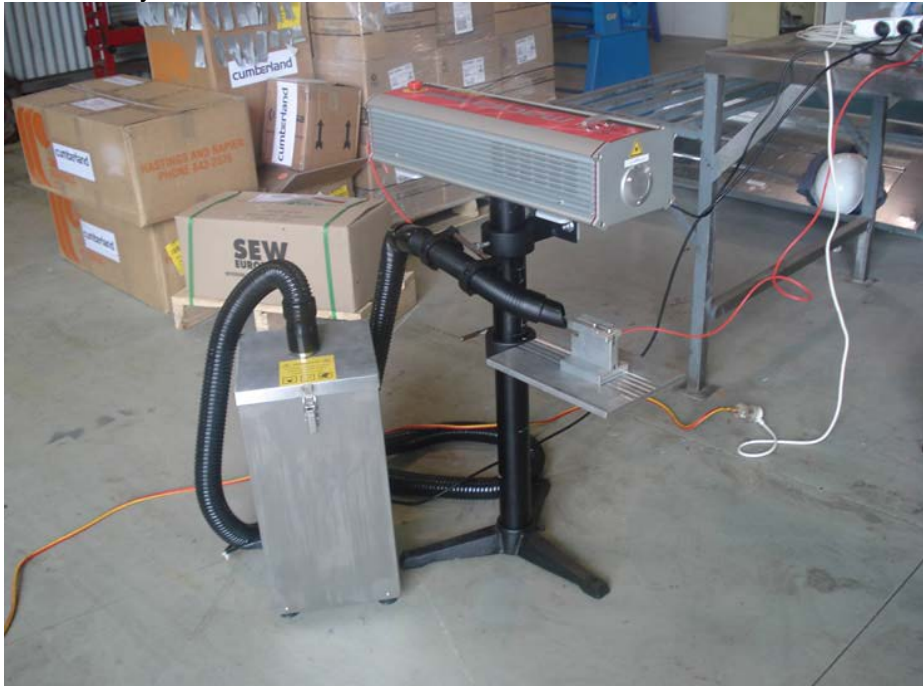
The laser system being used in this trial is a MACSA 10W CO2 laser c/w proprietary software and a fume extraction system.

**Image 1: MACSA Laser mounted on stand with fume extraction system alongside**

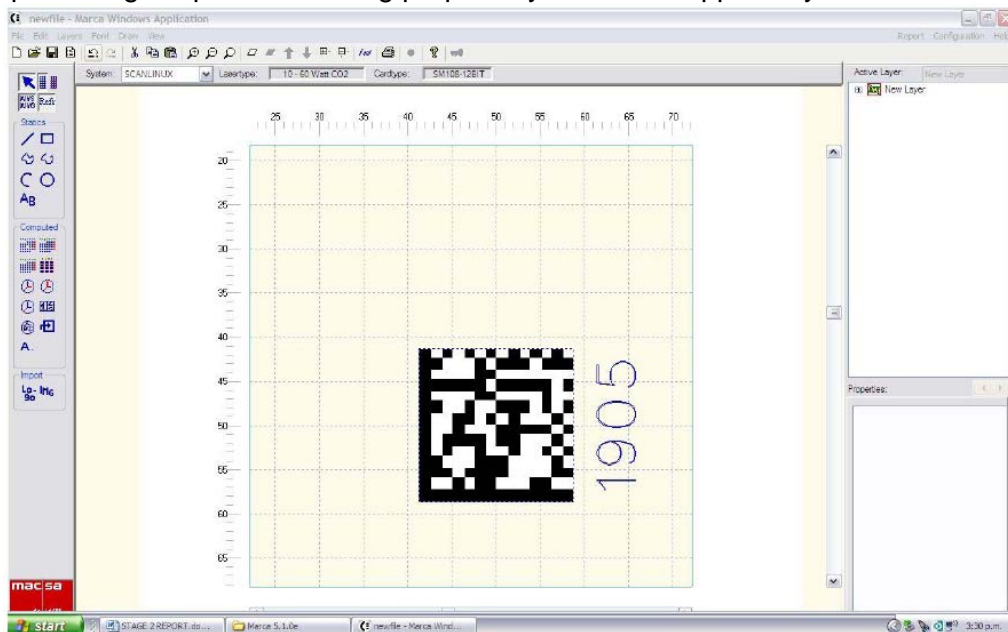
The laser print image is produced using proprietary software supplied by MACSA laser.

**Image 2: MACSA application software environment**

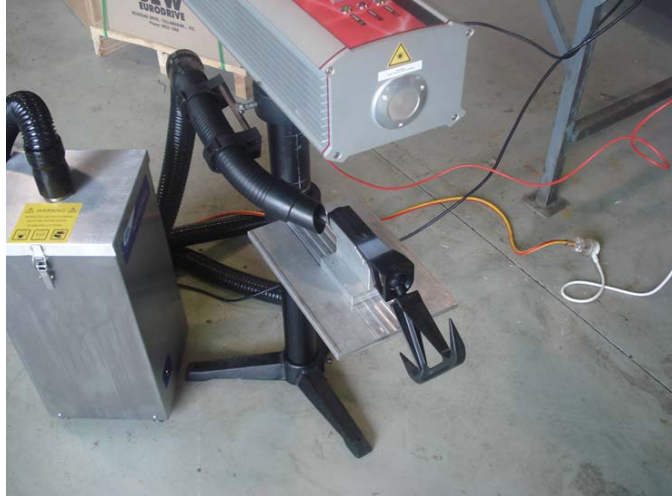
The laser printing is initiated through the MACSA software in the PC which is connected to the laser via a 10Mbit Ethernet connection. We would like to state at this point that the static printing

**Image 3: Laser is ready to print with skid sitting in the cradle**

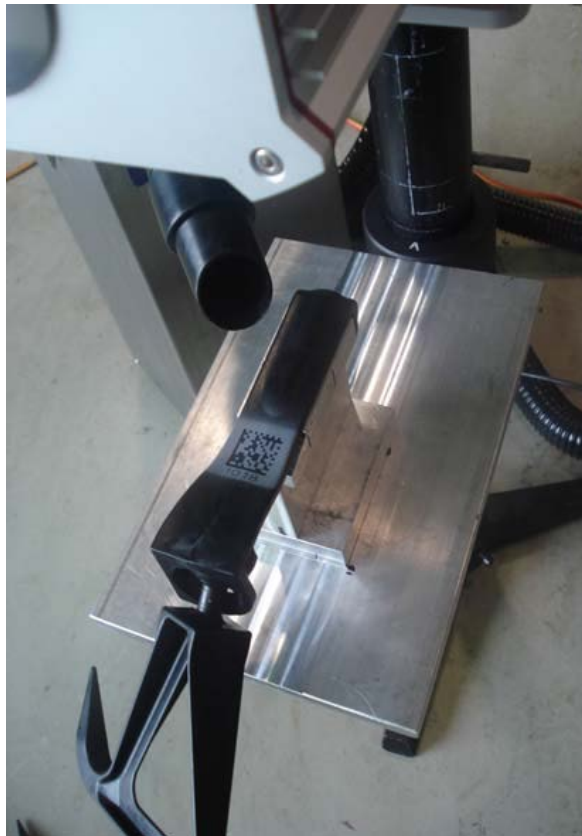
Each barcode and number printed was sequentially numbered and printed statically in the cradle for the purpose of this trial.

**Image 4: Printed skid sitting in cradle**

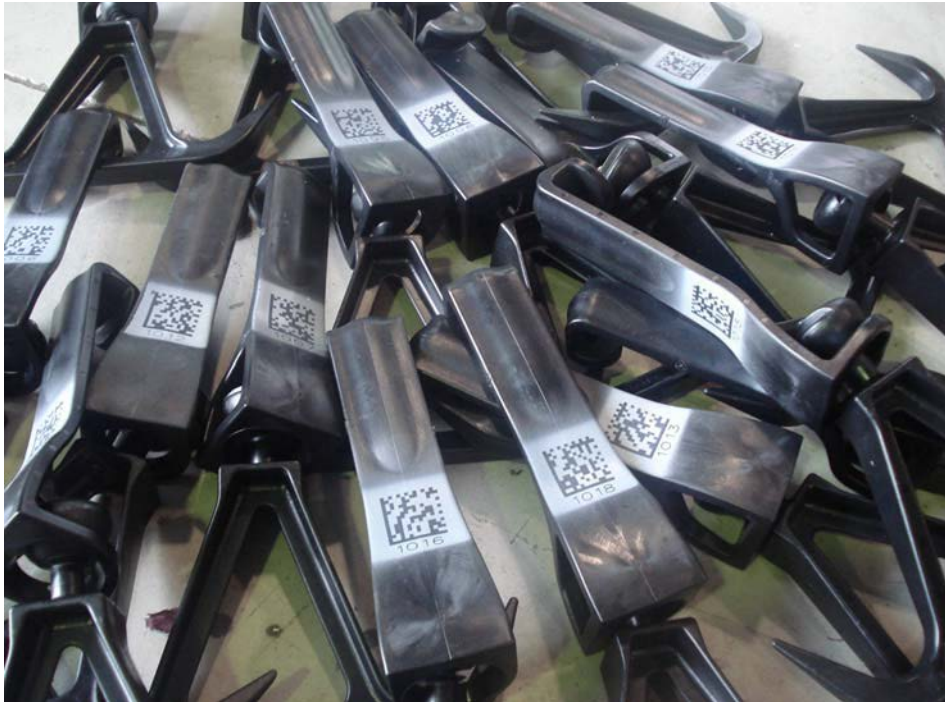
The completed skids with 2D Data Matrix (ECC 200) barcode and matching number printed onto the patch.

*Image 5: Skids with patch and Data Matrix barcode and matching sequential number The completed skids were then placed in boxes ready for use.*

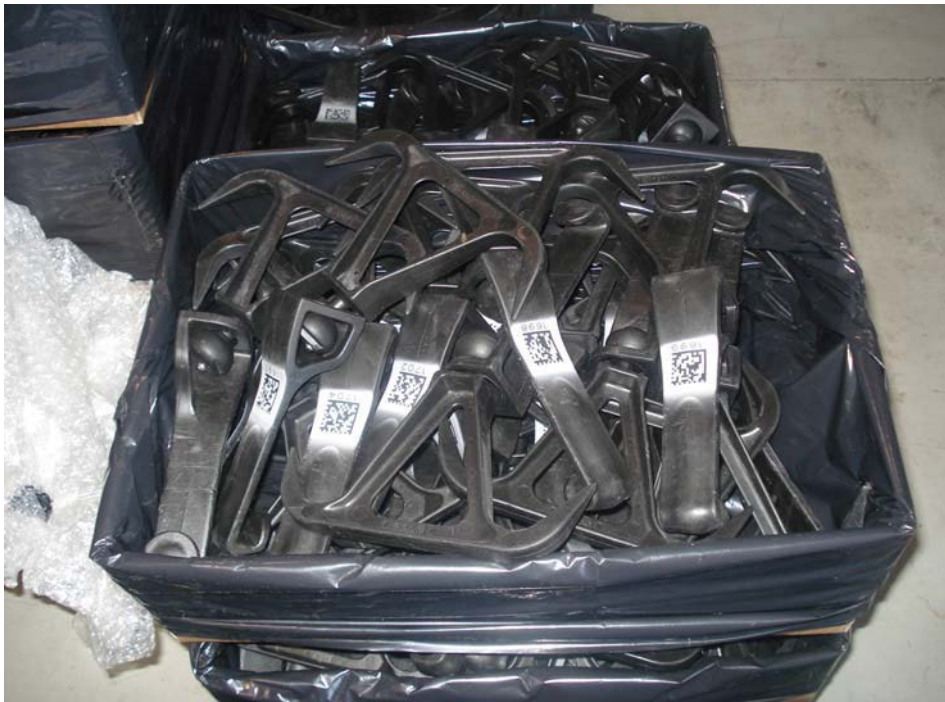
*Image 6: Skids placed into boxes*

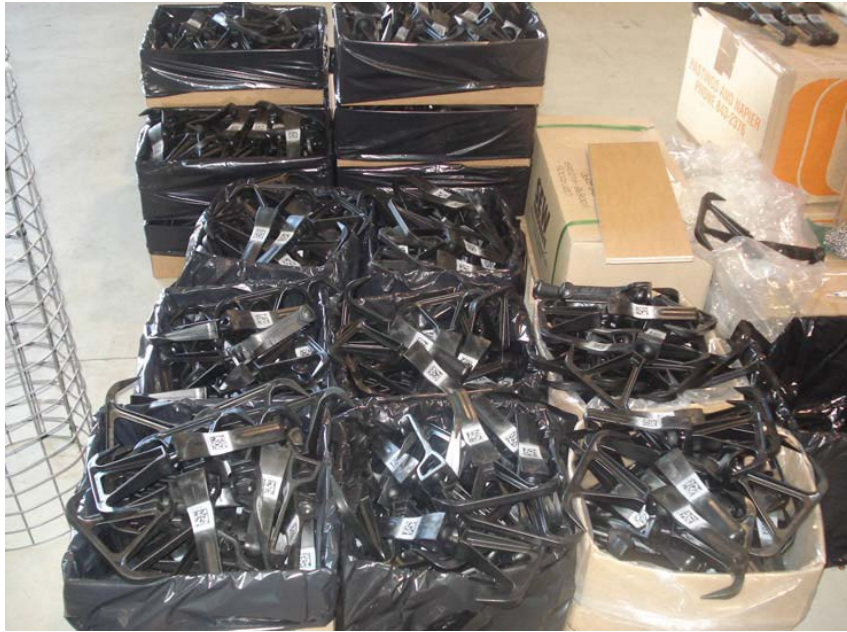
Over the course of this trial nearly 2,000 skids were printed and put into the process. Typically skids were prepared in bulk and introduced into the process in lots of 50 or 100 and the resulting read rate logged into the database software.

*Image 7: Prepared skids ready for use in the process*

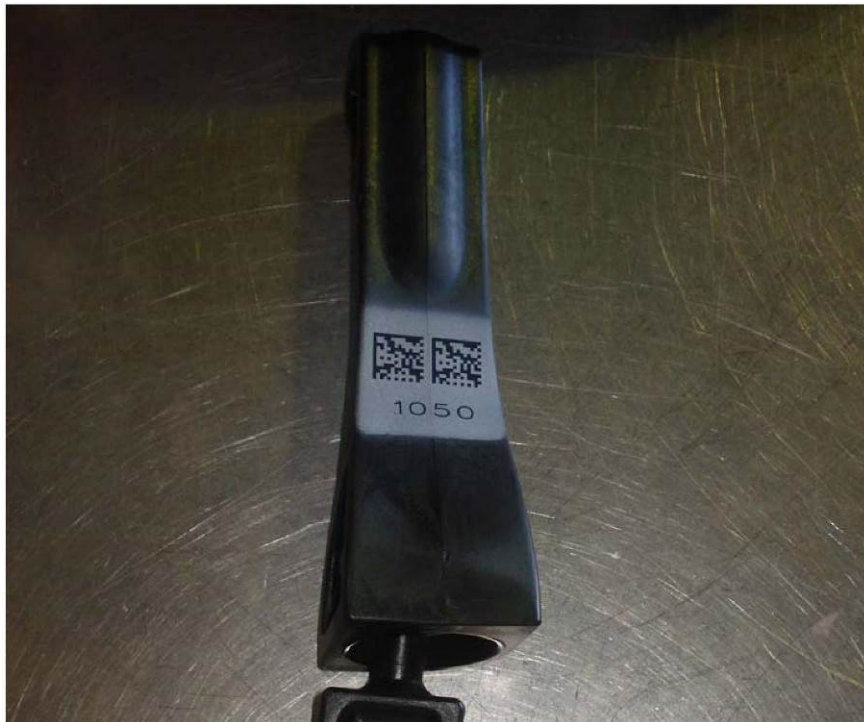
Tests were also carried out on printing skids with multiple prints of the same barcode to further improve read rates should a skid get damaged.

*Image 8: Skid with barcode printed twice*

The barcode printed is identical, the camera when triggered will find the first barcode it sees and decode it, and any further reads are not decoded. This is a relatively simple way of ensuring the maximum read rate is always possible.

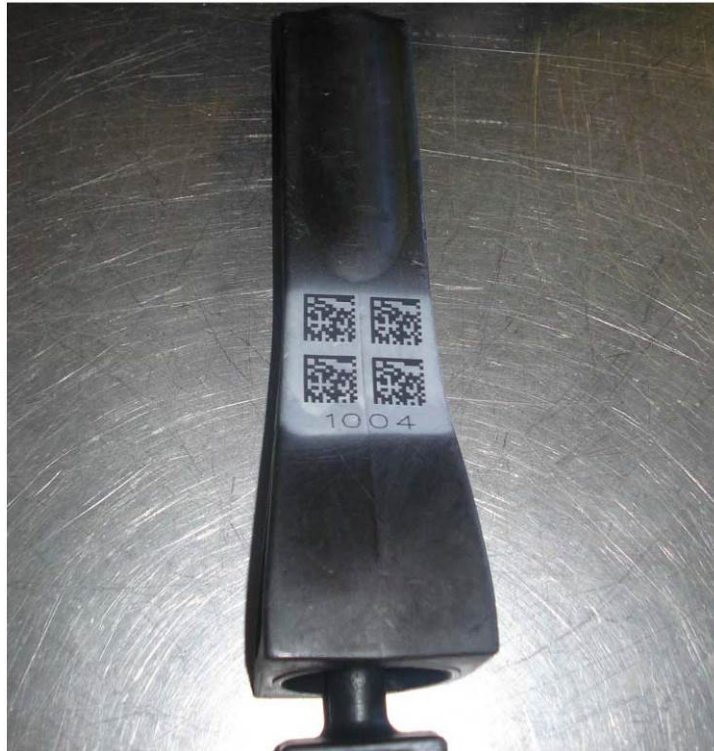
*Image 9: Skid with barcode printed four times*

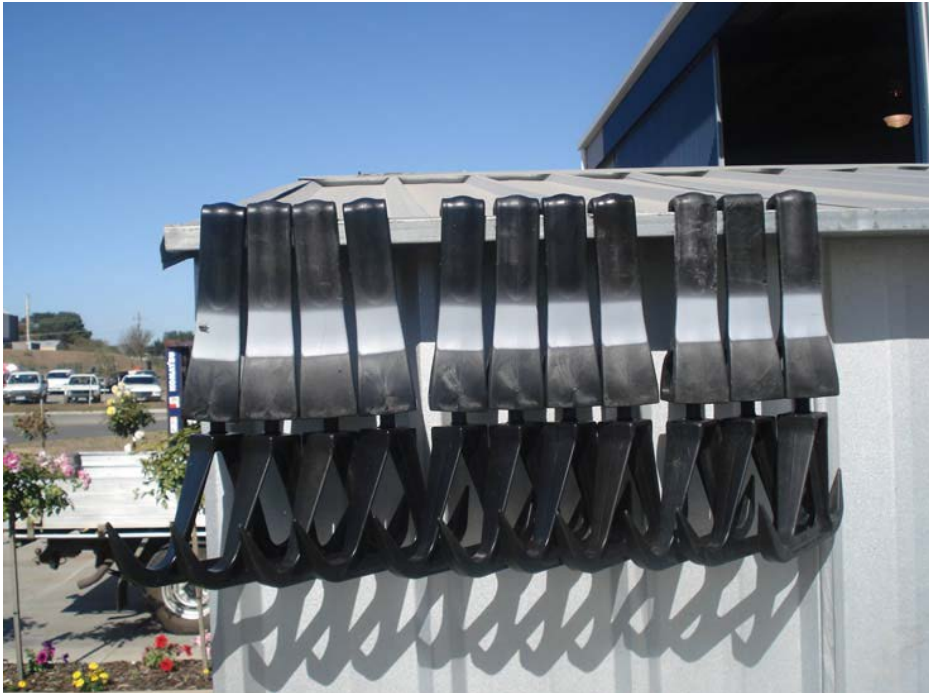
Once applied the patch was left to air dry, however the patch could be printed on almost immediately after the patch was sprayed on.

*Image 13: Patched skids air drying*

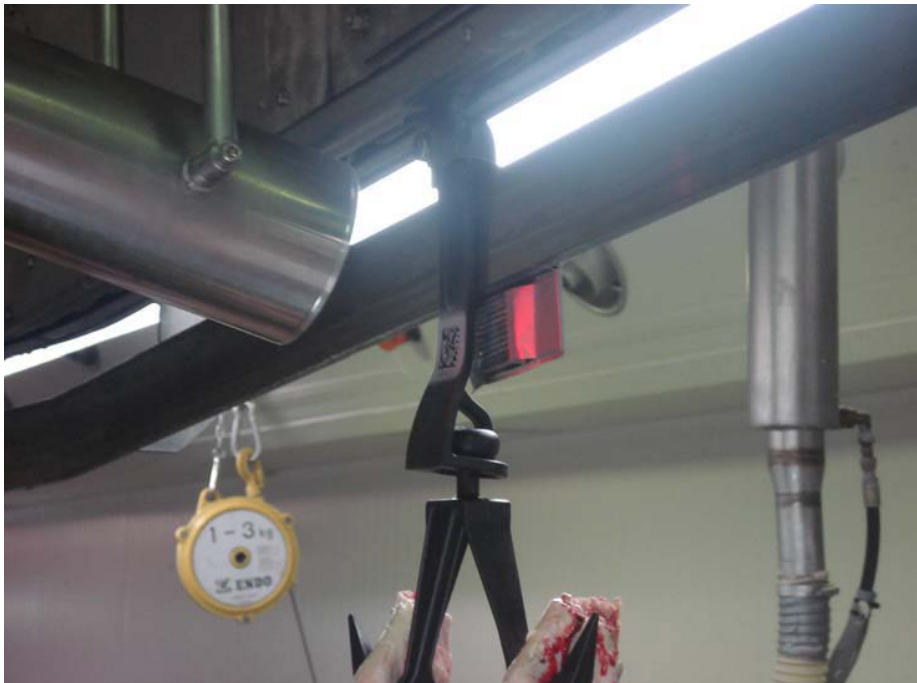
*Image 15: The Process Floor camera located prior to the detain gate*

The camera has two modes for capturing the barcode, Rapid mode and Continuous mode.

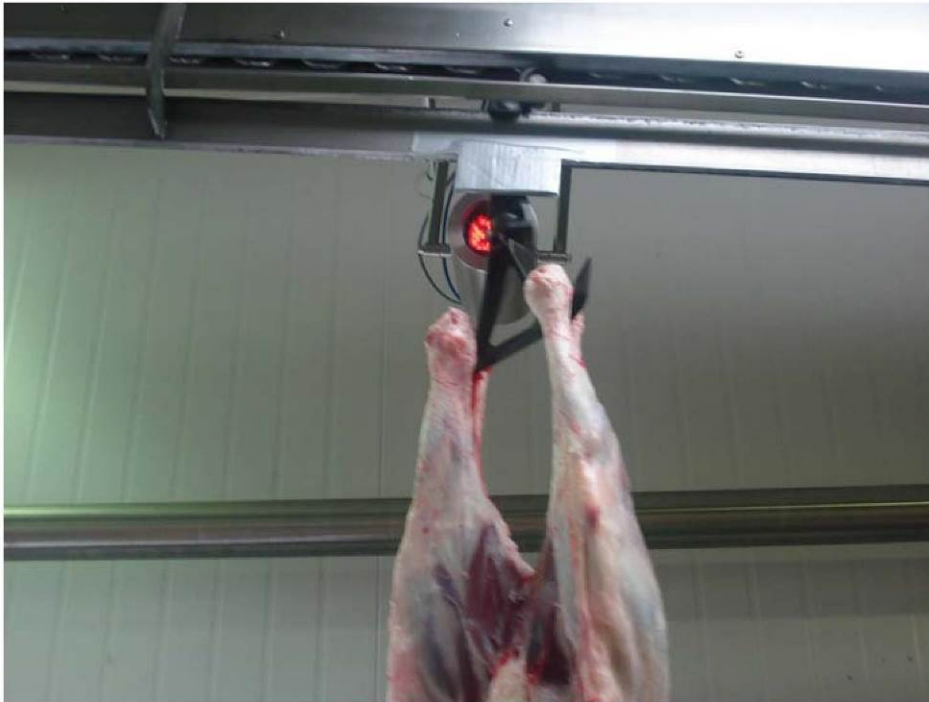
*Figure 2: camera has been triggered and the LEDs are illuminated*

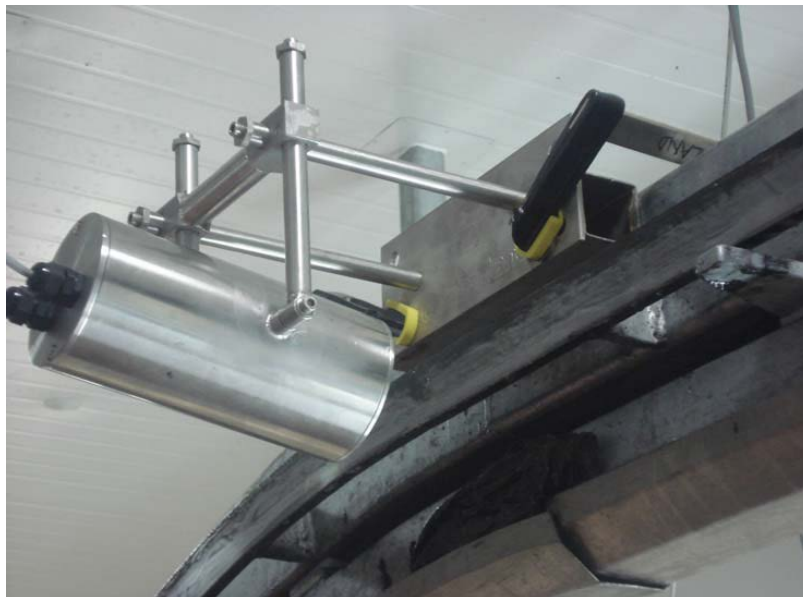
The Marshalling Area camera is mounted on the out-feed conveyor system.

*Image 16: Marshalling Area camera mounted on the out-feed conveyor*

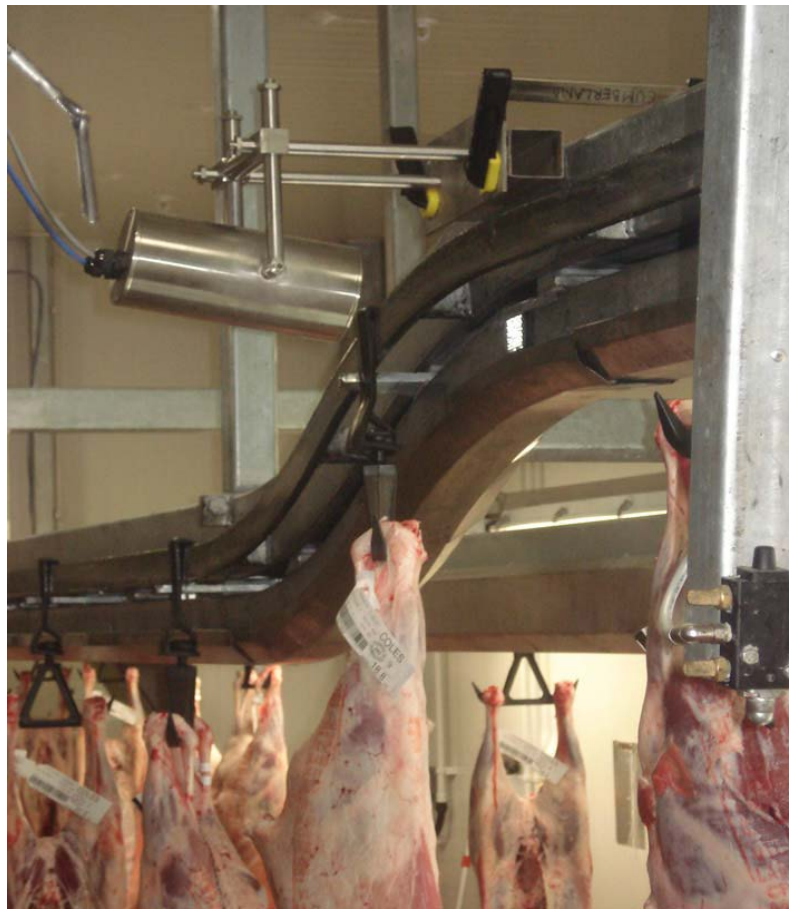
As the carcasses proceed along the Marshalling Area unloading conveyor they pass the second camera.

Image 17: Marshalling Area camera during load out to the Boning Room

The overall read rate recorded was 97%. We believe this is acceptable considering the manner in which the skids were printed, introduced into the system and the temporary nature of the installation. We are very confident a 100% read rate is achievable for a fully automated installation.

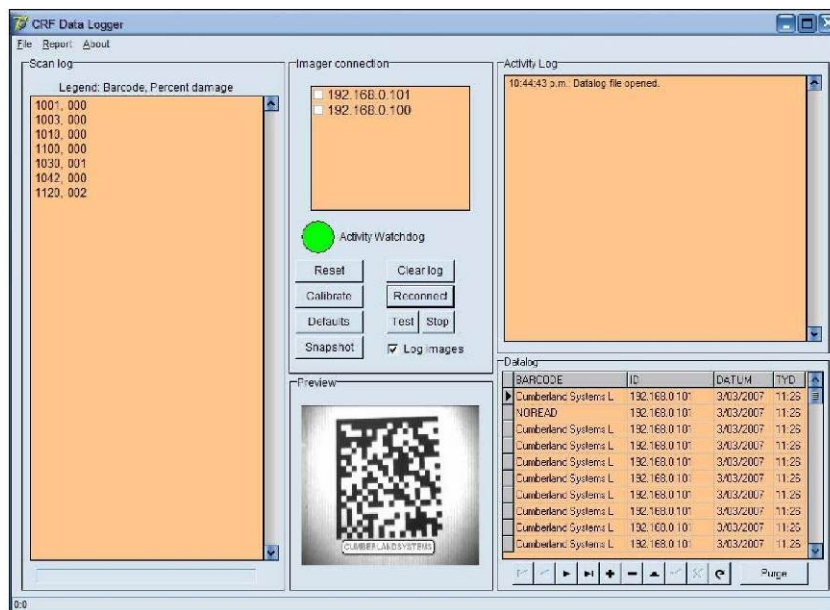
Image 18: Data Logger and Barcode capture software

The data logging software has been developed by Cumberland Systems Ltd specifically for this trial. The software has the ability to do the following:

- Connect to up to 10 cameras simultaneously via Ethernet.
- Maintain connection to each camera.
- Provide a means of calibrating all cameras.
- Receive bitmap images of faulty barcodes.
- Capture all barcode reads and store them in a database.
- Capture barcode 'percent damage' ditto.
- Additionally save data to a daily .CSV file.

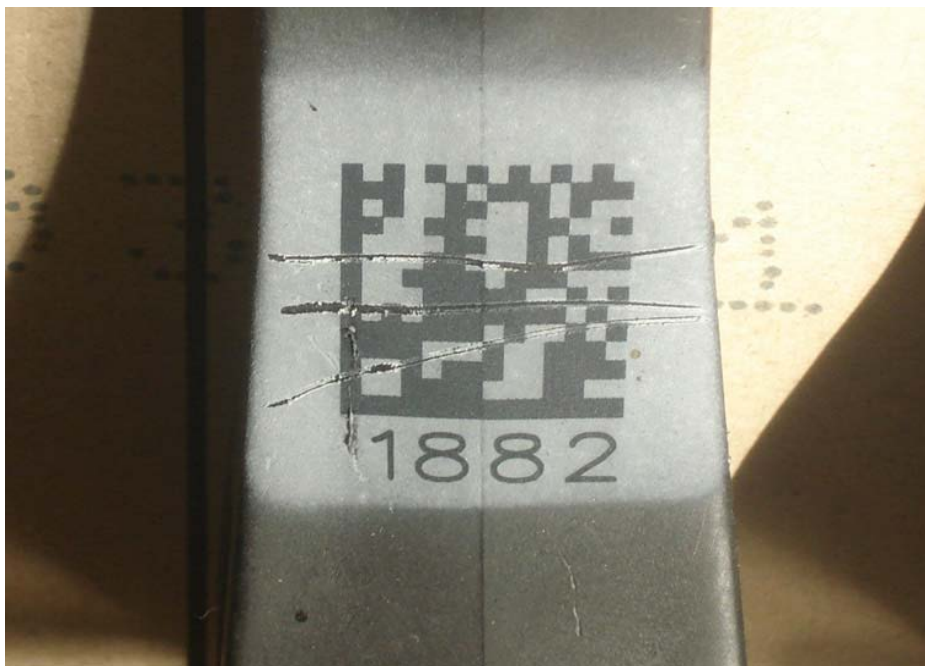
Some time was devoted to testing the read rate of damaged barcodes. Using Reed Solomon error correction, the printed Data Matrix symbol can also withstand damage without causing loss of data. This high level of error correction is far more advanced than one dimensional barcodes with check digits. The sample barcodes shown in images 19 and 20 were both readable. Data Matrix codes can reconstruct up to 20% of damaged characters while 1 dimensional barcodes have absolutely no error correction providing simply a check digit for basic error detection. If the 1 dimensional barcode is damaged or loses any characters, those characters are lost forever. This enables Data Matrix codes to guarantee a fast and accurate reading where misreading is almost a thing of the past.

*Image 19: Skid 1882 with barcode damage, reads okay*

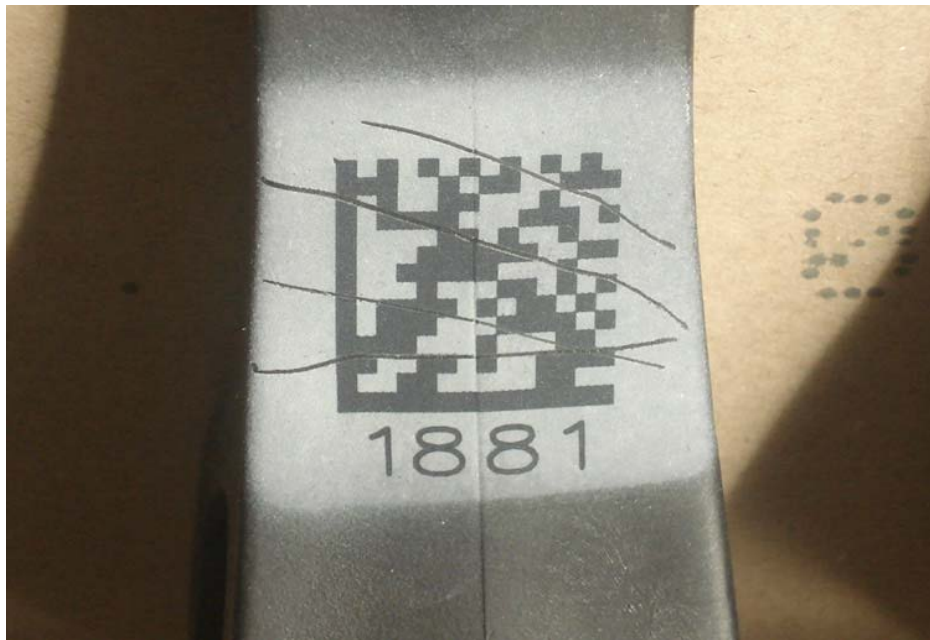
Image 22: Skid 1881 with barcode damage, reads okay.

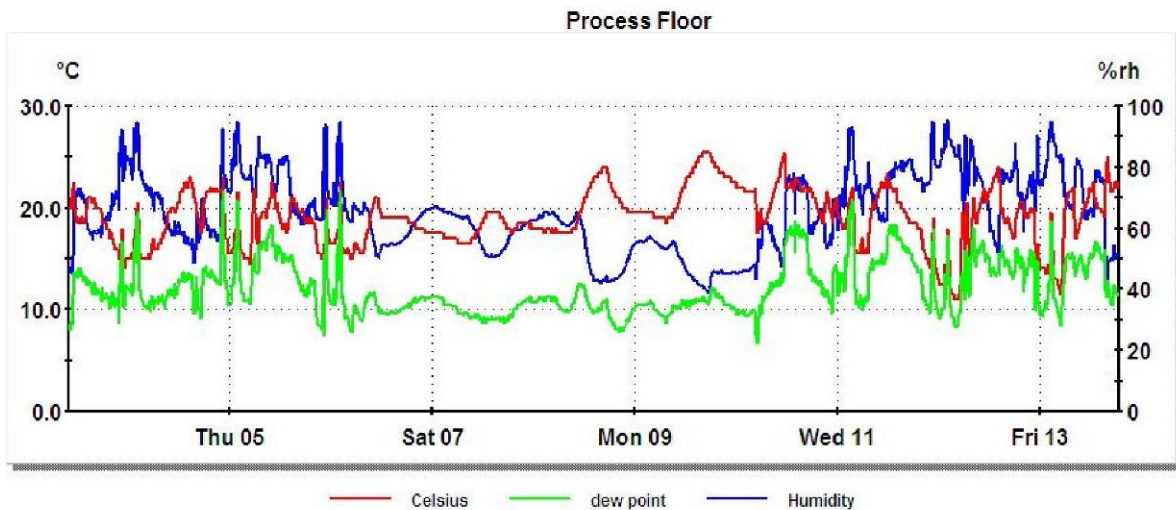
From:- 03 April 2007 09:55:40 To:- 13 April 2007 18:45:40

Image 21: Trend for the Process Floor showing Temperature, Humidity and Dew point

The average temperature for the Process Floor over this period was 19.00 deg C, the average humidity was 76.33 %RH.

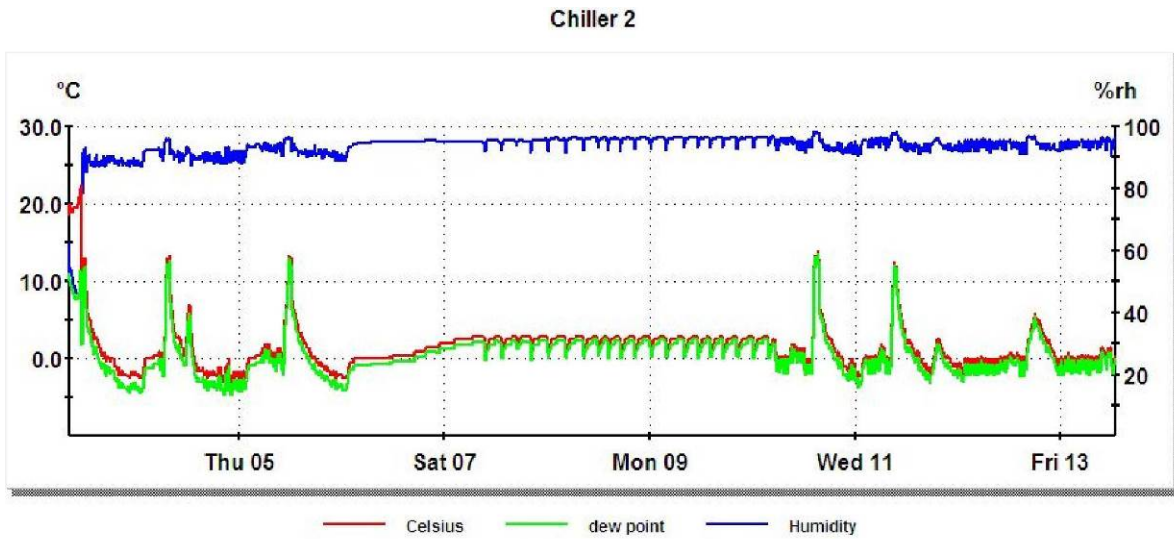
From:- 03 April 2007 08:24:40 To:- 13 April 2007 12:49:40

Image 22: Trend for Chiller no.2 showing Temperature, Humidity and Dew point

The average temperature for Chiller 2 over this period was 1.59 deg C, the average humidity was 93.4 %RH.

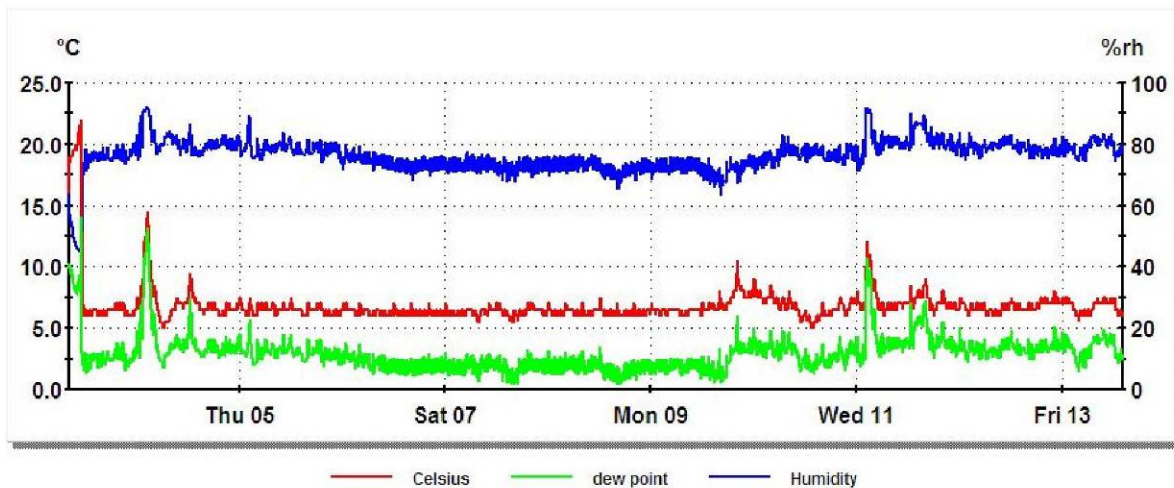
From:- 03 April 2007 08:19:12 To:- 13 April 2007 14:04:12

The average temperature for the Marshalling room over this period was 6.85 deg C, the average humidity was 76.3 %RH.

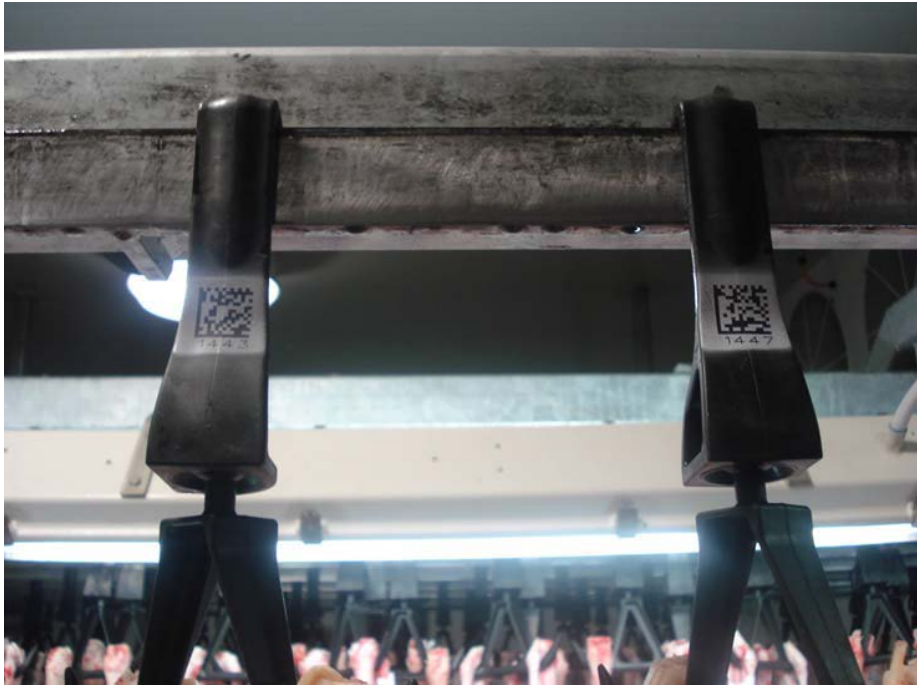
*Image 23: Skids in the Chillers*

The patches survived the chillers environment exceedingly well, the barcodes did not appear to be affected by the humidity or the temperature at all.

Having tested the printed skids in the Chillers and the freezer we are very confident with the ability of the patch to maintain adhesion to the surface of the skid and remain in excellent condition with no noticeable deterioration in readability.

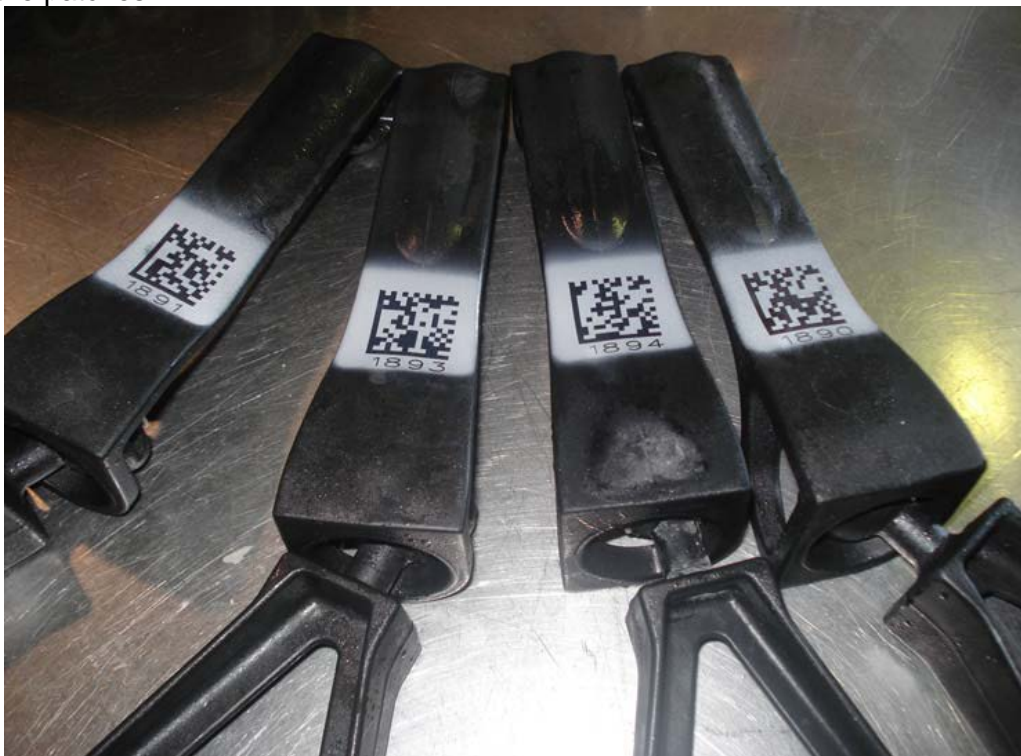
Several skids were placed into the freezer for a 48 hour period. No visible deterioration could be seen on the patches.

*Image 24: Two skids with each type of patch were subjected to 48 hrs at -20 deg C, note the ice on the skids*

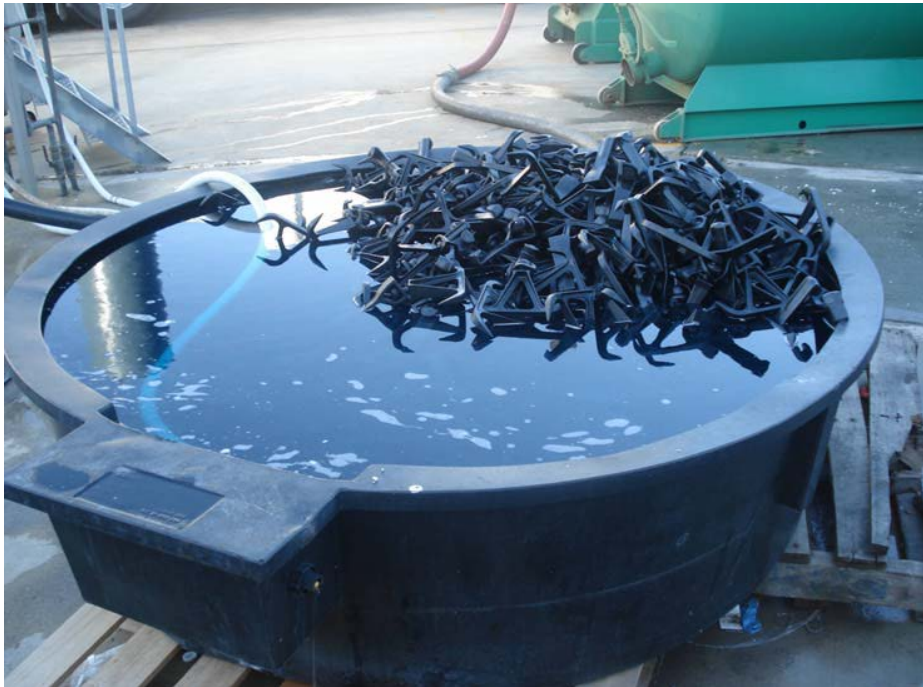
*Image 25: One of three skid washing tubs*

Each tub contains approximately 1600 litres of water, and 75 litres of Applied Chemicals Pty Ltd, F50 heavy duty cleaner and degreaser.

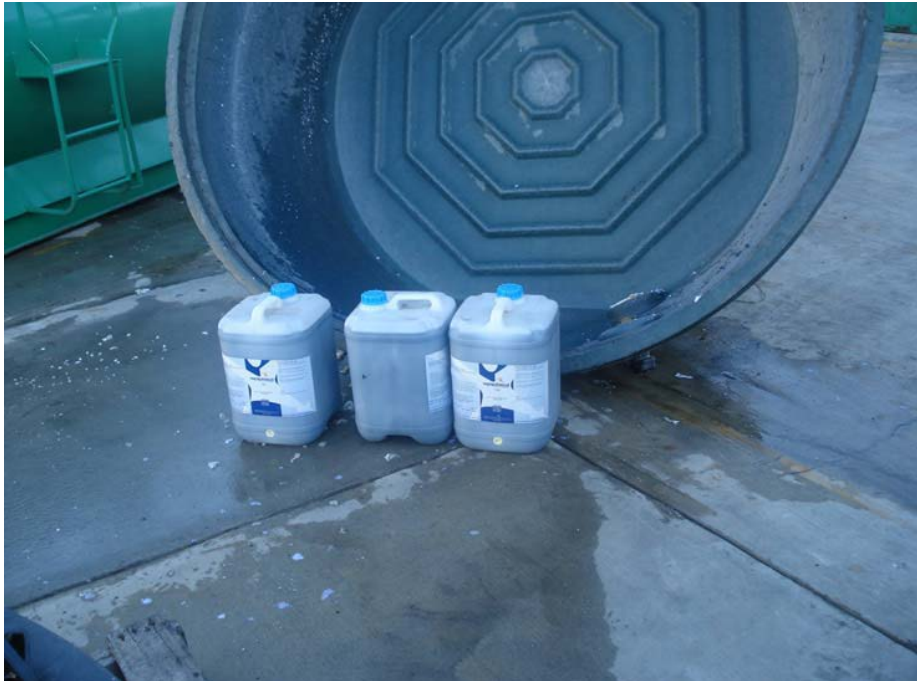
*Image 26: Weekly cleaning of tub and re-charging with detergent*

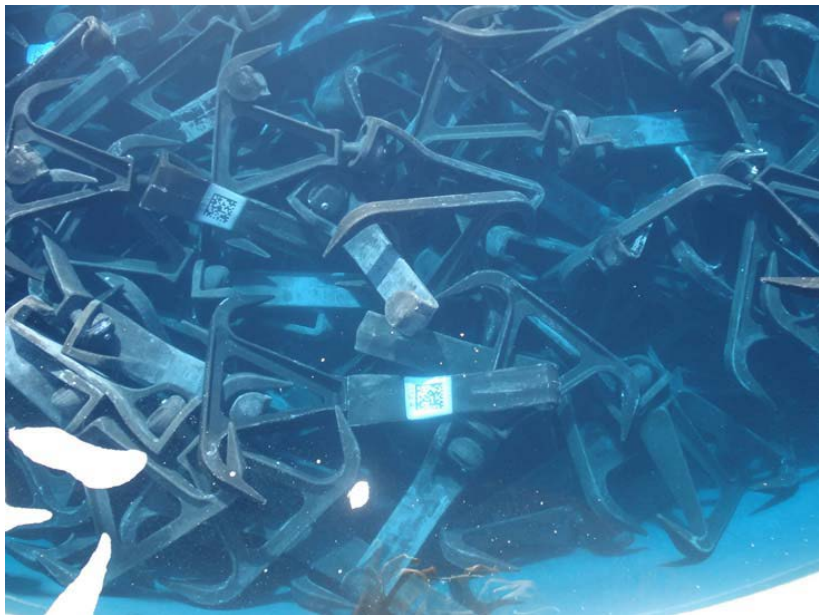
*Image 27: Skids soaking in tub*

The Low Strength patch begins to soften and bubble almost immediately.

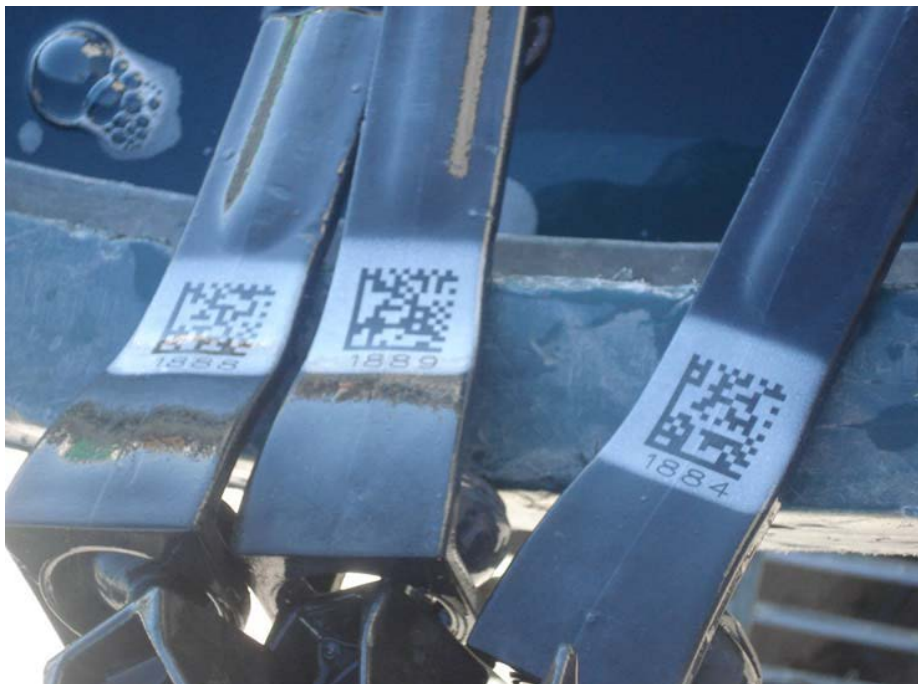
The High Strength patch maintained a very good adherence to the skid through the process. Subsequently the skid washing had less effect on removing the patch. This we determined to be mainly because of the low water temperature in the soaking tubs.

*Image 29: Skids with High Strength patches being tested in the soak tubs*

Several tests were conducted to find out what was required to remove the High Strength patches. The most successful test was done using the detergent and 82 deg C water temperature, the patch softened considerably and could be seen to be dissolving over a period of time.

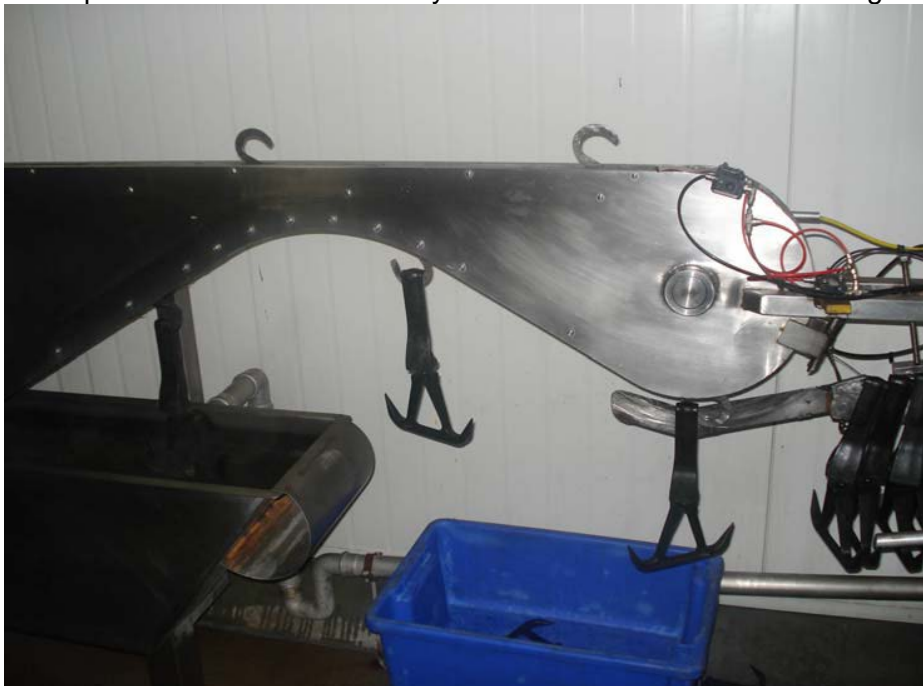
When the soaking period is completed, which can be anywhere from two to eight hours the skids are removed from the tubs and put into wheel barrows and taken to the skid room. The skids are then placed onto the skid conveyor and elevated to the Processing Floor for re-use.

*Image 31: The Skid Supply conveyor transfers skids from the skid room to the Processing Floor*

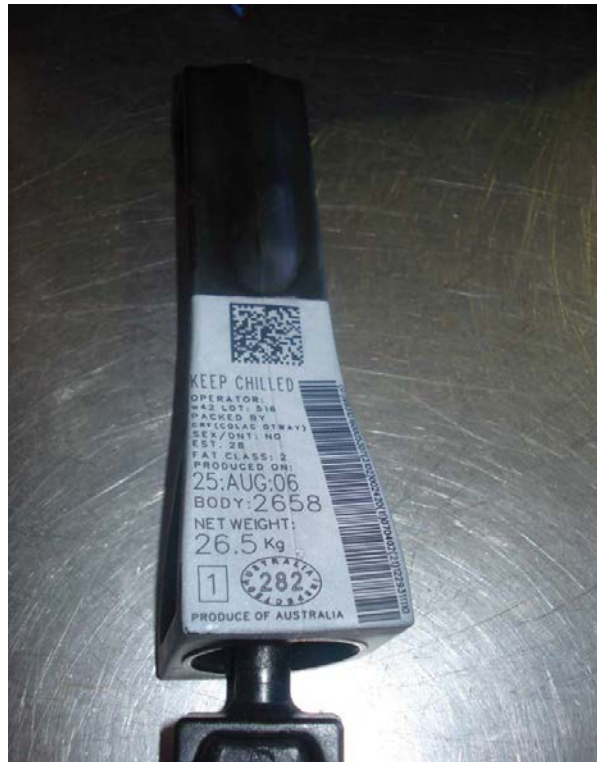
Image 32: Skid printed with the carcass ticket data and an additional Data Matrix barcode

As shown in Image 33 the skid is printed with the same data as per the paper ticket, the advantage of the printing onto the skid being it can be done without any human intervention, similarly the current practice of manually reading the barcode would be rendered extinct as the skid can be machine read. Based on the manning used at CRF there may be potential to save two staff per shift by employing this method of carcass ticketing.
