# final report

Project code: P.PIP.0450  
Prepared by: Nekta Nicolaou  
Date published: 01 Nov 2015

## Trim UV Light E. coli Intervention

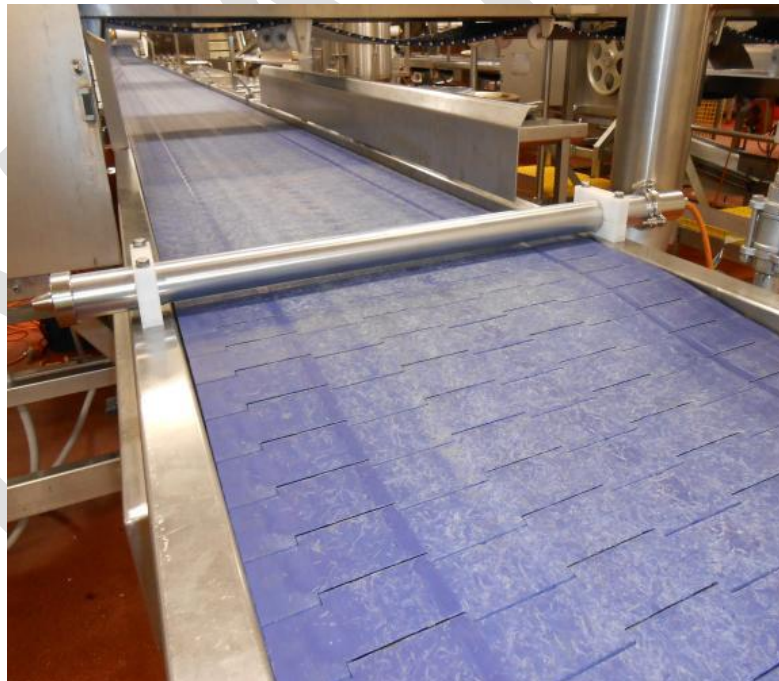
Figure 1: Steribelt Trial Installation

The UV lamp unit fitted to the lamb shoulder belt was Heraeus SteriBelt SB650 with the following specifications

- Construction 316L Stainless Steel (IP67 rated)
- Overall length 880 mm
- Window dimensions 650mm L x 25mm W
- Distance to the belt 9mm
- Power consumption 80 Watt
- Irradiance at surface of belt (as tested) 25.5mW/cm<sup>2</sup> @ 9mm.

Photos of the trial UV unit fitted to the conveyor belt are shown in Figures 1, 2 and 3 below.

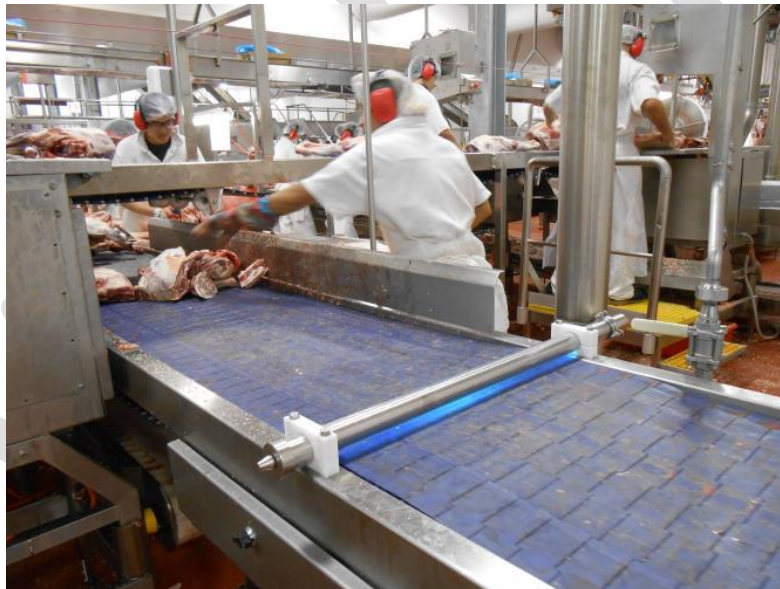
Figure 3: Steribelt operating on belt

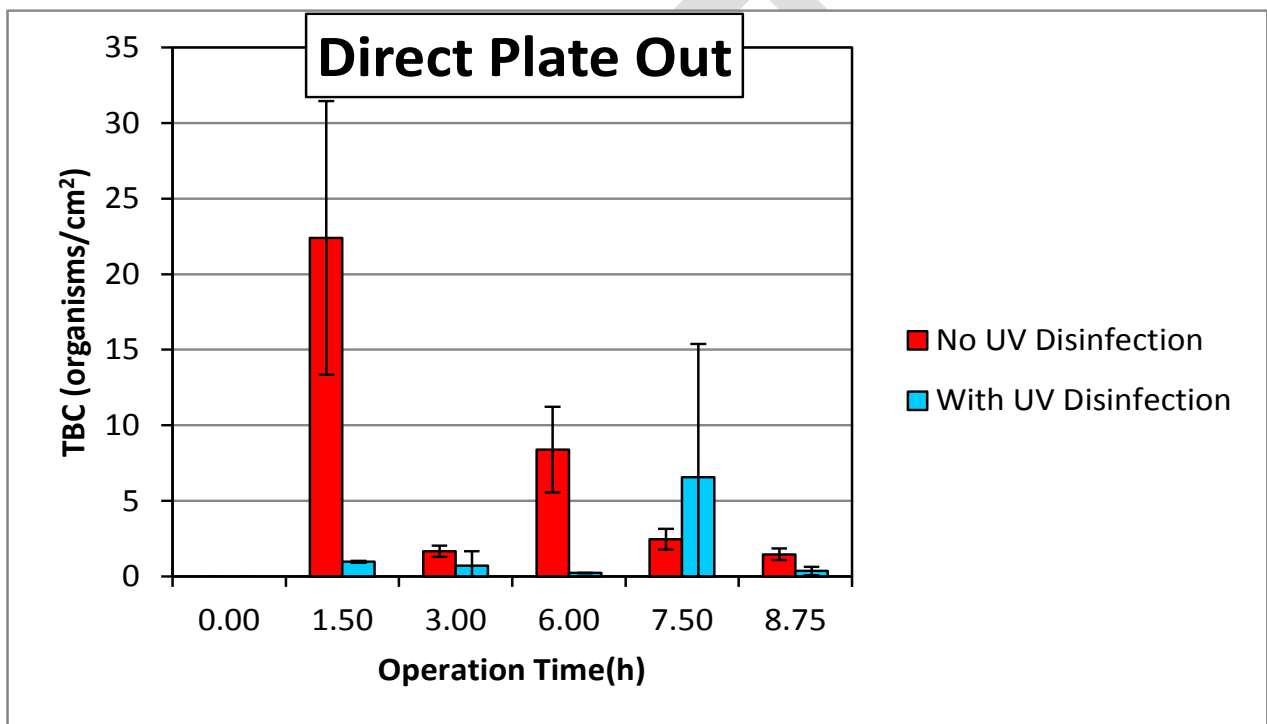
Figure 4: TBC results obtained with the 'Direct Plate-Out Method', with & without UV Disinfection

A summary of TBC results obtained with the “Direct Plate-Out Method” is given Table 1 and Figure 4. The test results clearly indicate a significant reduction in TBC as a result of UV disinfection, with the exception of the swab sample collected at 7.5 hours.

For the two samples in which the TBC were not lower when the UV lamp was operating, *i.e.* 3 h sample (pour plate method) and 7.5 h sample (direct plate out method); in both cases the results of the duplicate samples taken at each sampling time were very different. For the 3 h sample, the duplicate samples gave results of 3.2 organisms/cm<sup>2</sup> and 25 organisms/cm<sup>2</sup>. The first result is in line with the other results for the pour plate method with the UV lamp operating, but the second much higher result means that on average, the TBC is substantially higher for this sample than

for the others. Similarly, for the 7.5 h sample, the duplicate TBC results from the direct plate out method were 13 and 0.32 organisms/cm<sup>2</sup>. Again, the lower result was in line with other results for the direct plate out method with the UV lamp operating, so it is the higher duplicate result which provides a higher than expected average TBC. It should be noted in this instance, the high result *i.e.* 13 organisms/cm<sup>2</sup> is an estimate only, as the original result was 640 organisms per swab (before calculation on a per area basis), which is well above the quantifiable limit of 300 organisms per swab. This puts further qualification on this particular result.

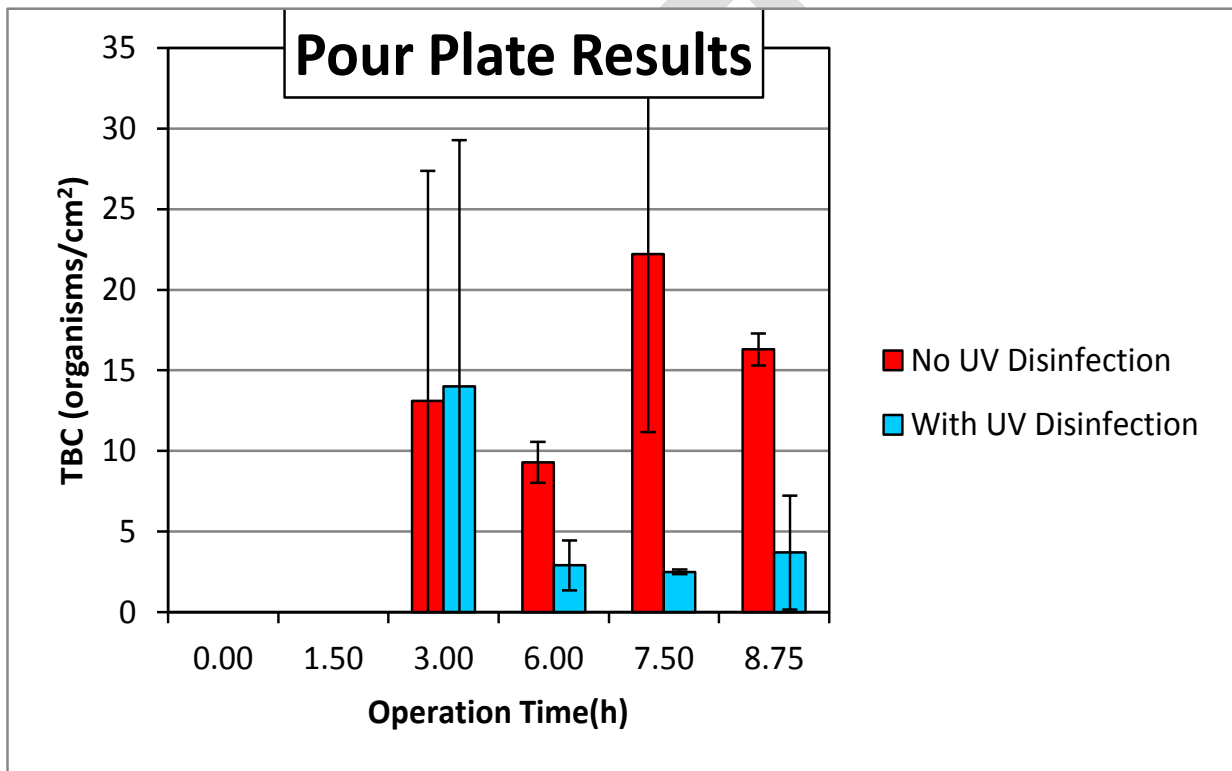
Figure 5: TBC results obtained with 'Pour Plate Method' with & without UV disinfection

A summary of TBC results obtained with the "Pour Plate Method" is given in Table 2 and Figure 5. The test results again indicate a significant reduction in TBC as a result of UV disinfection, with the exception of the swab sample collected at 3 hours.

Generally, TBC were higher for the “Pour Plate Method” than the “Direct Plate-Out Method”. This is likely due to better transfer of bacteria from the swab to the nutrient solution than from the swab directly onto the agar plate.

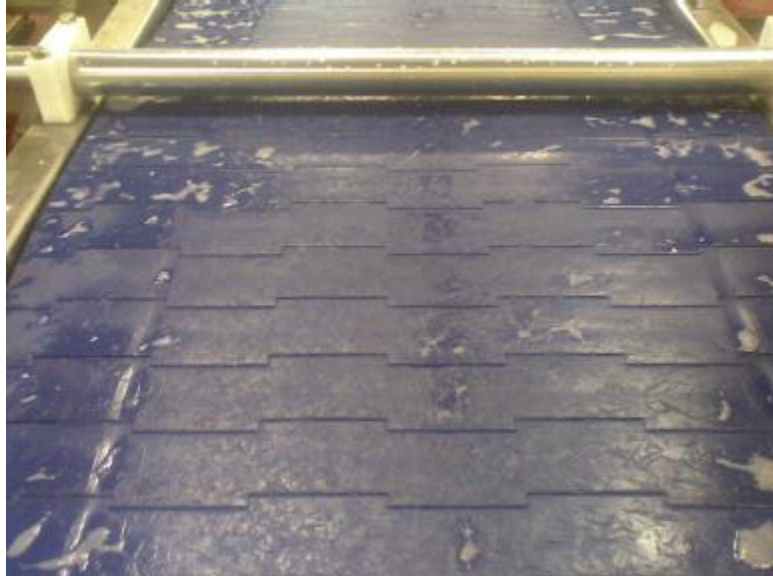
Figure 6: Day 1 Lamb Shoulder Belt 05:00 (prior to commencement of production shift). No UV Disinfection

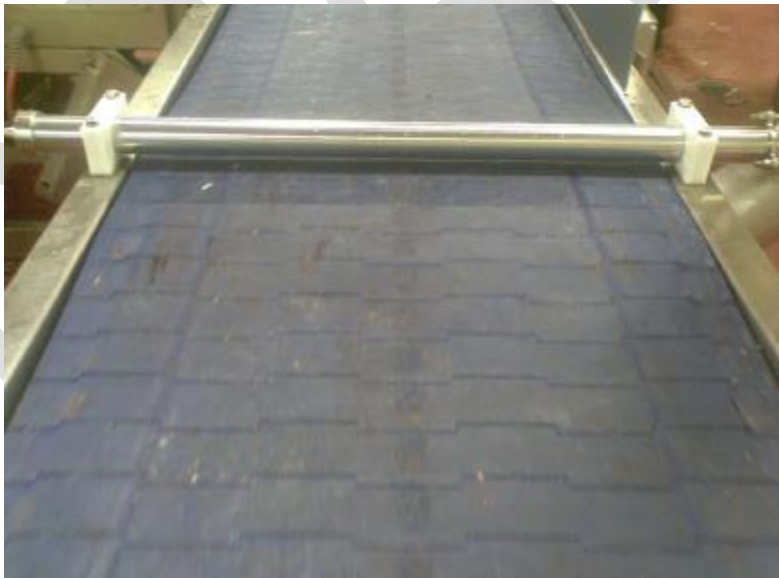
Figure 7: Day 1 Lamb Shoulder Belt 07:00 - No UV Disinfection

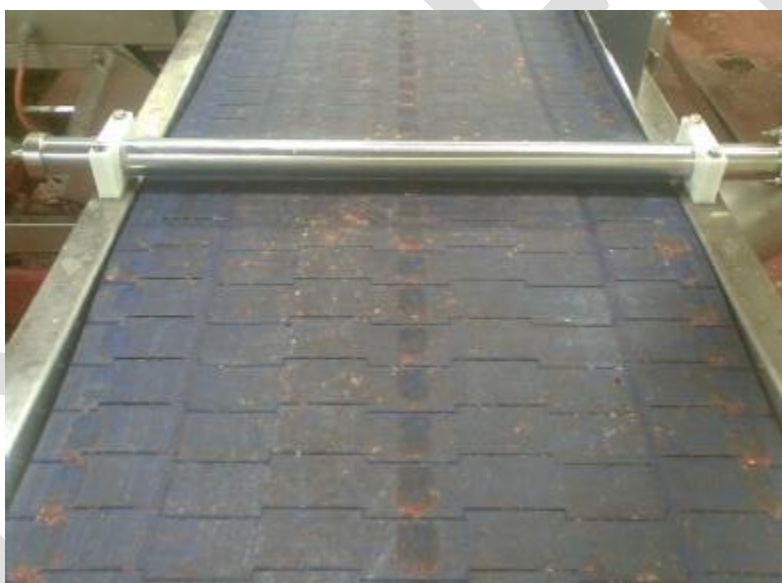
Figure 9: Day 1 Lamb Shoulder Belt 11:15 - No UV Disinfection

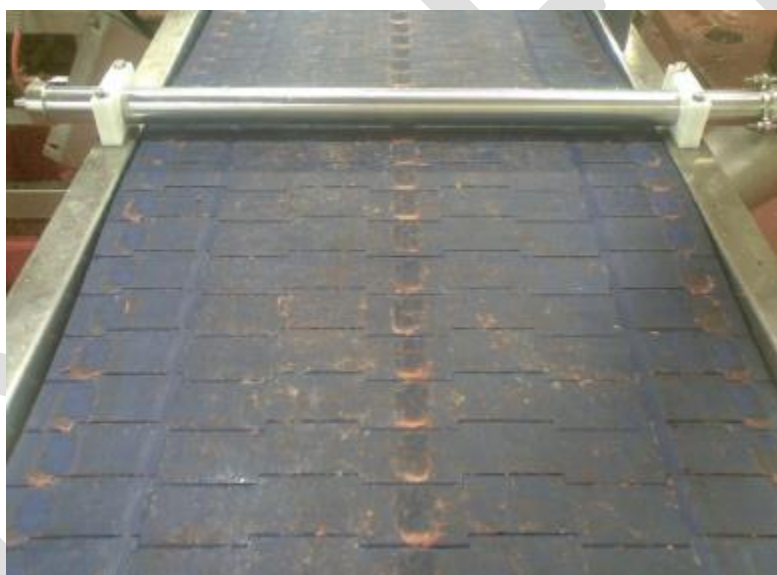
Figure 11: Day 1 Lamb Shoulder Belt 13:20 - No UV Disinfection

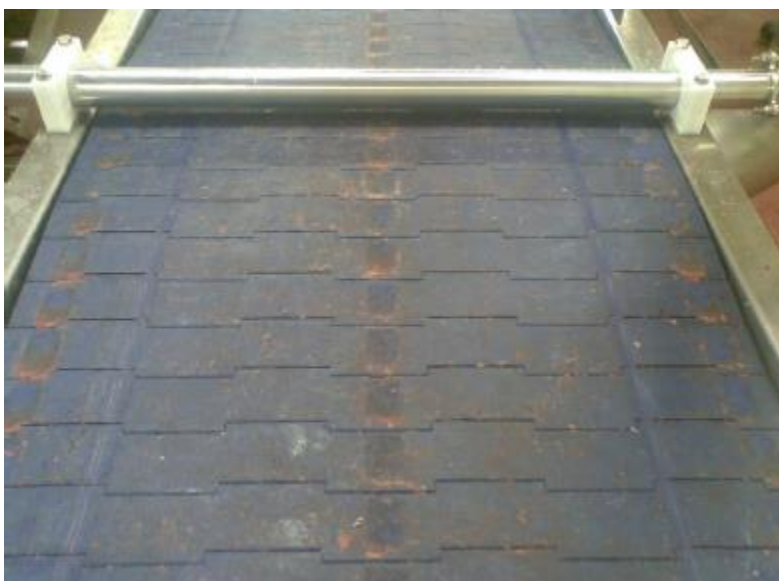
Figure 12: Day 1 Lamb Shoulder Belt 14:45 - No UV Disinfection

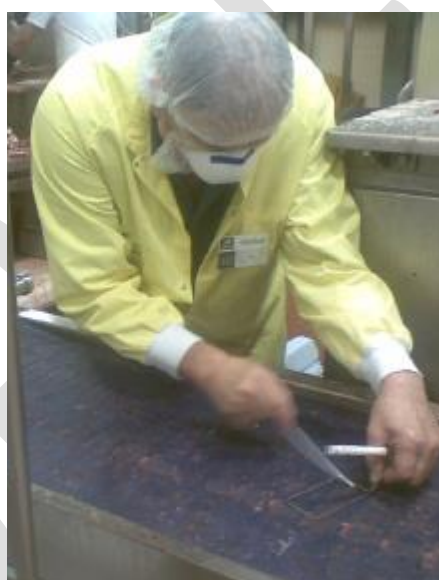
Figure 13: Day 1 Swabbing Lamb Shoulder Belt 14:45 - No UV Disinfection

On each day, swab samples were collected from the belt surface according to Australian Standard AS 2997–1987 Appendix B. Two grid sizes were used for swabbing, 50 cm<sup>2</sup> and 25 cm<sup>2</sup>. Duplicate swab samples were taken before operation began (freshly cleaned belt surfaces = time 0 hours), approximately 1.5, 3, 6, and 7.5 hours during the morning shift and at the end of the shift (about 8.75 hours). Microbiological testing of swab samples included E.coli counts and Total Bacterial Counts (TBC). The “Direct Plate-Out Method” and “Pour Plate Method” were used.

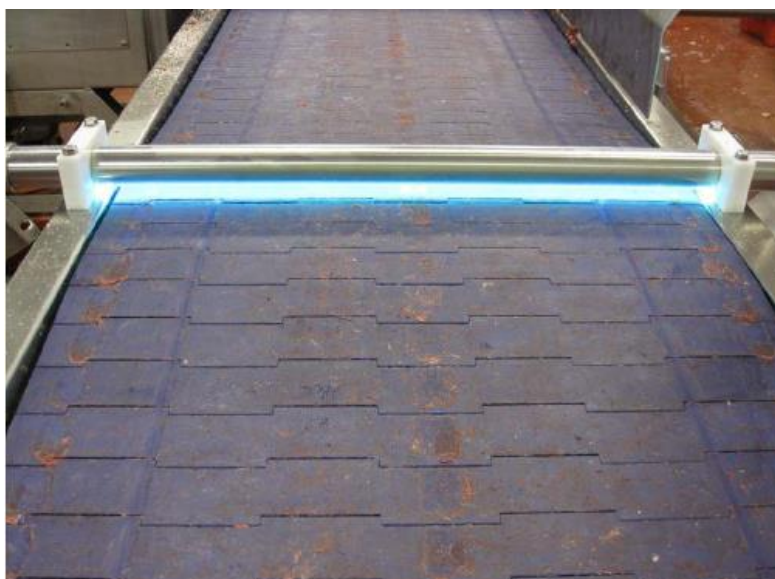
Figure 18: Day 2 Lamb Shoulder Belt 13:31 with UV Disinfection
